Cavity Critter

Under floor Inspections

Date: 6 September 2017

Prepared by: Gideon Couper

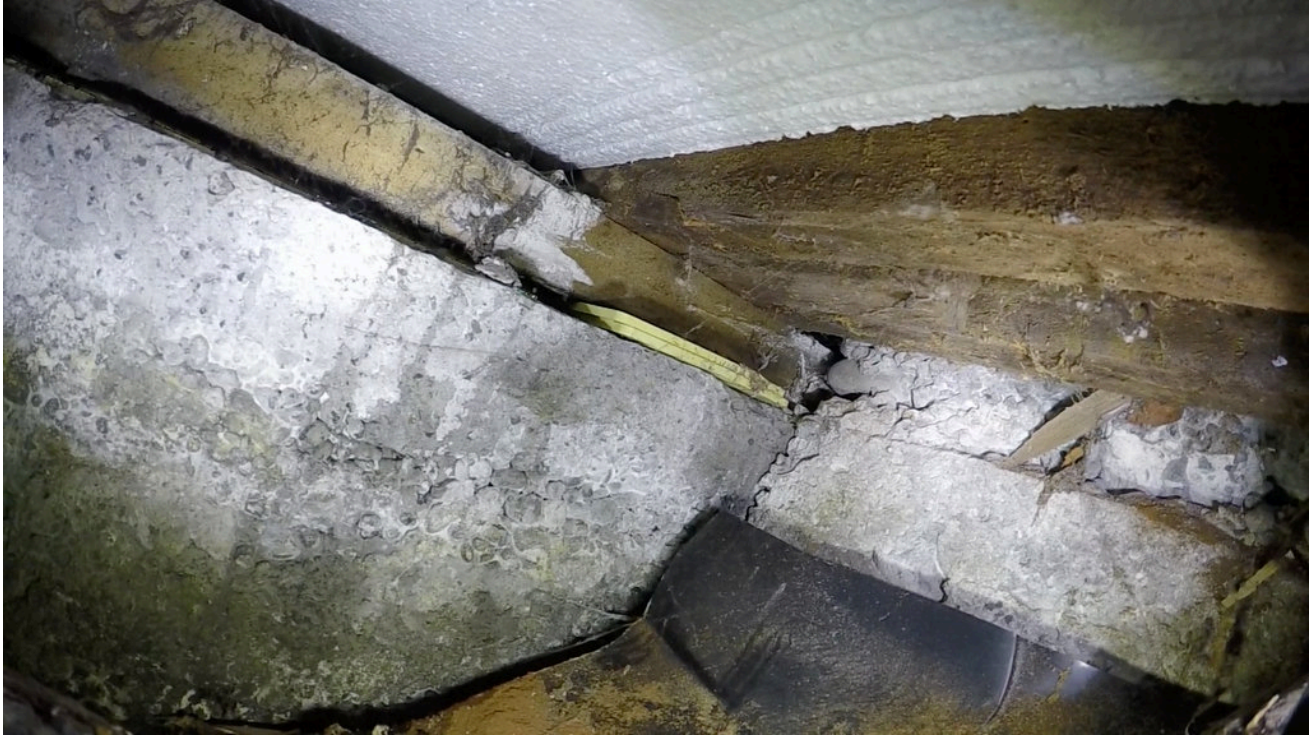
3: Here we can see that the ring foundation plate has been packed. This has taken place right along this foundation. Plastic packers are not recommended, as they are slippery and hard to fix in place. These are not fixed in place and there is no fixing bracket to the foundation.

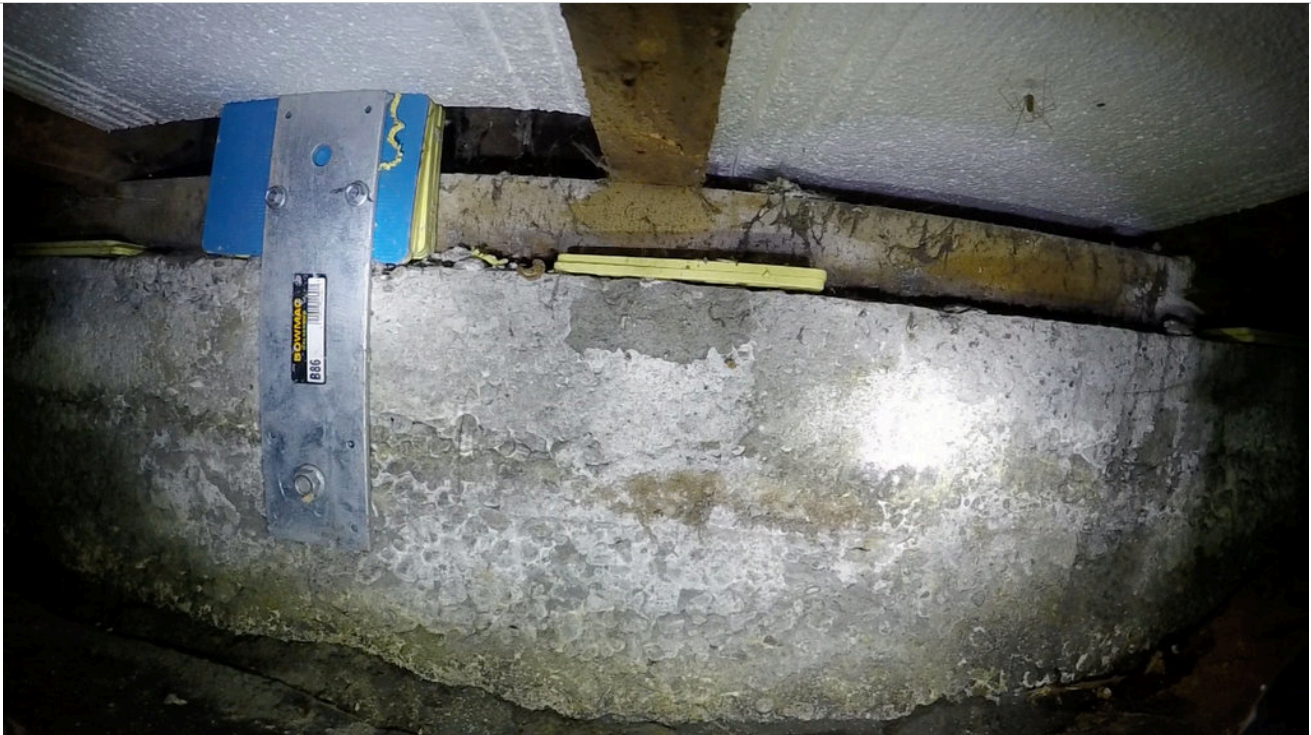
4: Here we do see a fixing bracket but again we see multiple packers. All packing should be done with the minimum amount of packers, ie cut to fit the gap. Ideally the ring foundation should be fully supported not packed and fixed intermittently.

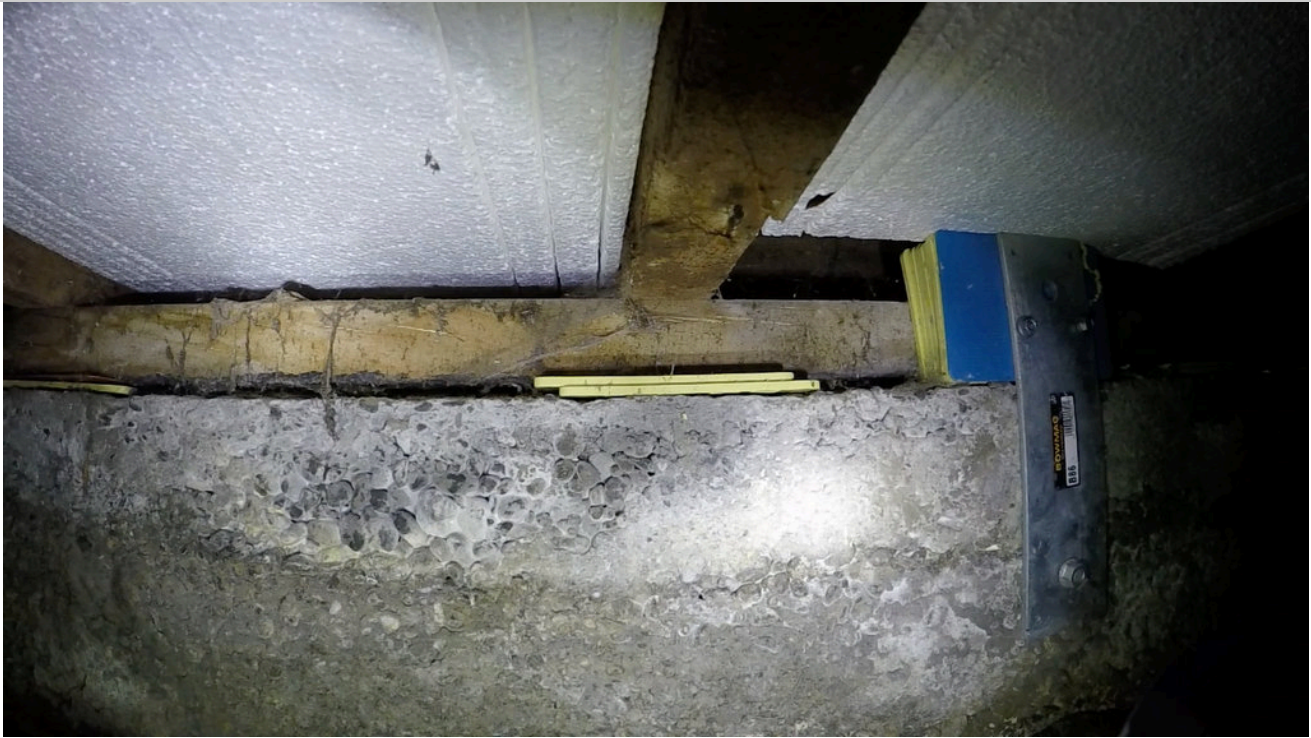
5: The packers are sited under the joist loading points.

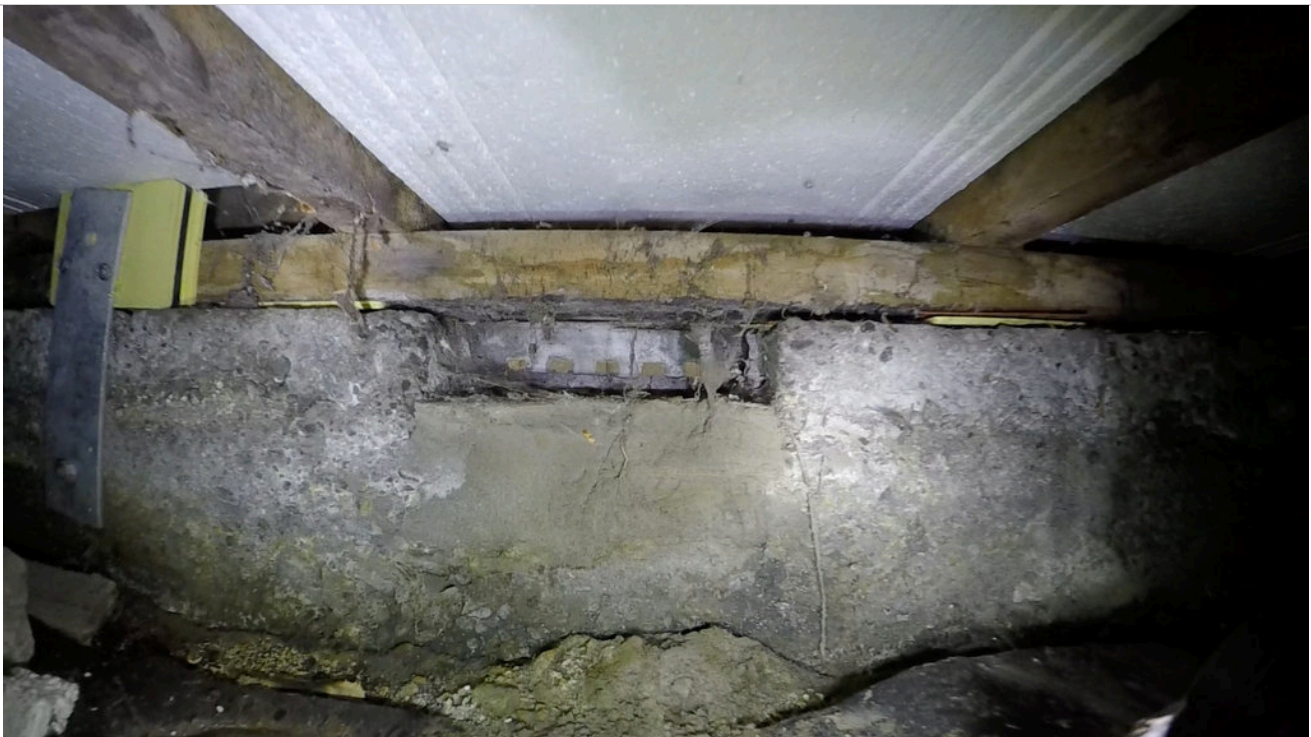
6: This vent is blocked and it appears to be blocked with liquefaction. There is evidence of there having been significant liquefaction along this section of the home.

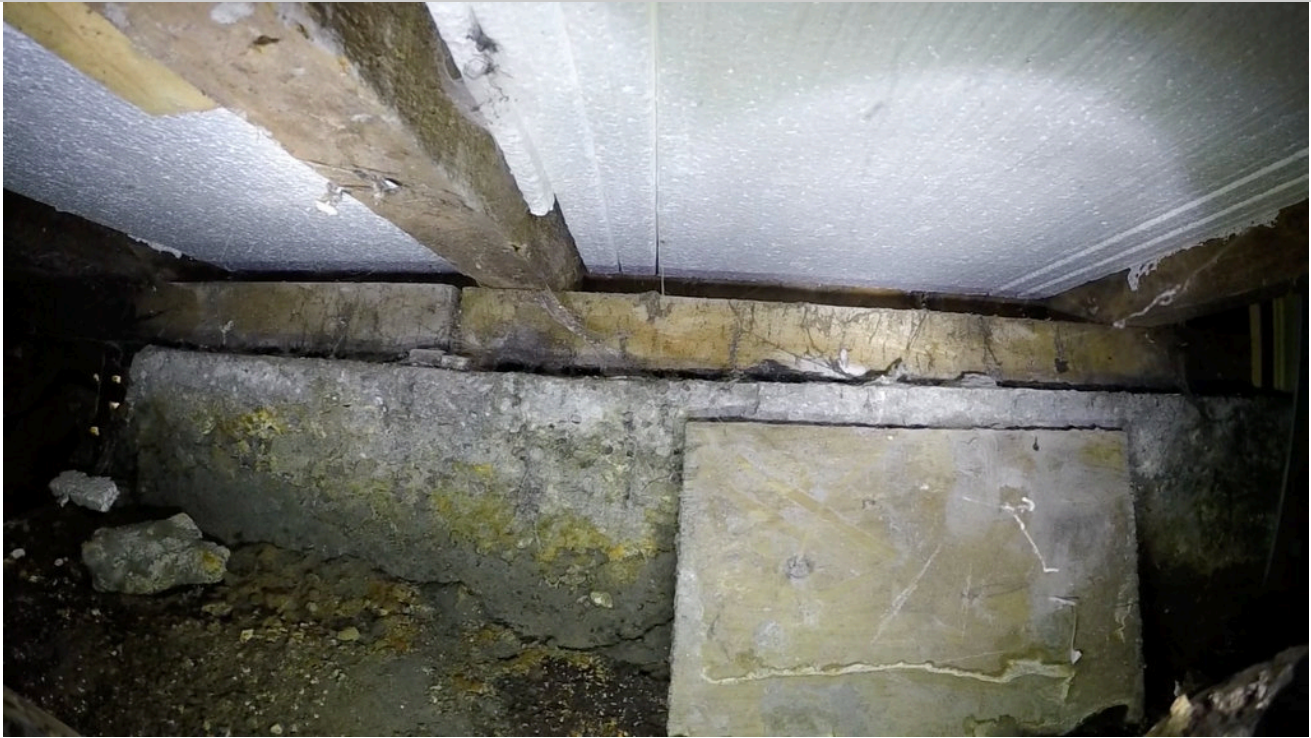
7: Here the packers have been changed to small bits of random stuff. All packers should be h3.2 treated timber and these are not that.

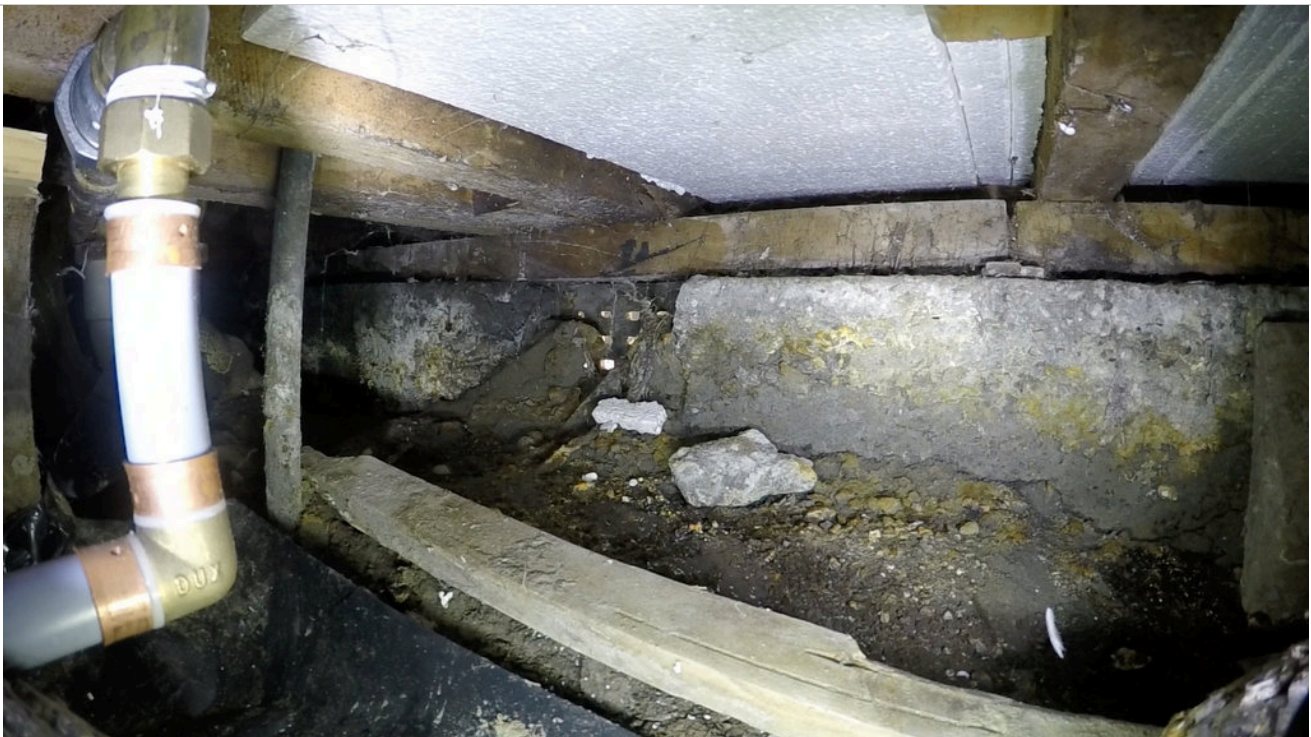
8: There is some liquefaction in this area.

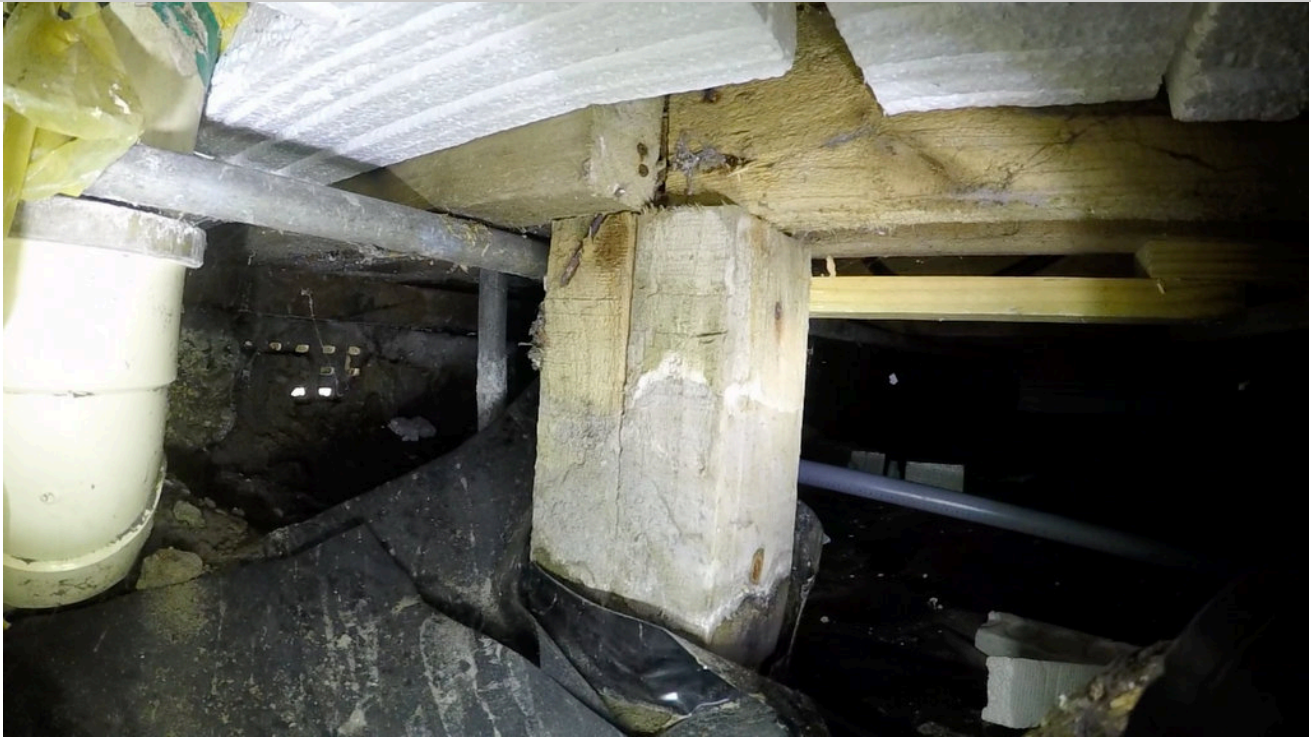
9: The joists have been altered here and are held on this non-compliant prop.

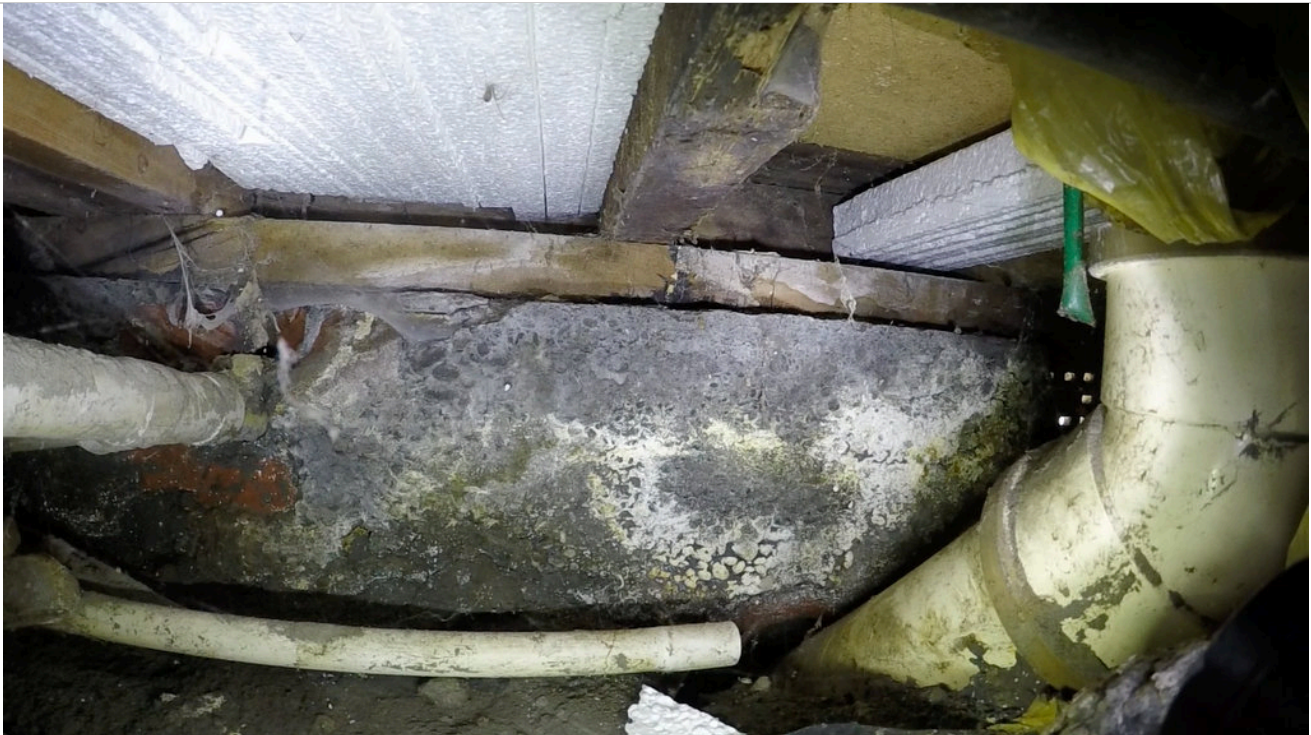
10: The foundations are average quality type “B” Rubble foundations. There has been extensive use of large stones and bricks in the aggregate. These can weaken the concrete and often create voids. The joist has extensive borer.

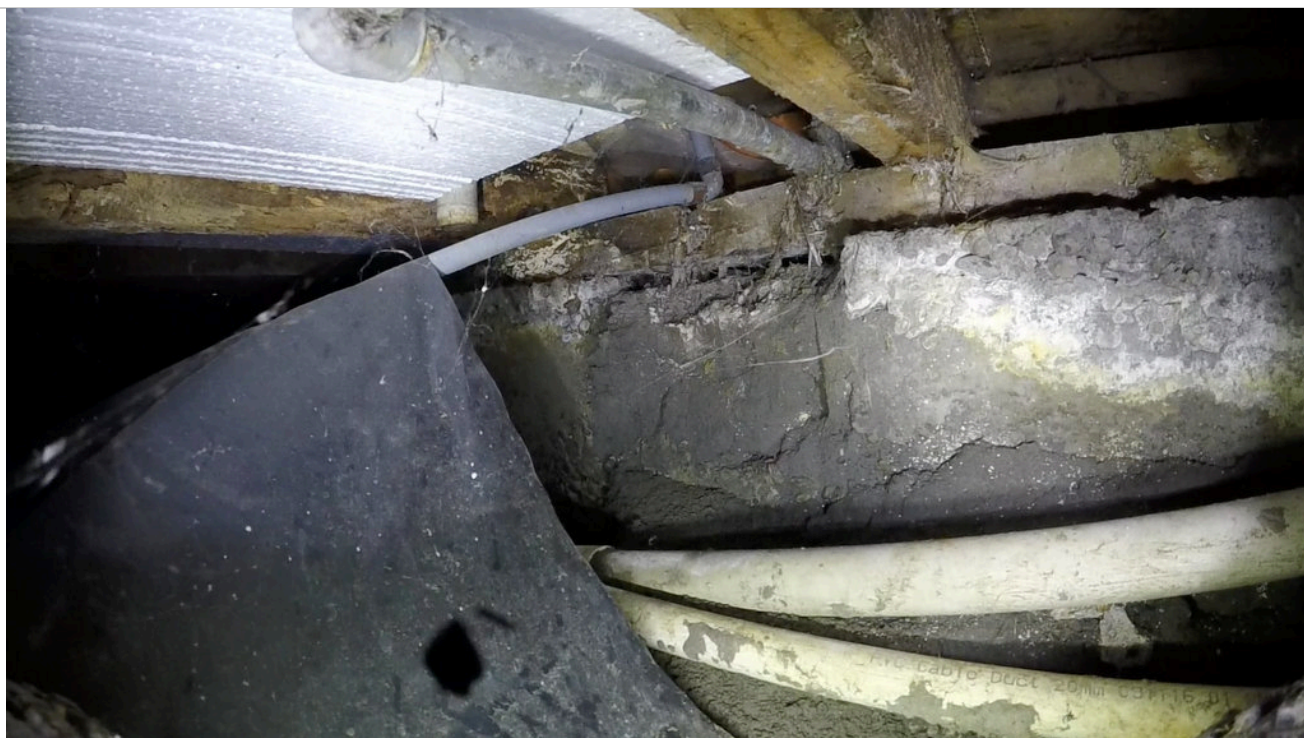
12: Here again liquefaction is blocking the vent.

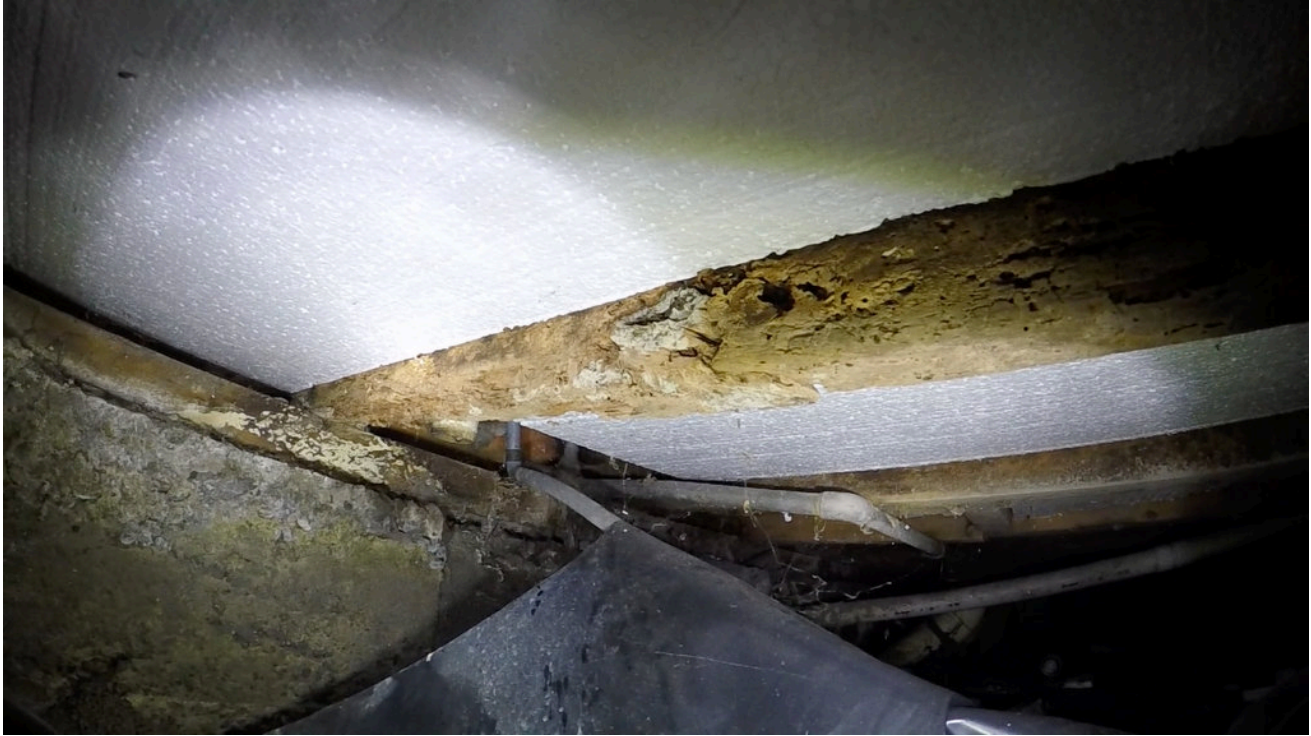
13: This joist has terminal borer and the ring foundation is rotting. It should be noted that if this is that bad then the surrounding timber is likely to be in poor condition as well. However, this is obscured by the polystyrene.

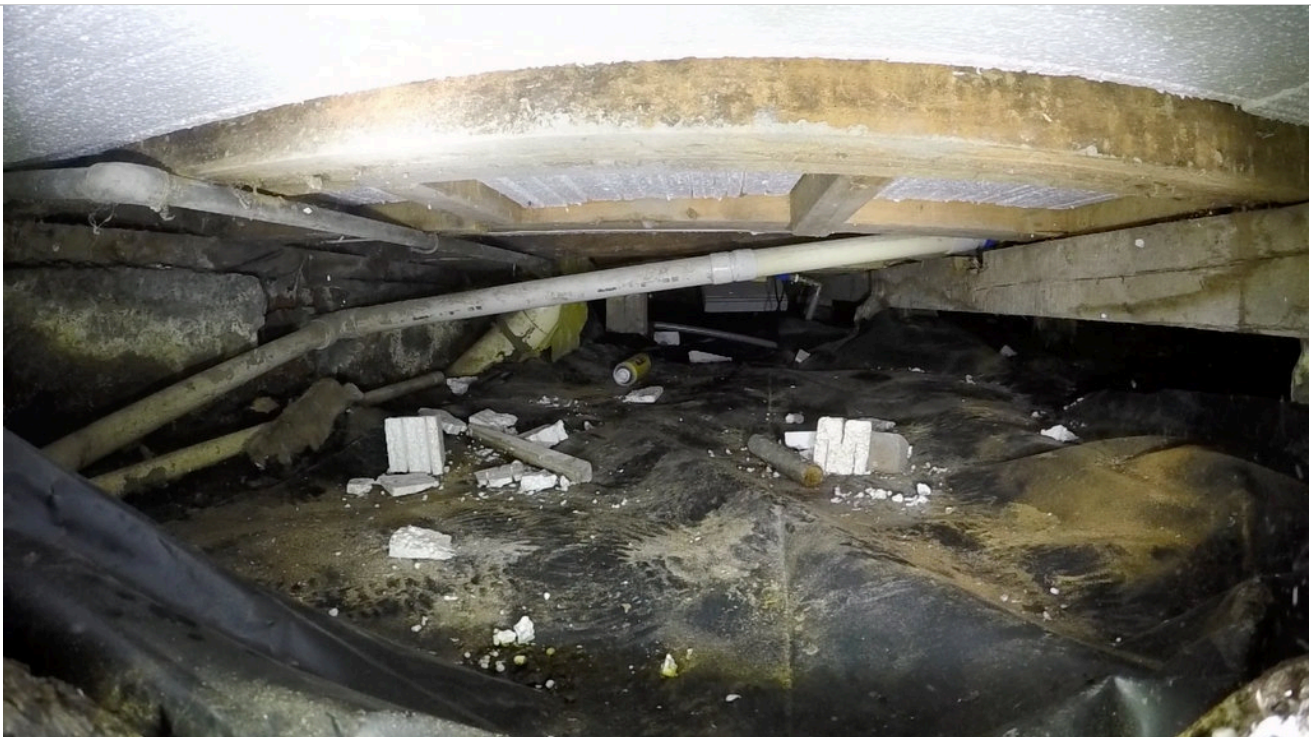
14: The brown powder on the ground is borer excrement, the thicker this lays on the ground the worse the borer involvement. So heavy involvement here.

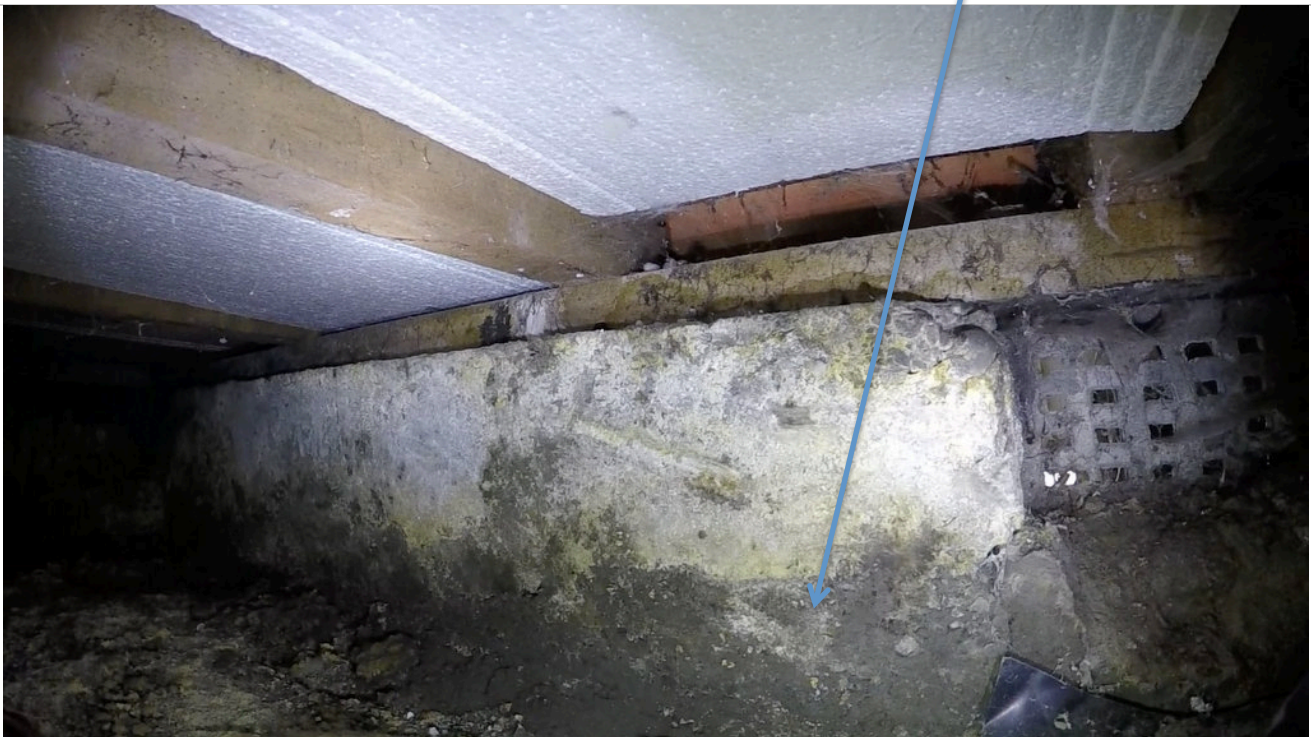
16: View of ring foundation. Here we can see the height that the liquefaction was at before being removed.

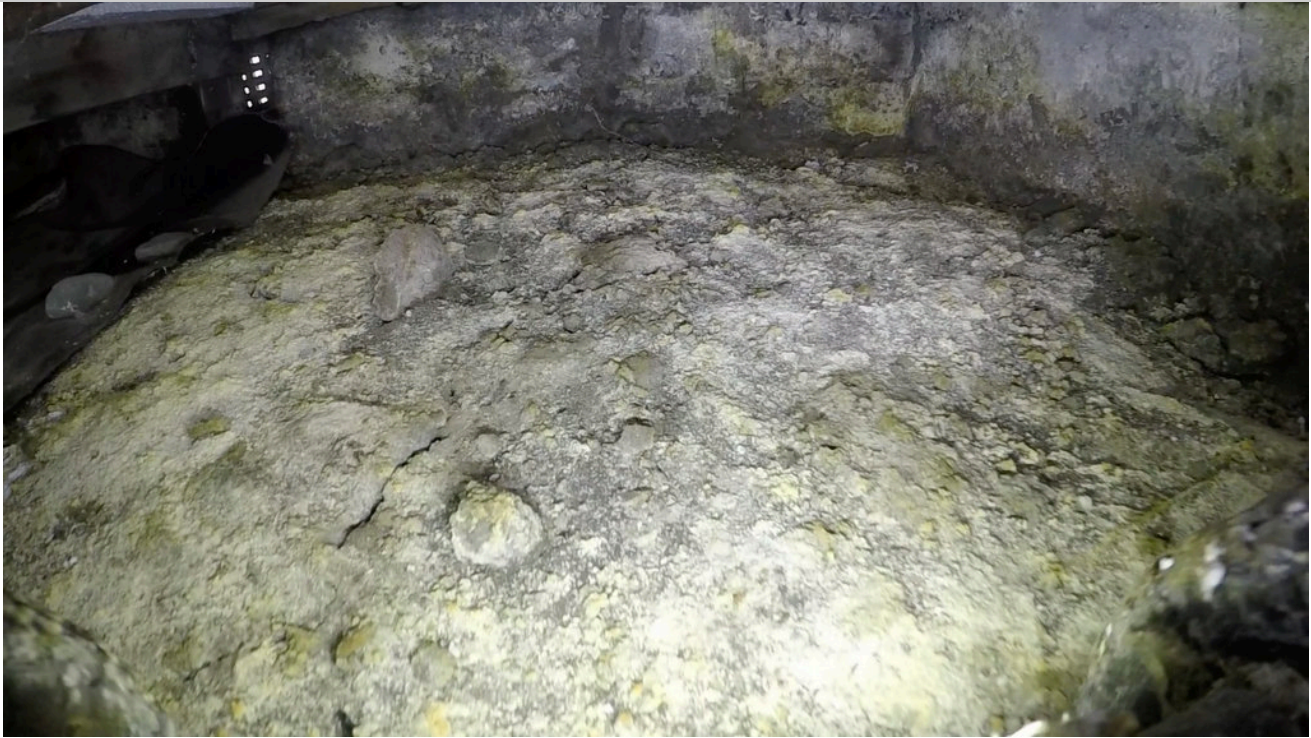
17: This is the only area we could see under the polythene, we can see extensive mold growth on the ground.

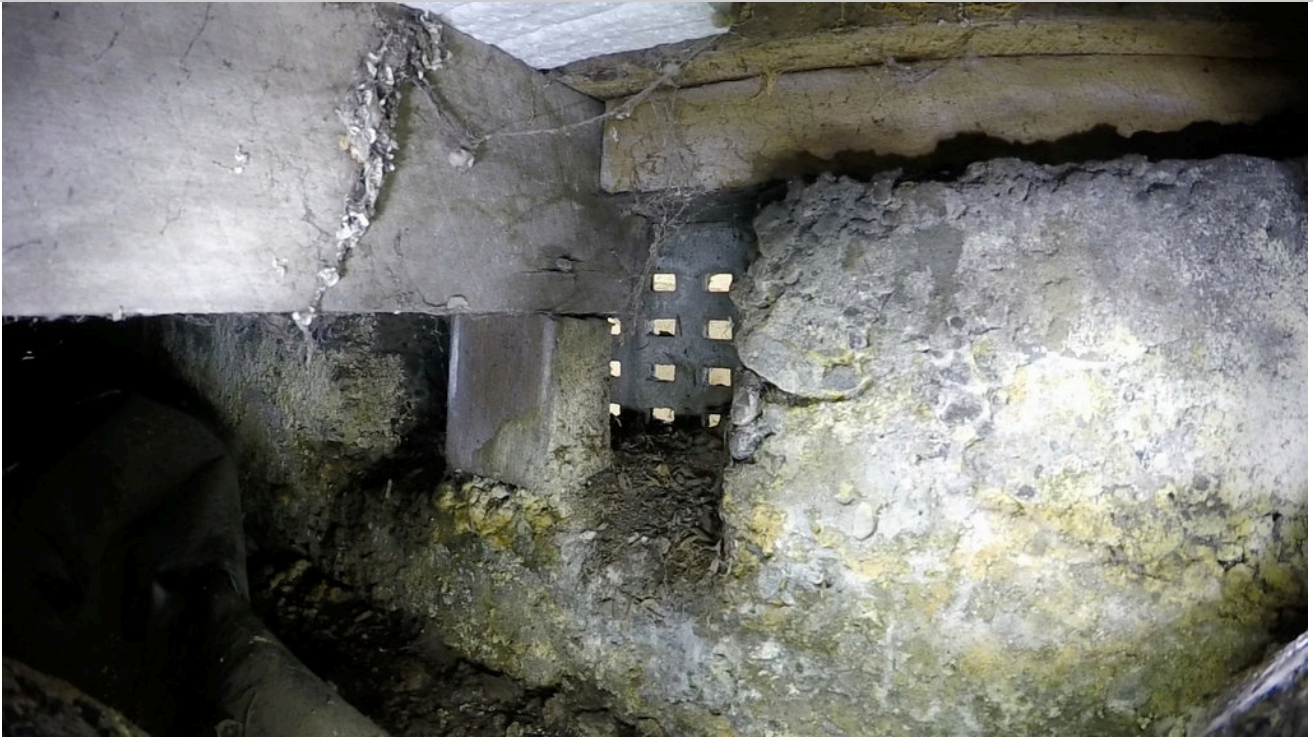
19: At this end of the home all the bearers are sitting on blocks in the vents. This is not suitable support but this was how it was constructed at the time of the original build.

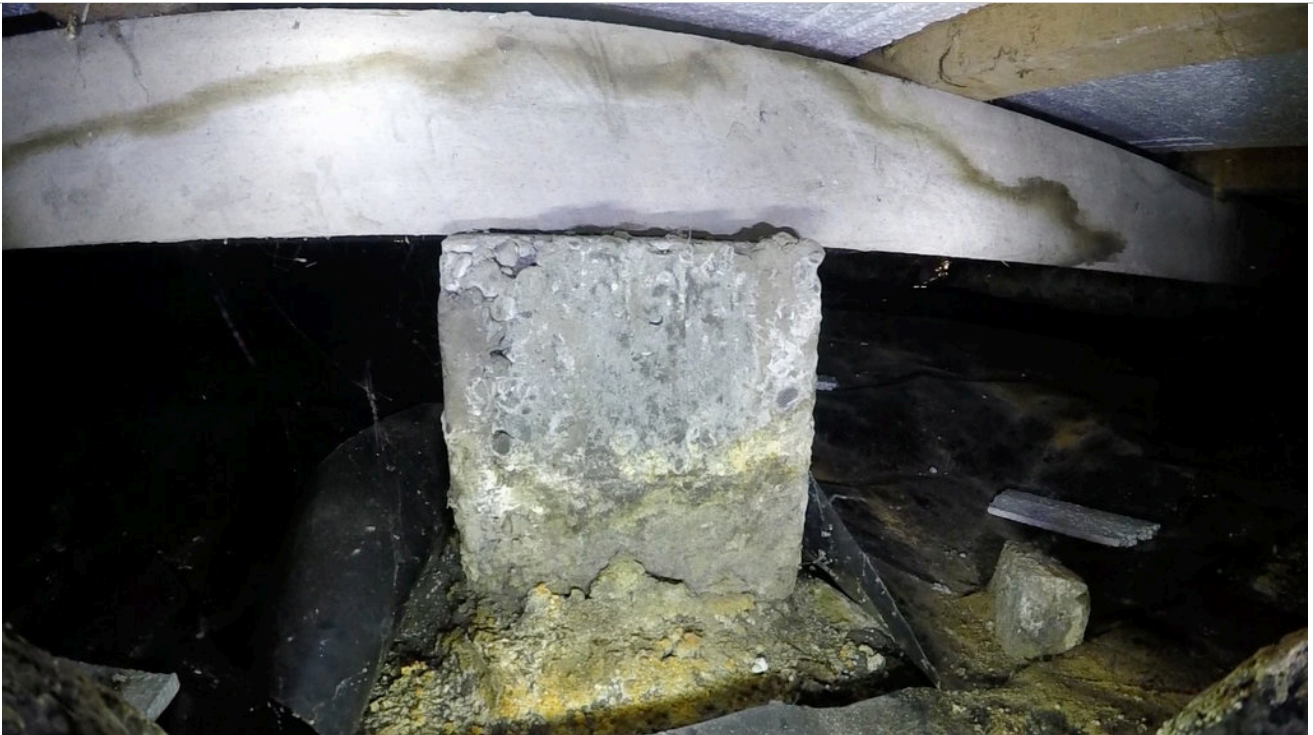
20: The original piles are precast concrete and lack any wire connections.

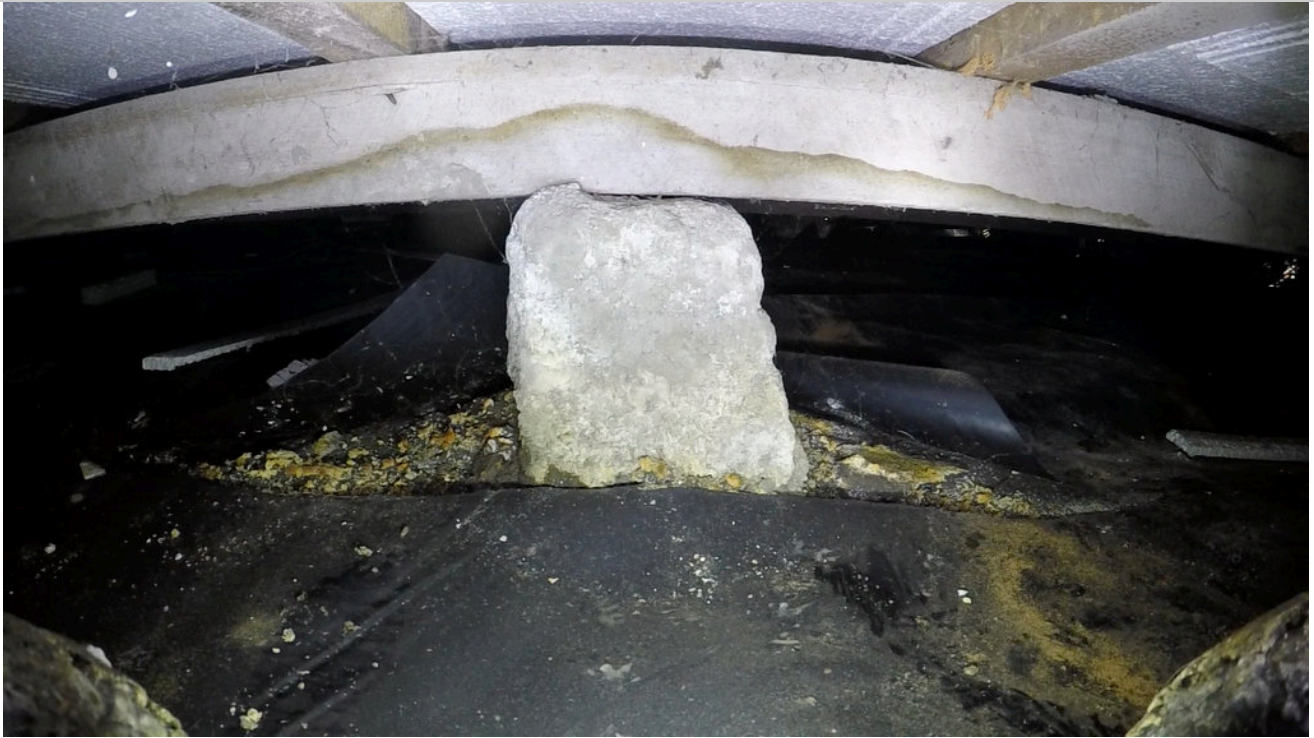
21: Precast concrete pile with no connection.

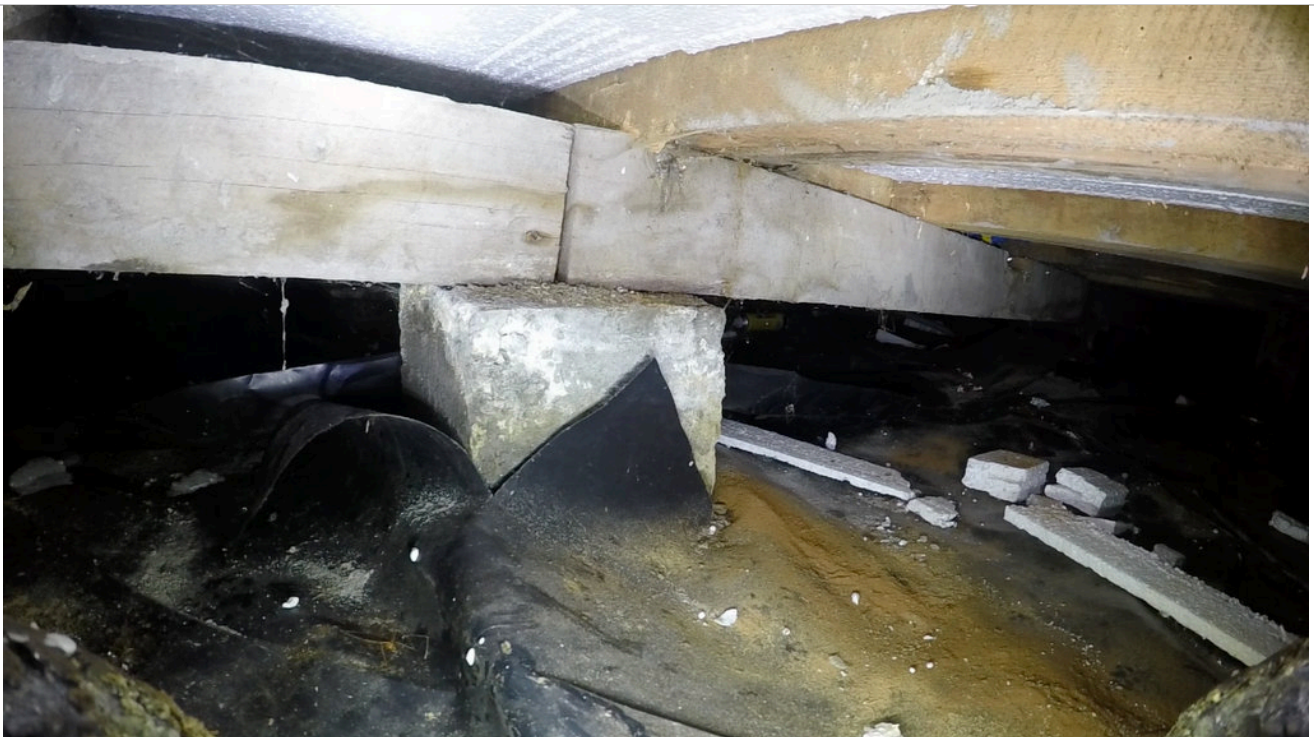
22: Precast concrete pile with no connection. These joists have extensive borer.

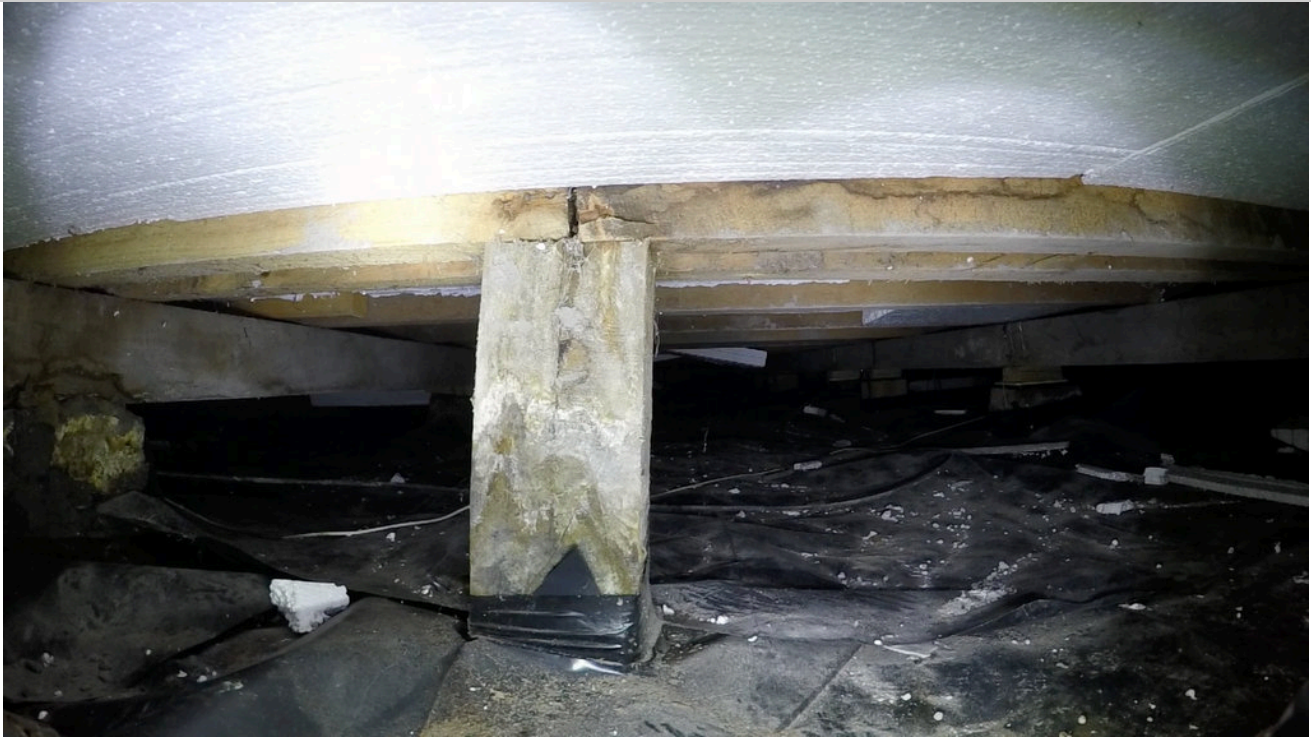
23: Here we see a cut joist with a non-compliant prop/pile.

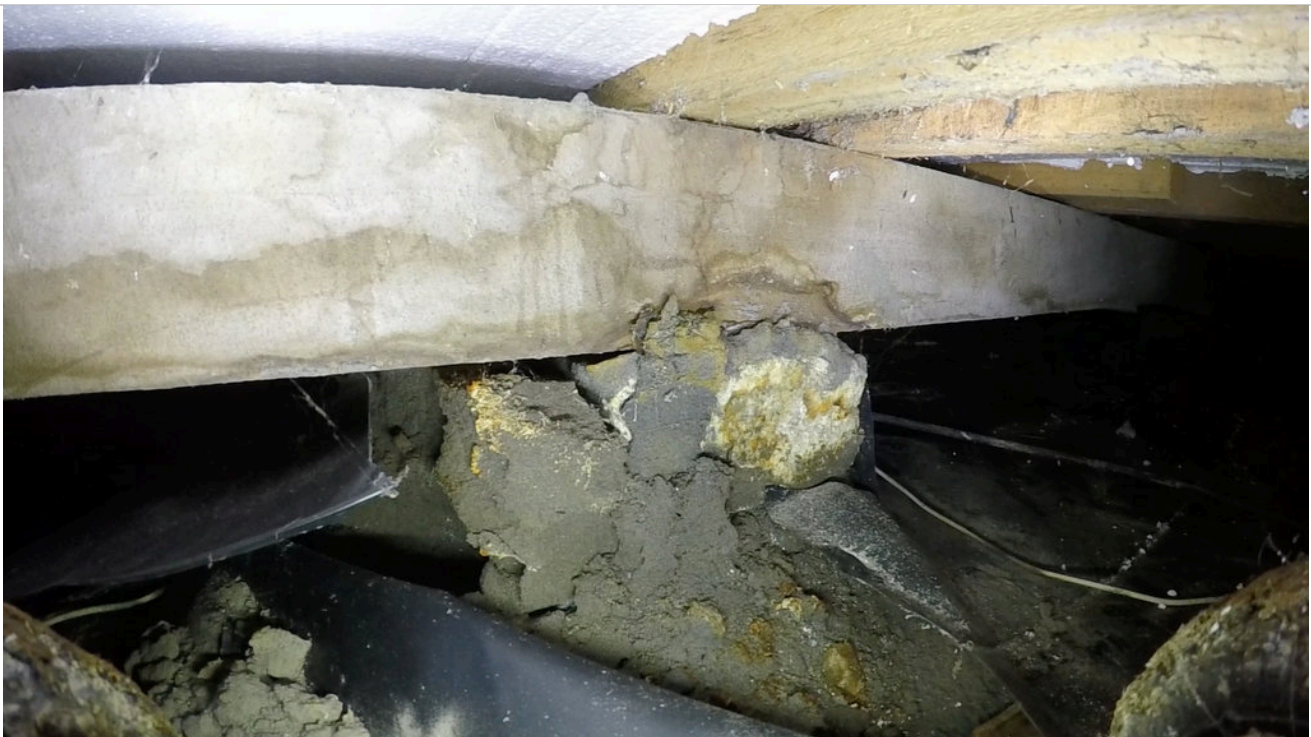
24: Precast concrete pile with no connection. Note the liquefaction around it.

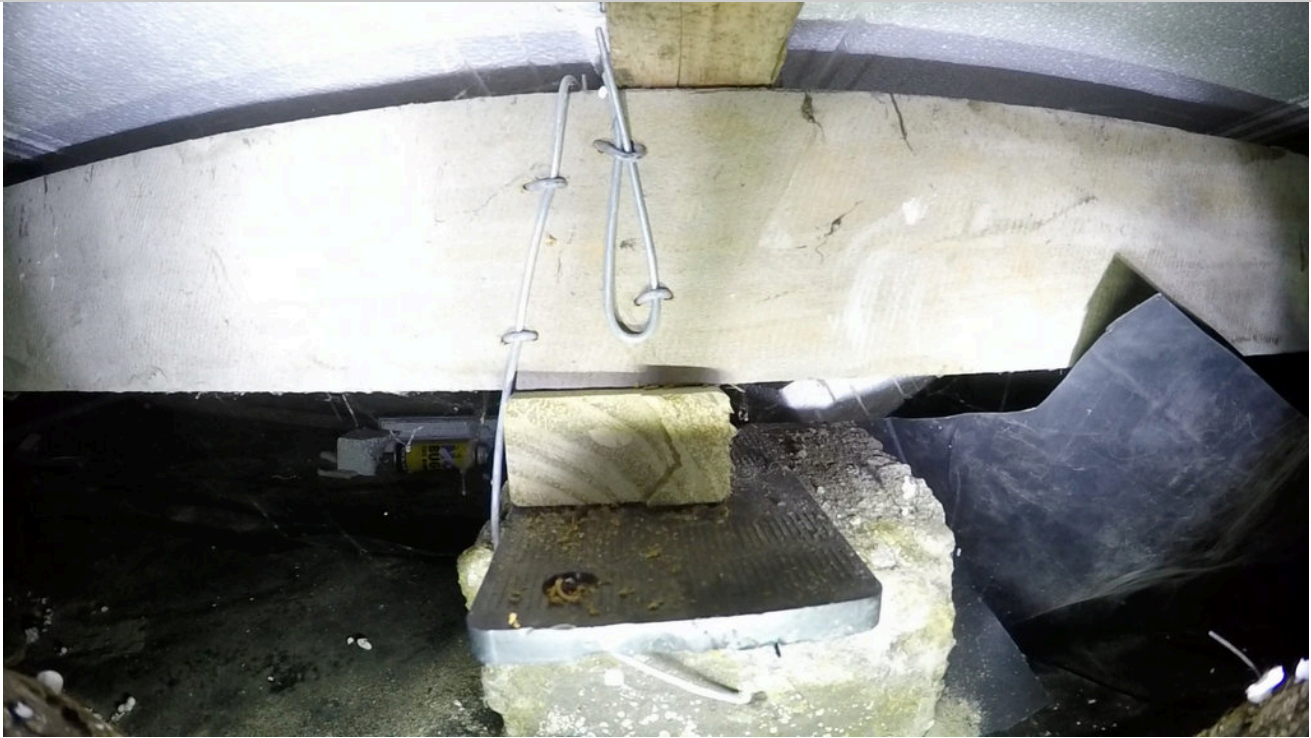
25: Many of the piles are packed. The wire connections have been carried out correctly but again see multiple packers, unfixed and of the wrong type.

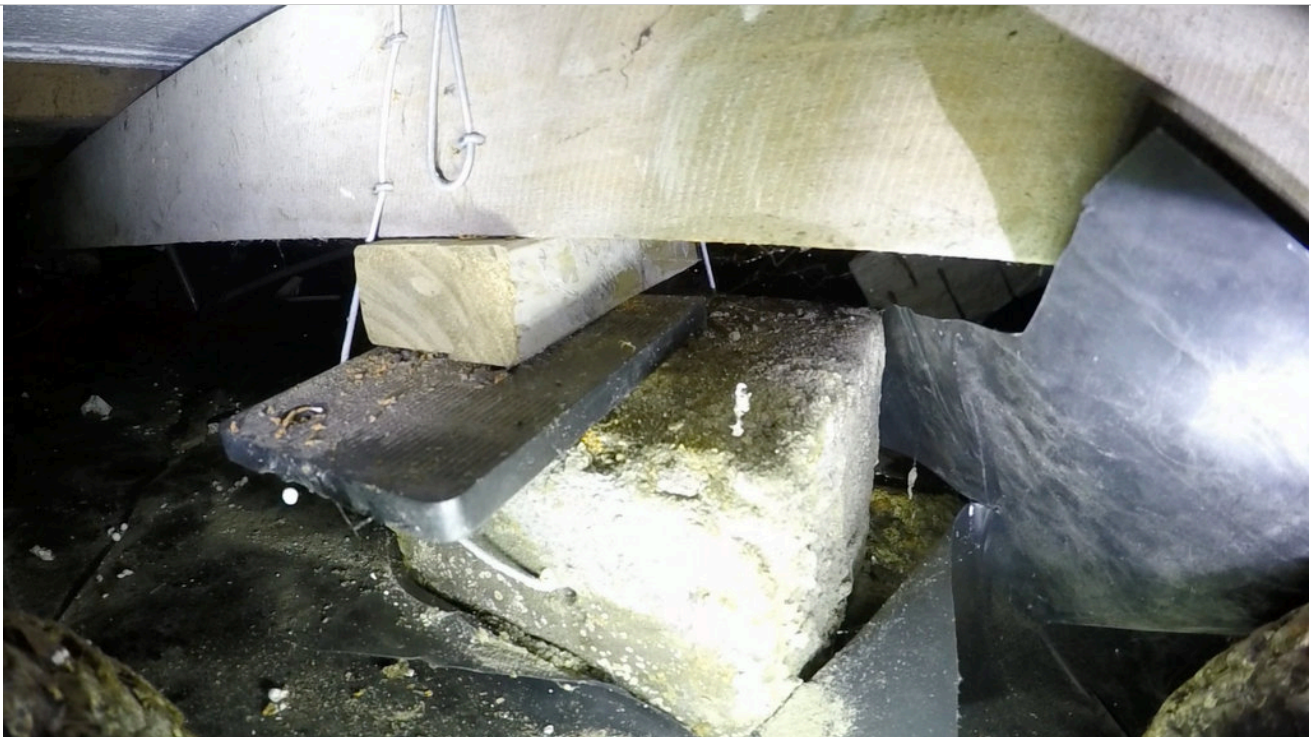
26: This is another view of the packers in 25. All packing of piles should be full width of the bearer and extend the full width of pile top and be fixed to the bearer.

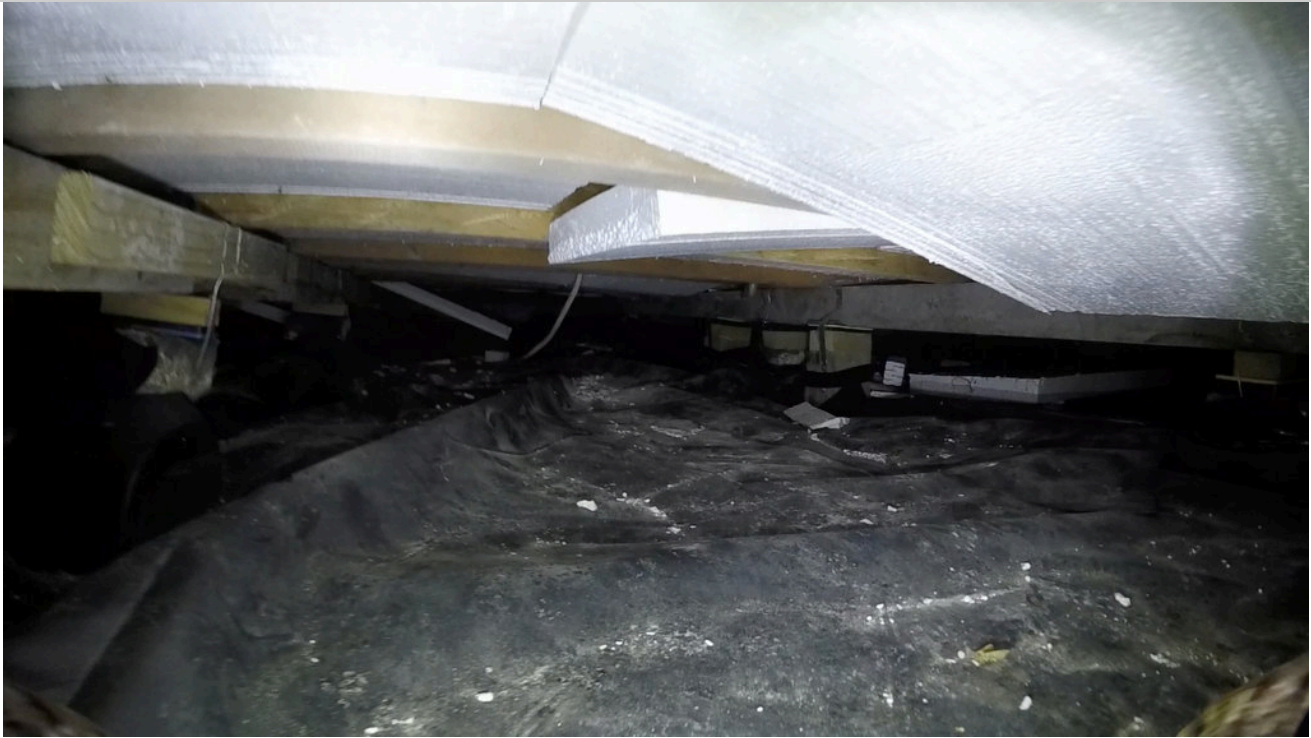
27: Another view of insulation falling down.

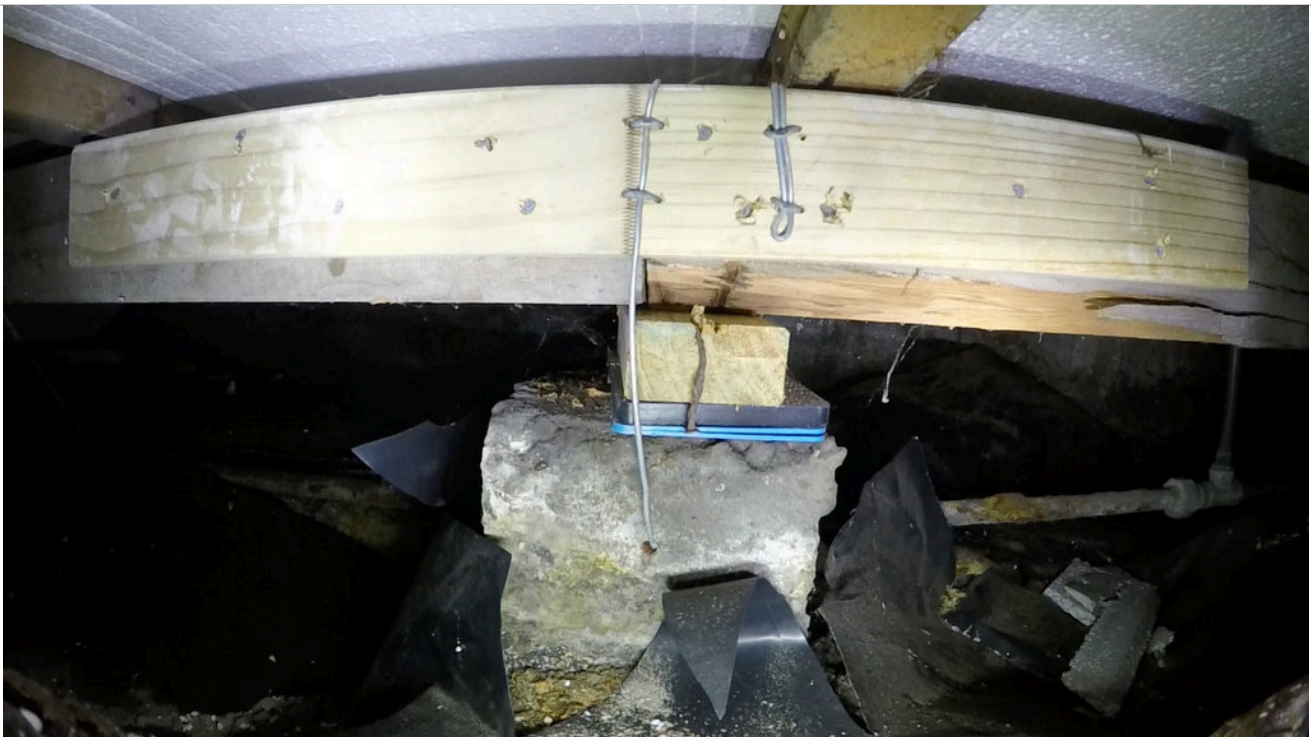
28: The connection is fine as is the bearer join connection but the packers are non-compliant and give poor support to the left bearer.
