Cavity Critter

Under floor Inspections

Date: 6 September 2017

Prepared by: Gideon Couper

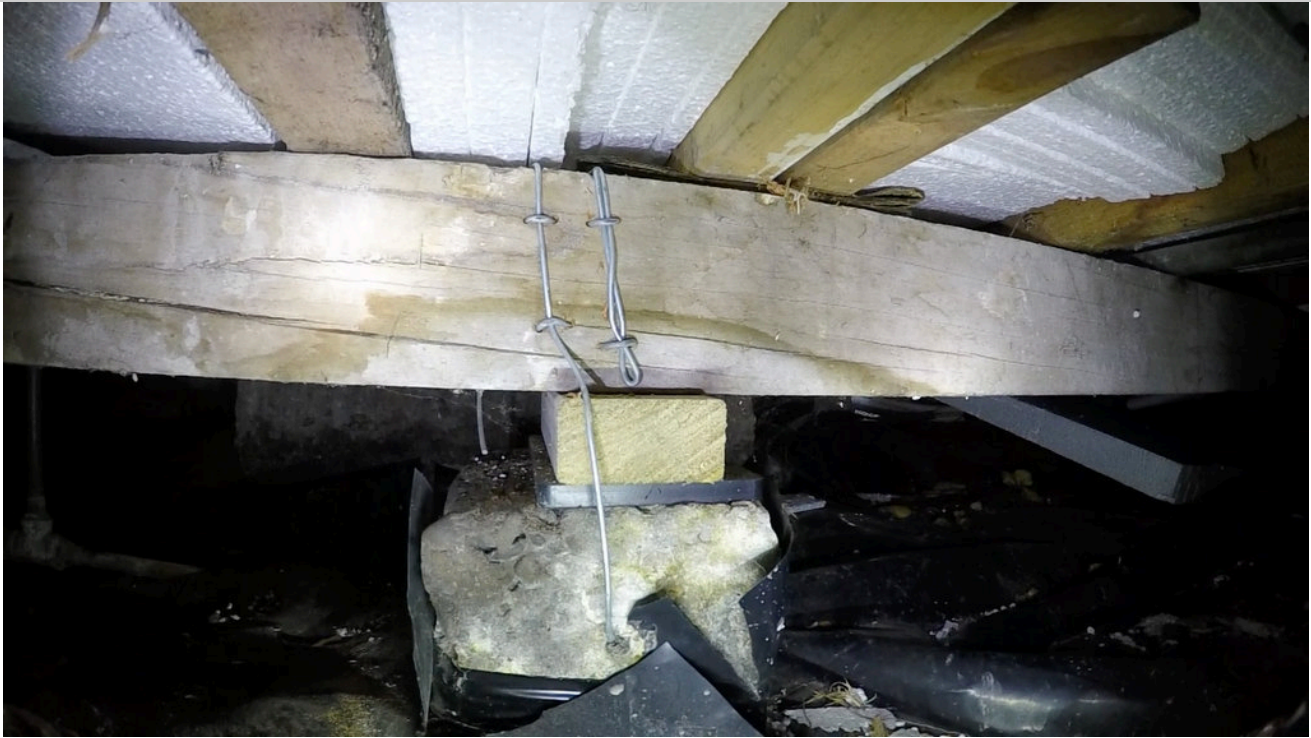
29: Pile with connection and non-compliant packers. Note that the joist has been packed as well.

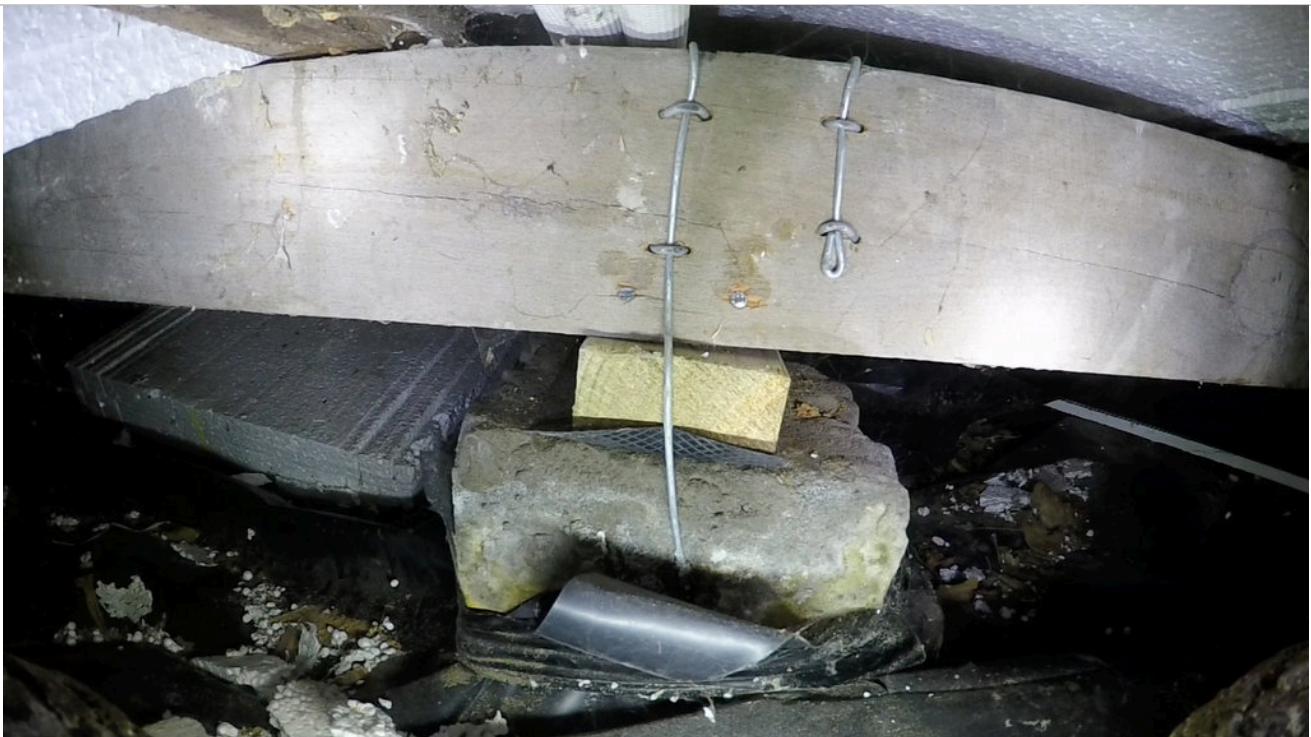
30: This packer is fixed and there is only one. It doesn't fully span the pile but it is better than the others.

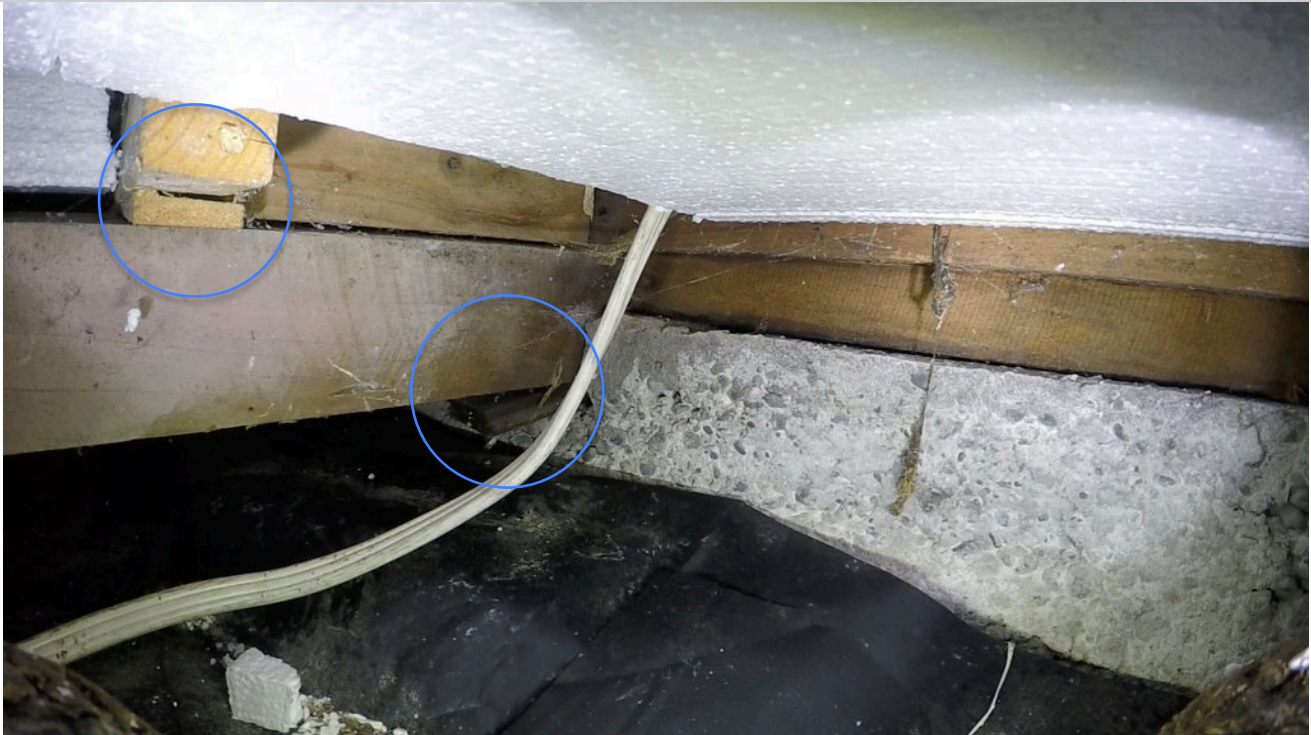
31: Here we can just see that the bearer has been packed with an old bit of flooring which appears to be falling out and also the joist has been packed.

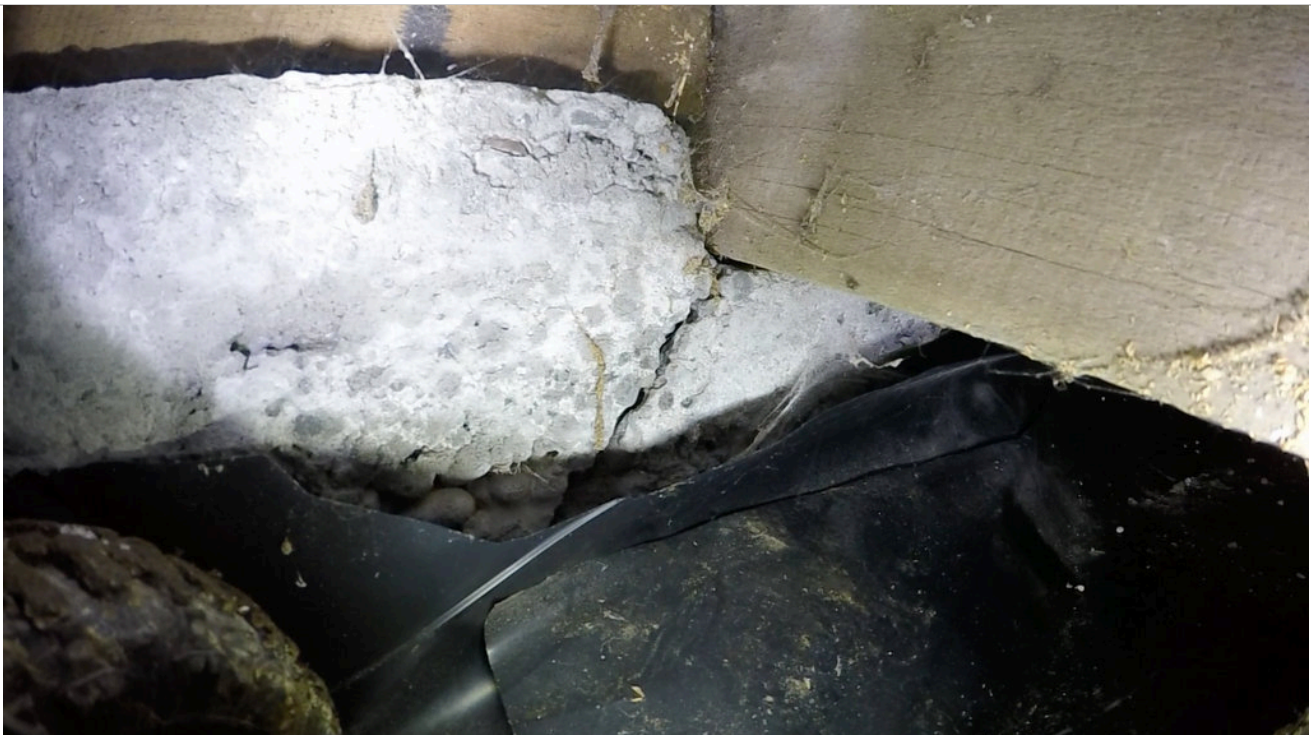
32: View of bearer meeting ring foundation with crack, approximately 5mm at its worst.

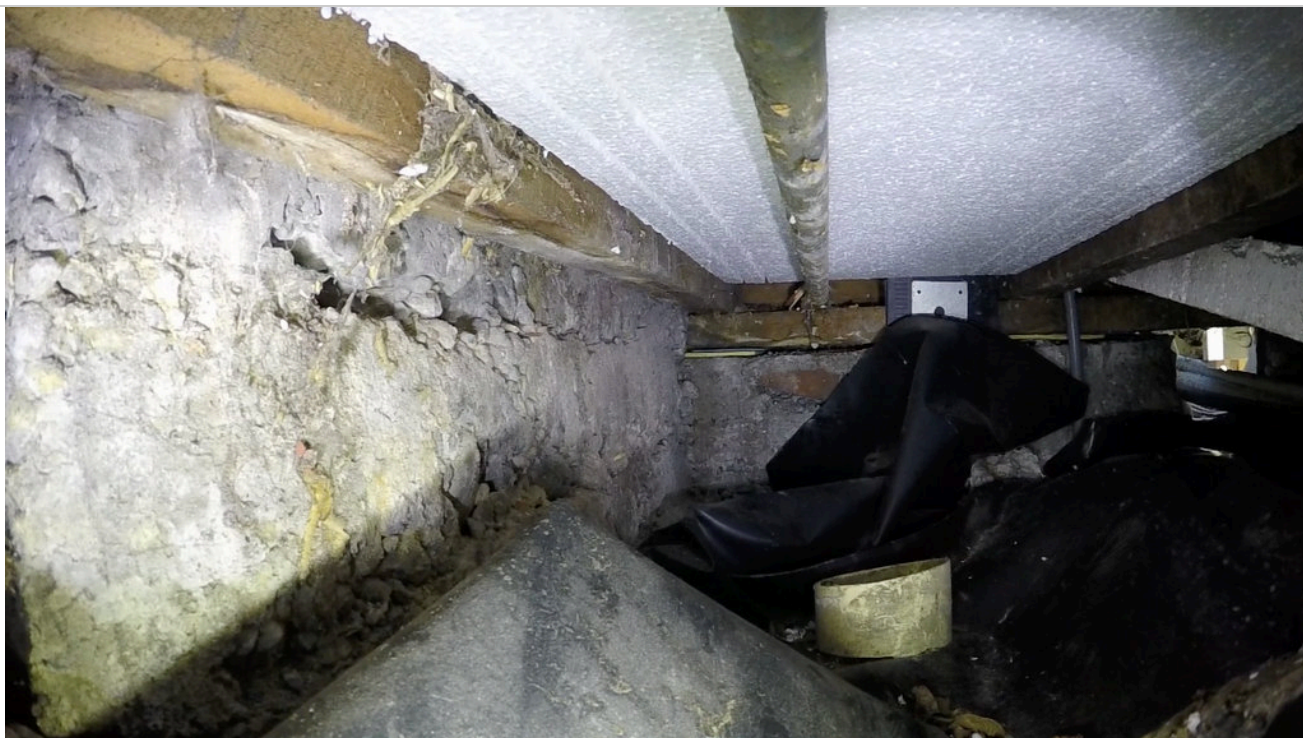
33: View along concrete base. We can see more foundation packing.

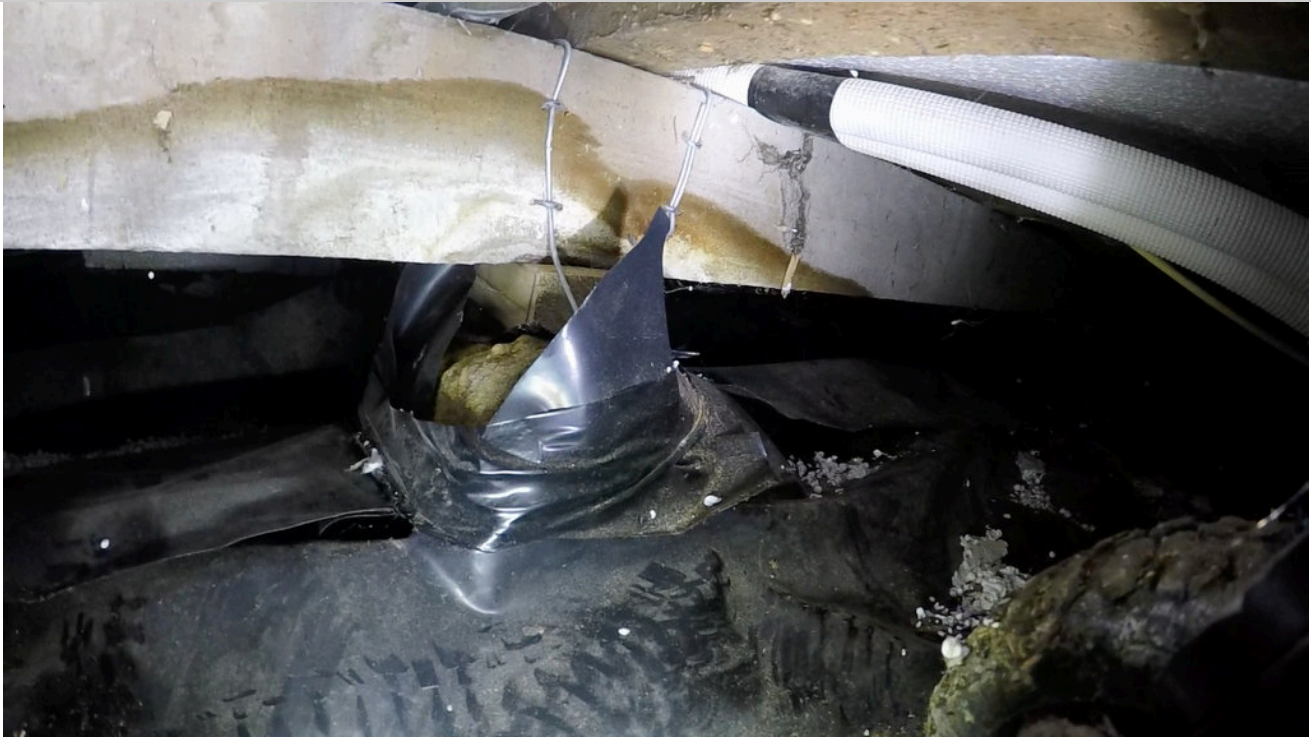
35: Pile with connection packer. The bearer appears to be rolling over.

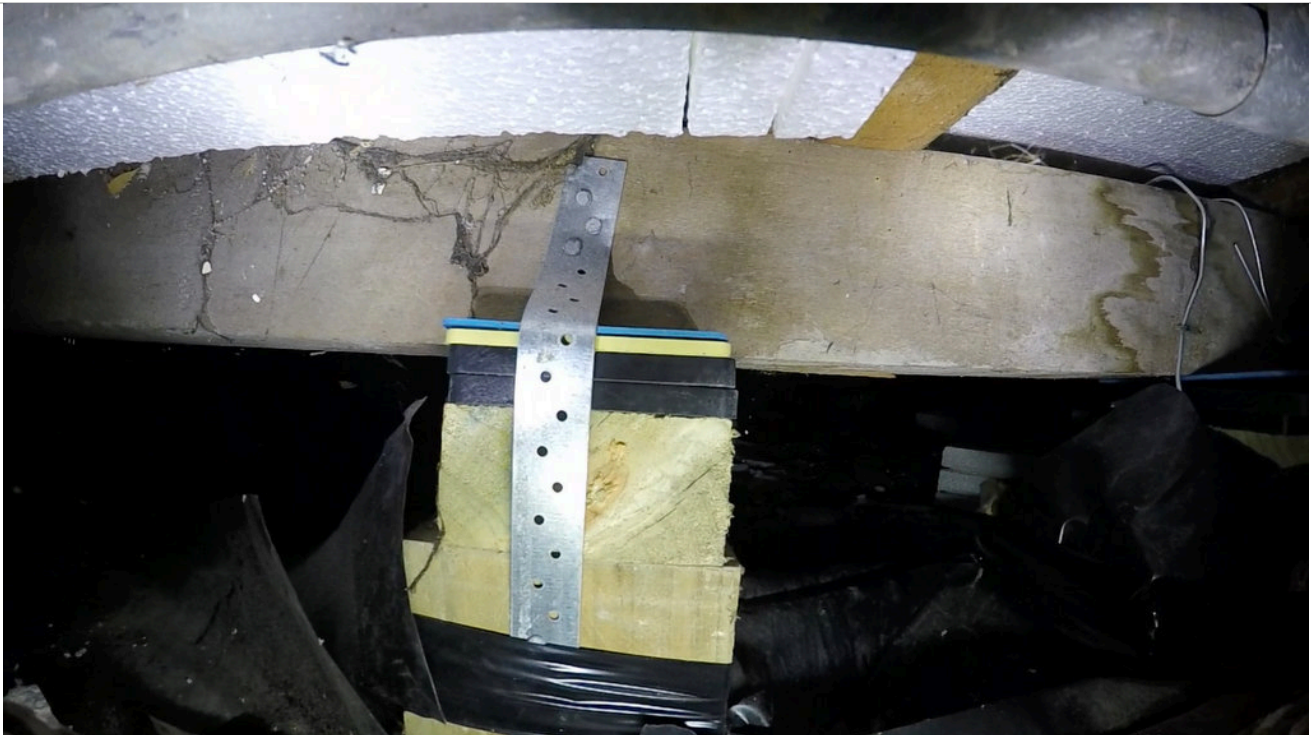
36: Treated timber pile with non-compliant packing and non-compliant connection. This fixing is electroplated. Pile fixing within 600mm of the ground is [required to be stainless](#) unless it is a wire fixing. (See code section 4.2)

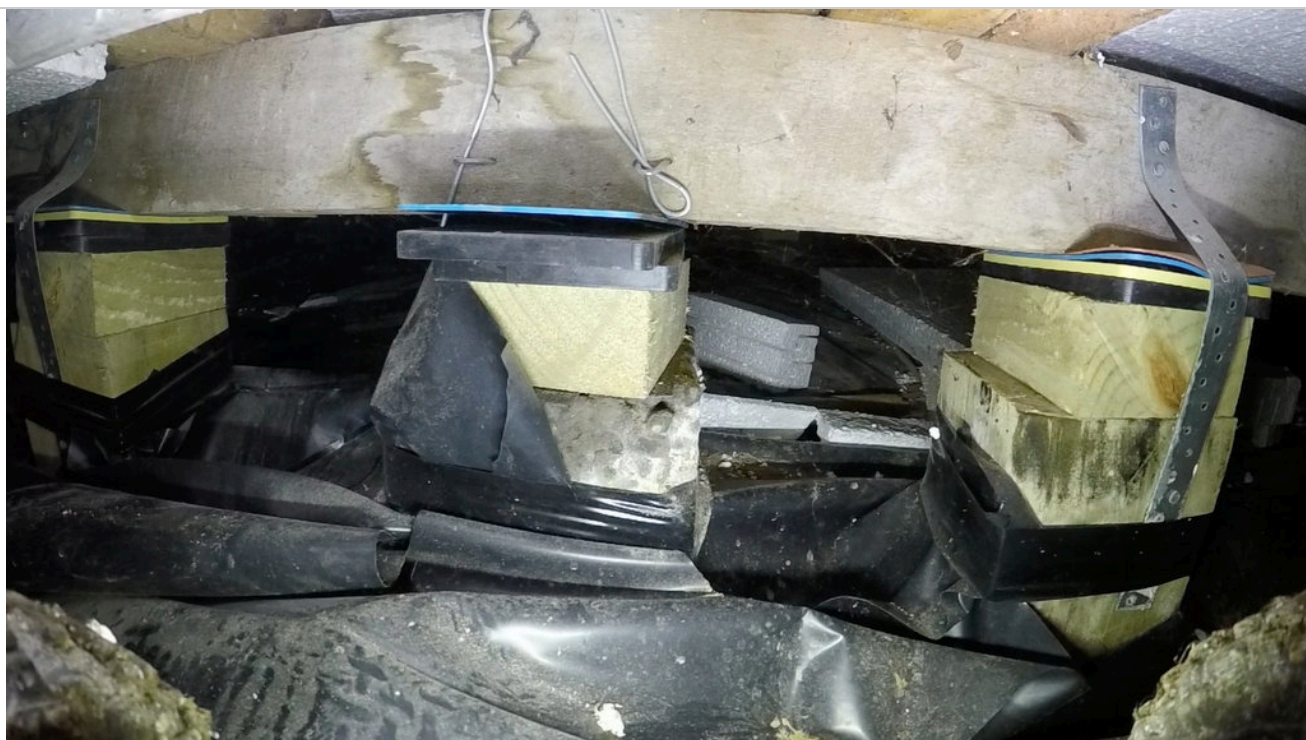
37: Pile with connection and non-compliant packers. This wire has not been stapled off correctly.

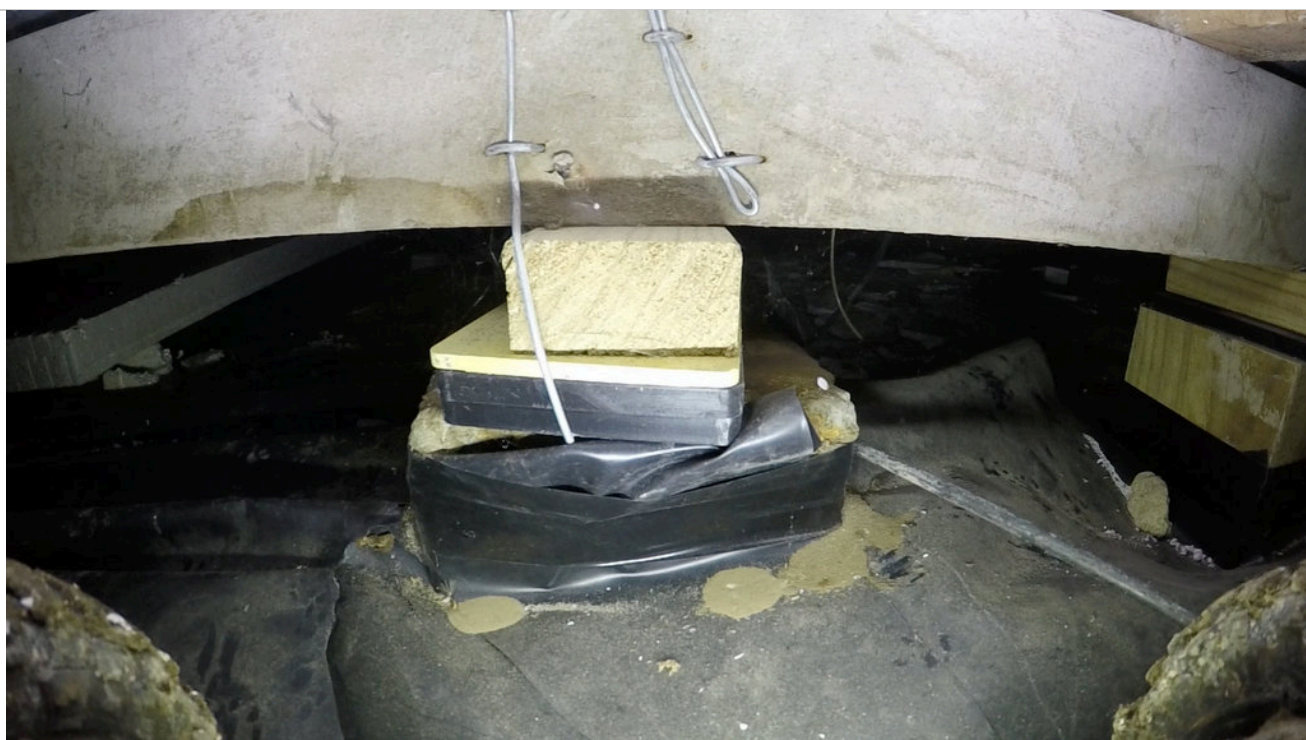
38: Pile with connection and non-compliant packers.

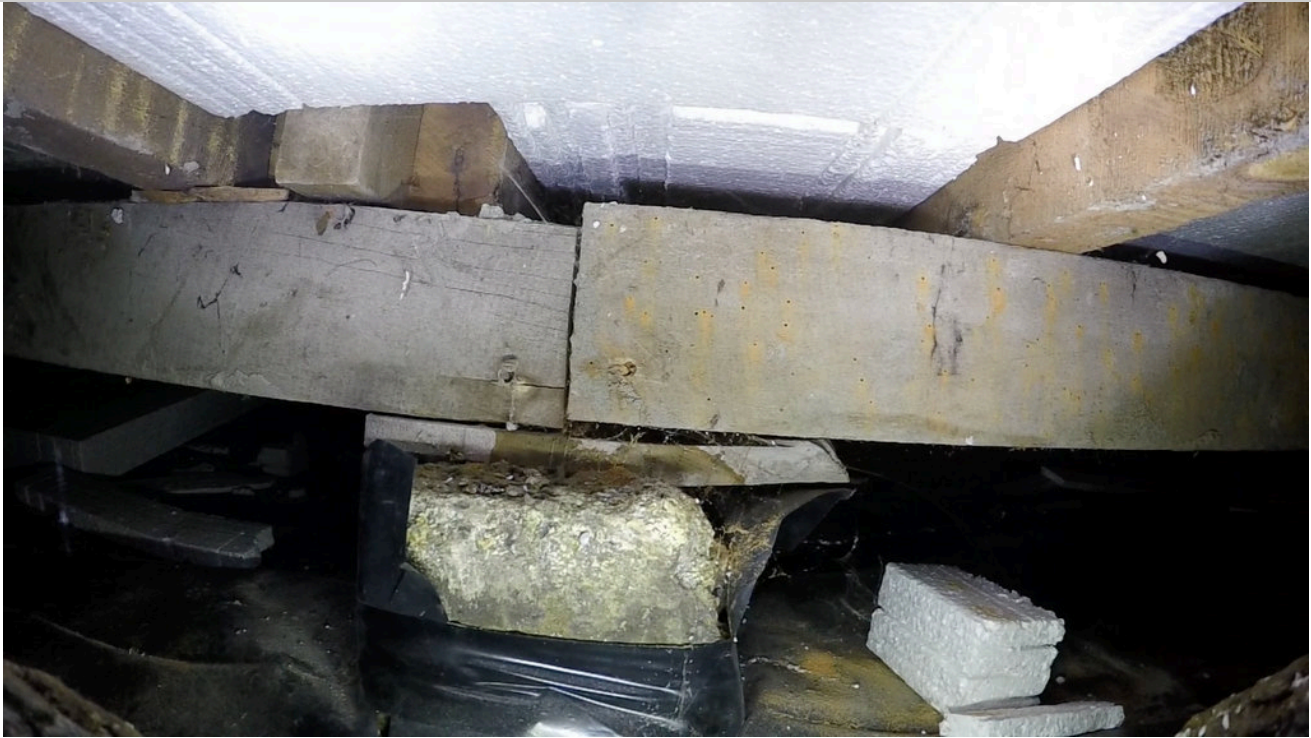
41: Here the packing used is not treated, there is no pile connection, no bearer connection and the bearer to the right has extensive borer. Note also that the joist to the left has been packed and has extensive borer.

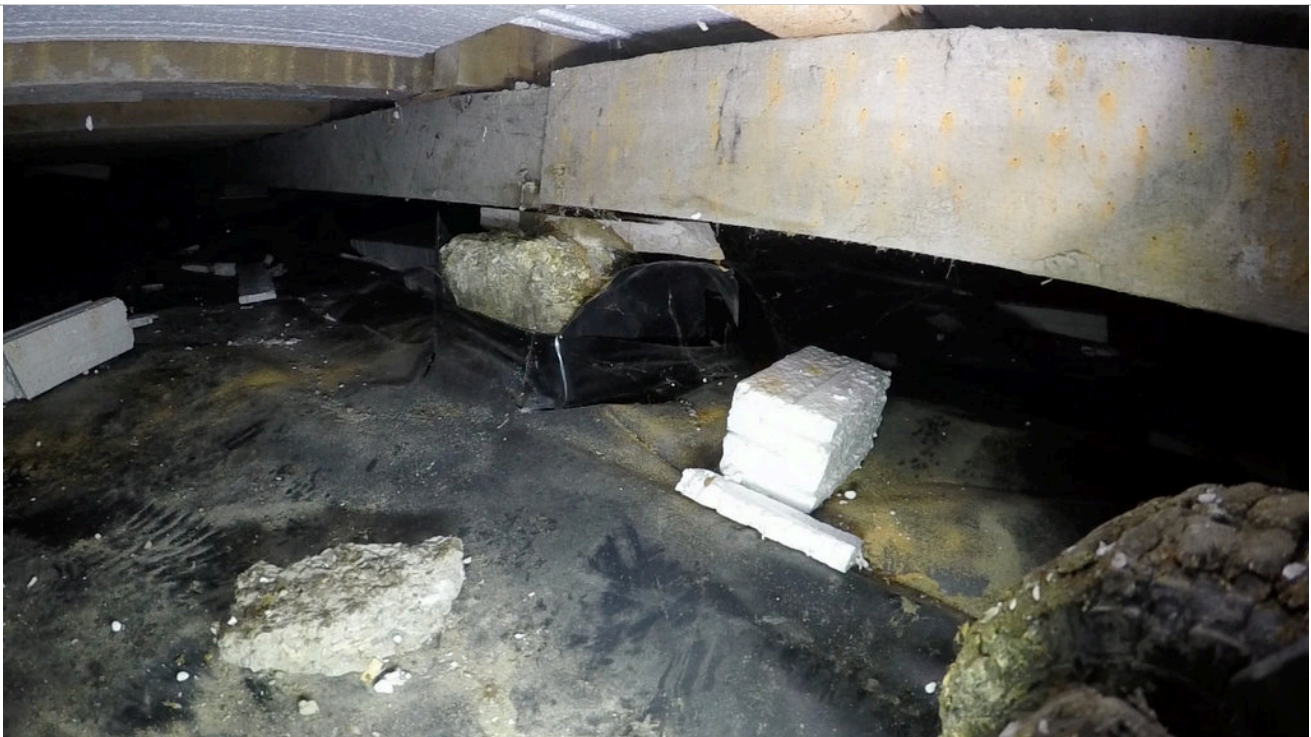
42: Here we are looking at the same pile as in 41 and the bearers can clearly be seen to be rolling over.

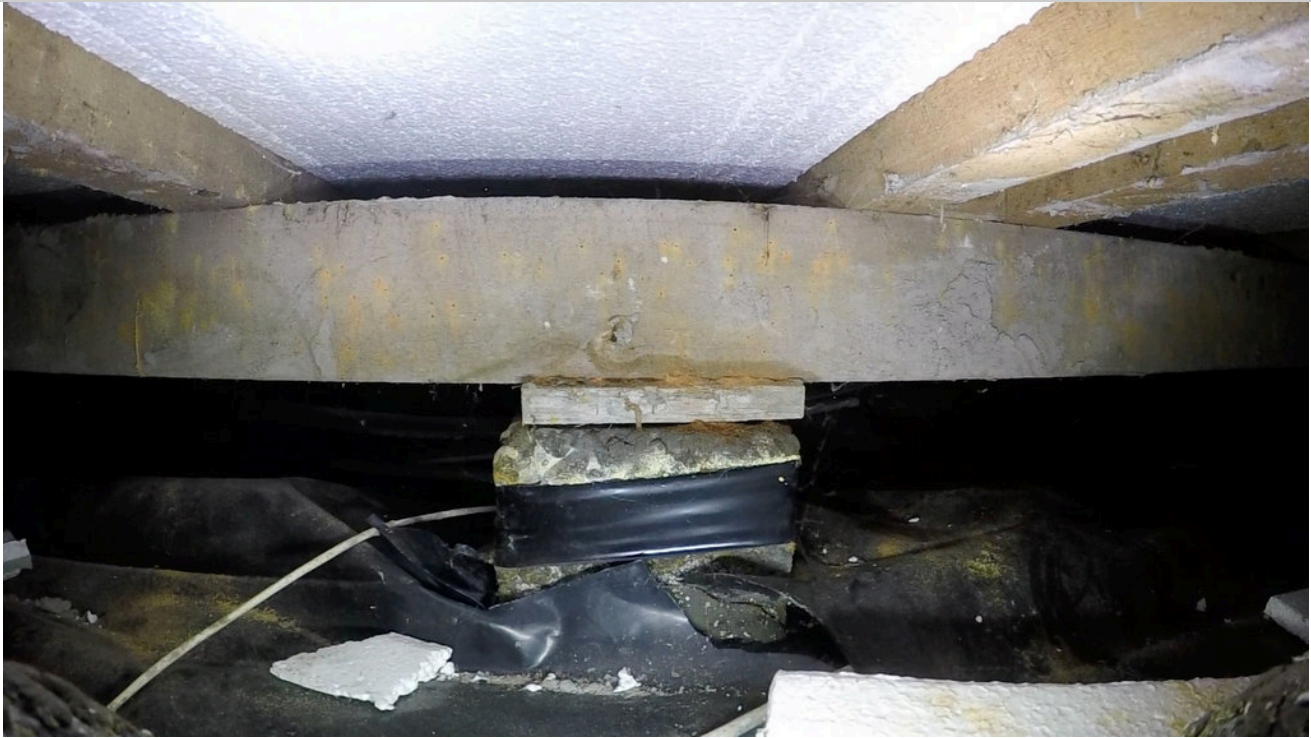
43: Pile with no connection and non-compliant packer. The bearer has extensive borer.

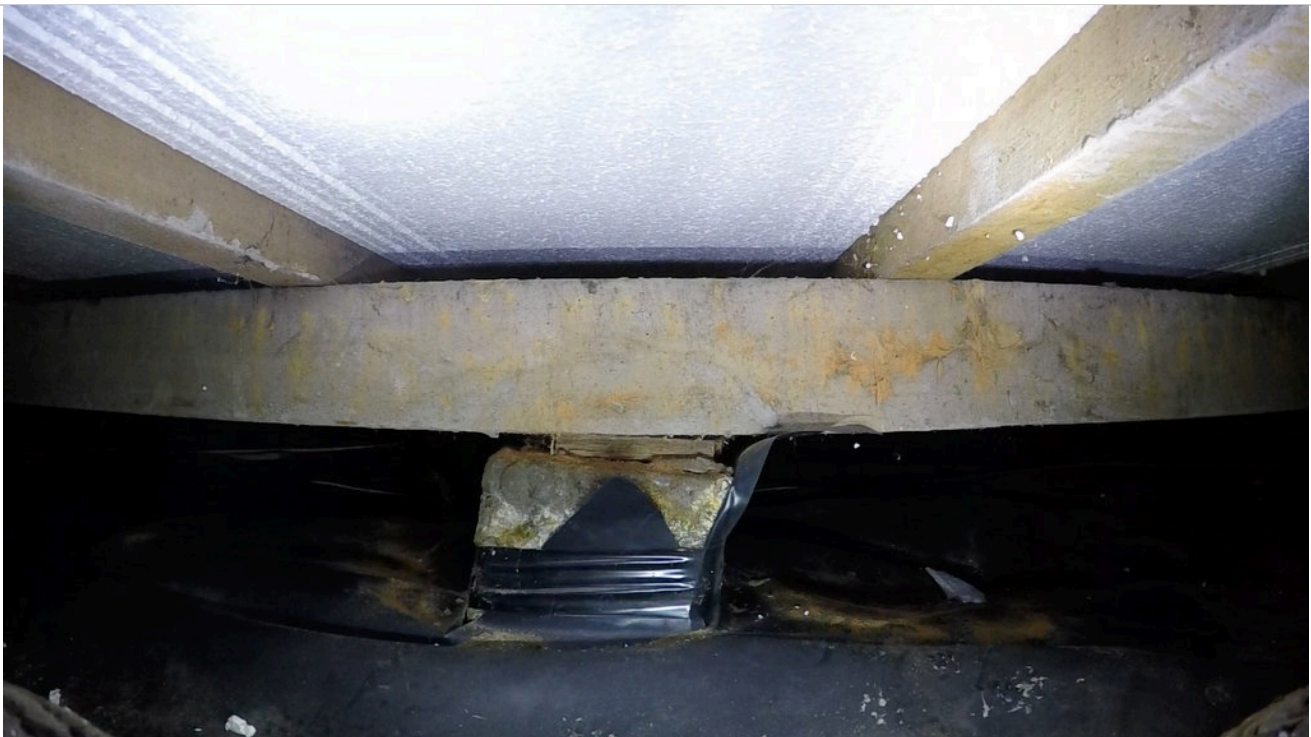
44: Pile with no connection and non-compliant packer. The bearer has extensive borer.

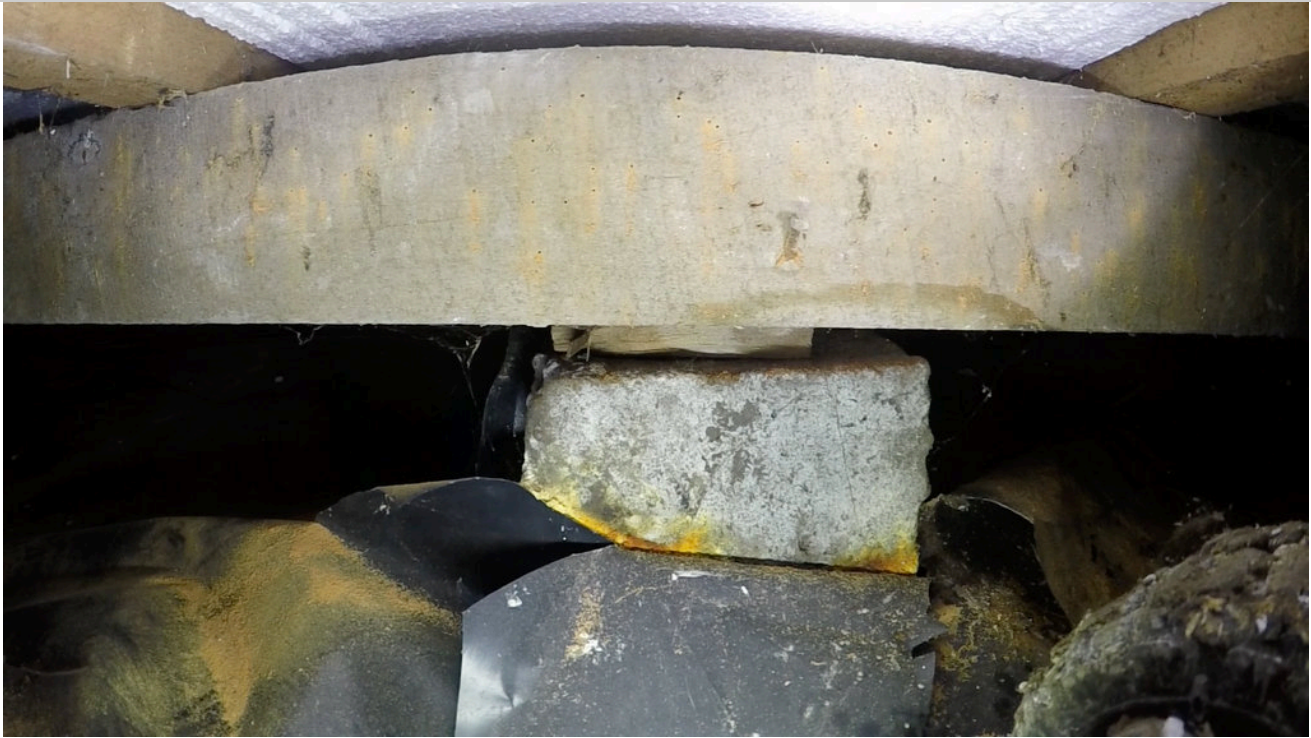
45: Pile with no connection and non-compliant packer. The bearer has extensive borer.

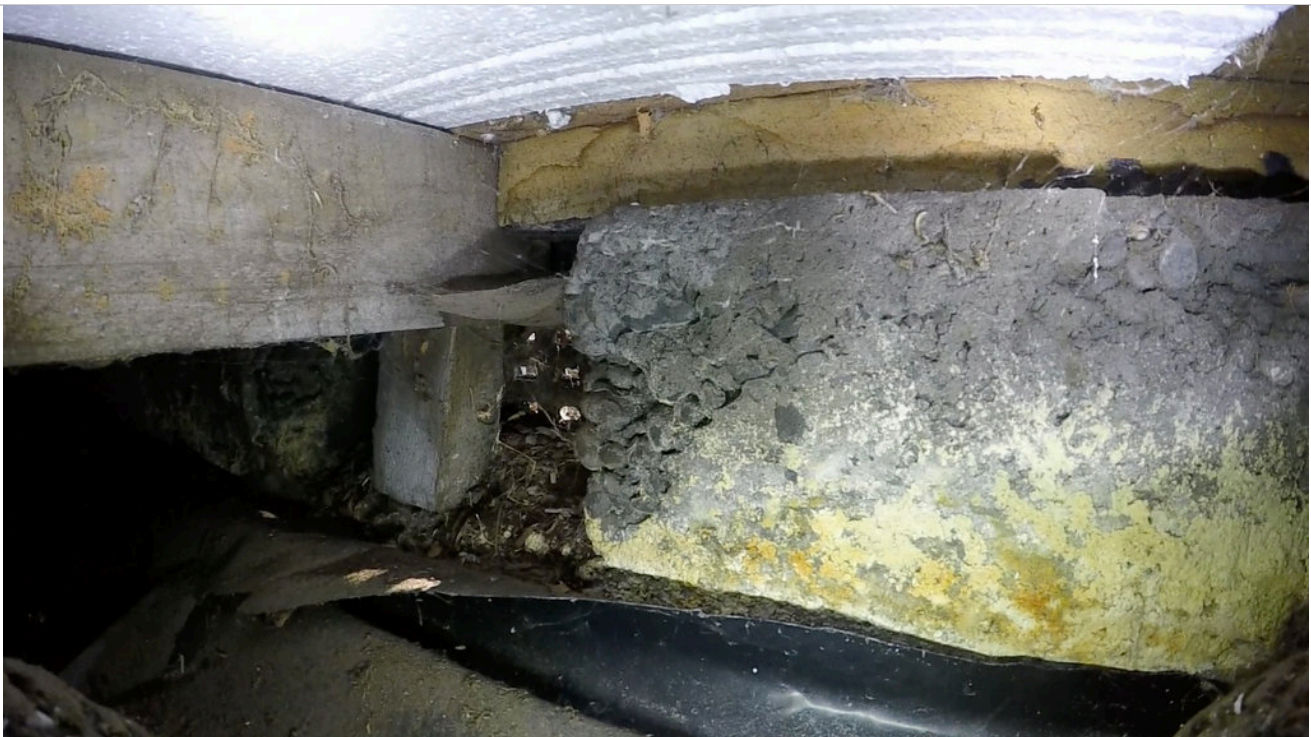
46: View of bearer meeting ring foundation and again we see the support block.

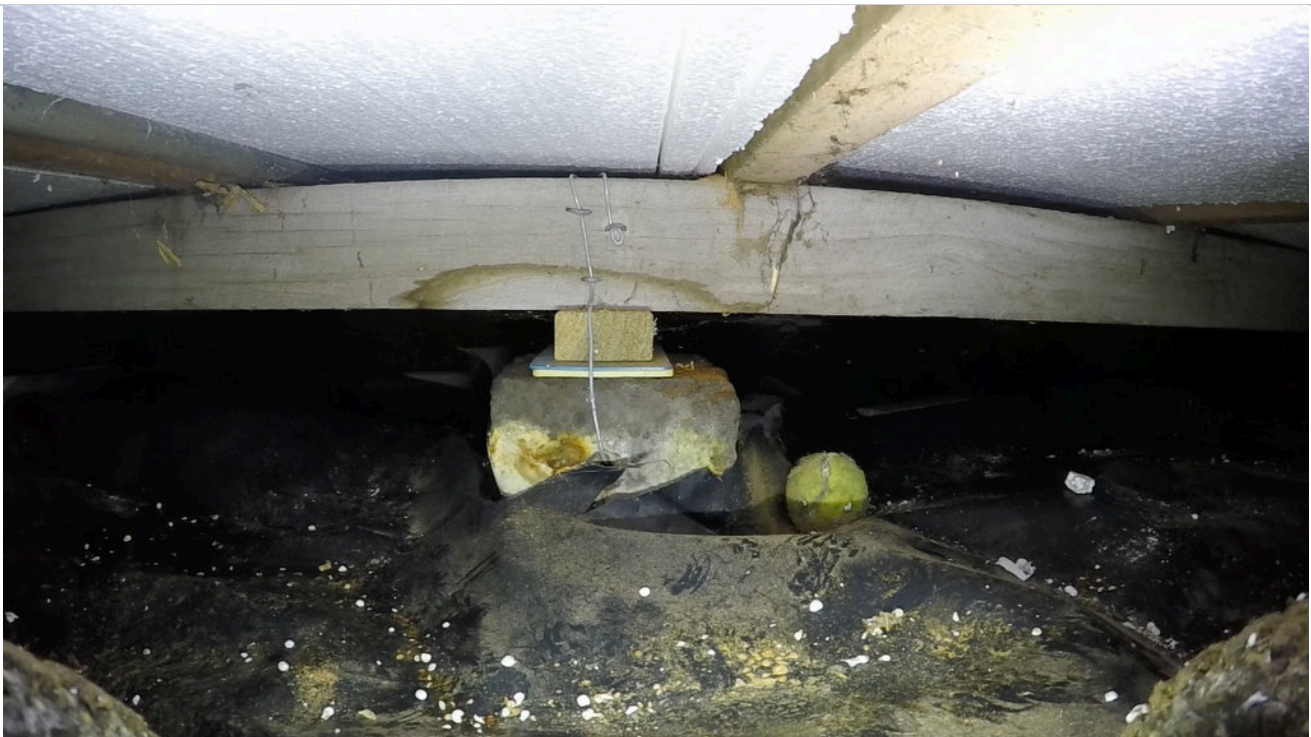
48: Pile with connection and non-compliant packers. The stapling has not been carried out correctly.

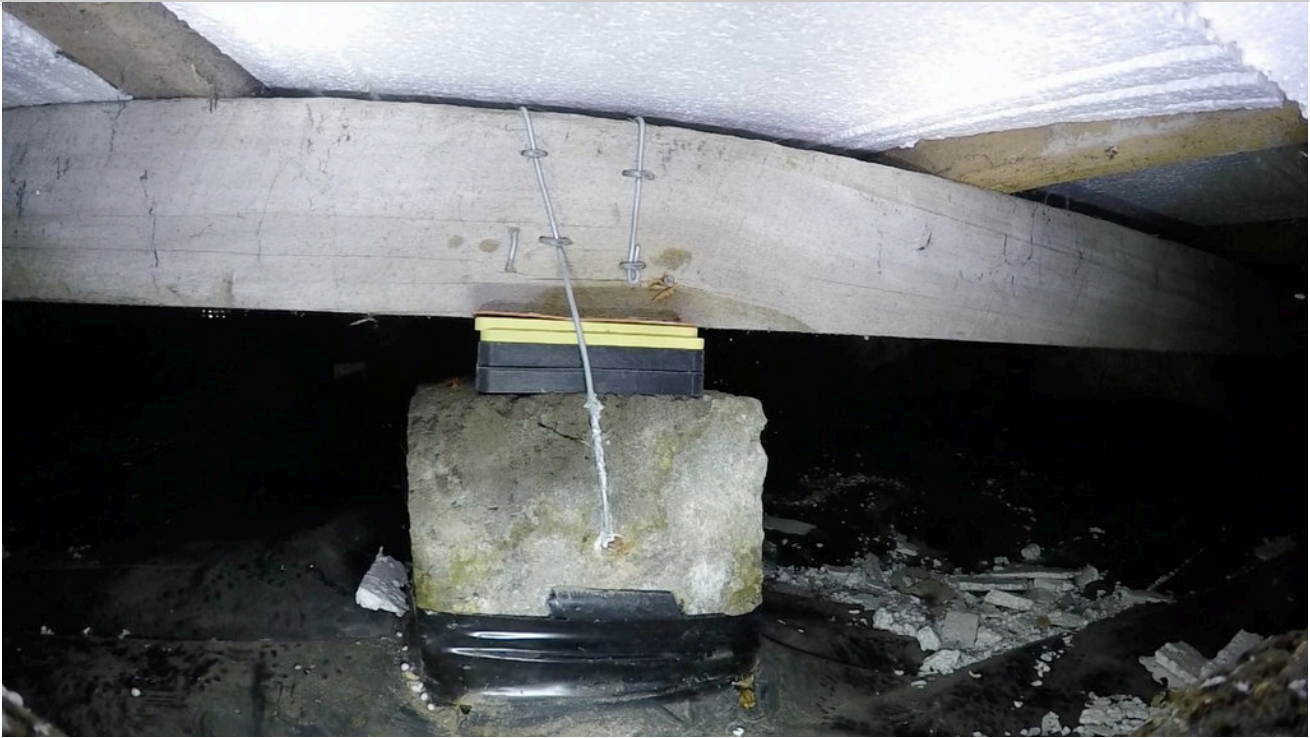
51: Pile with non-compliant connection and non-compliant packing.

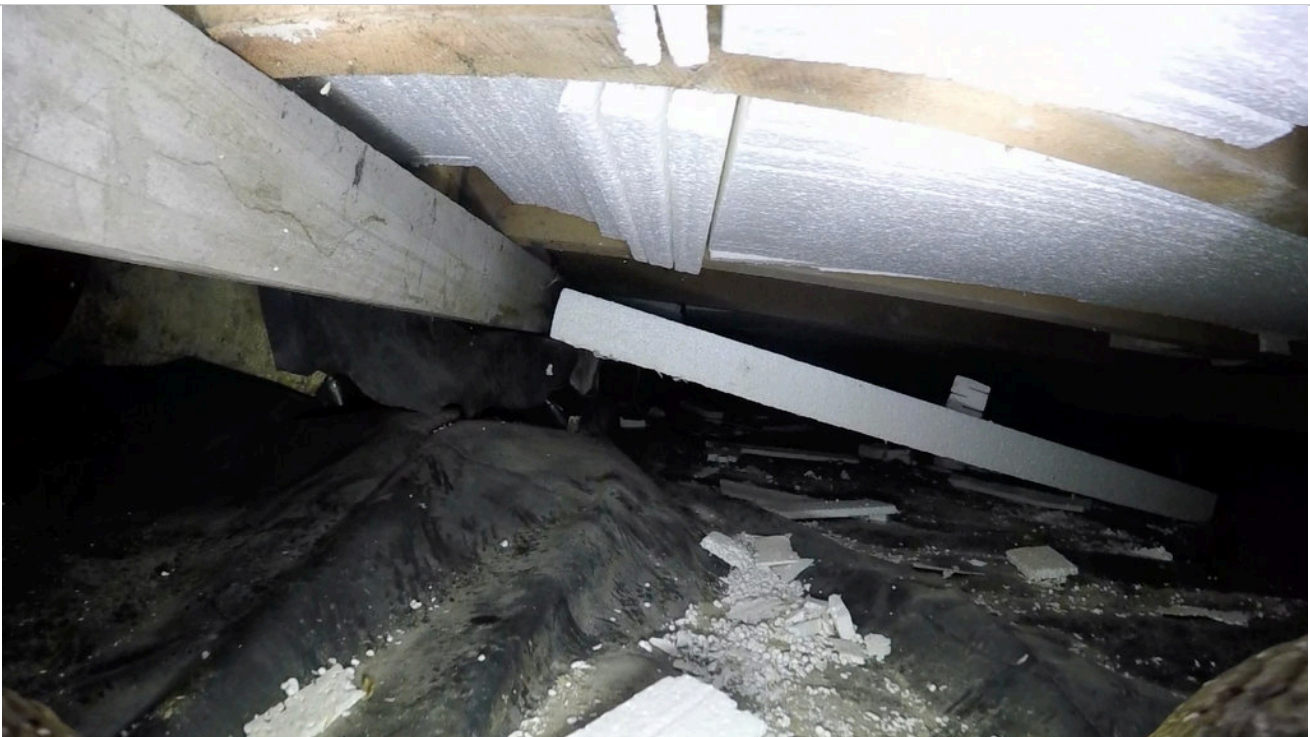
52: Another view of collapsing insulation.

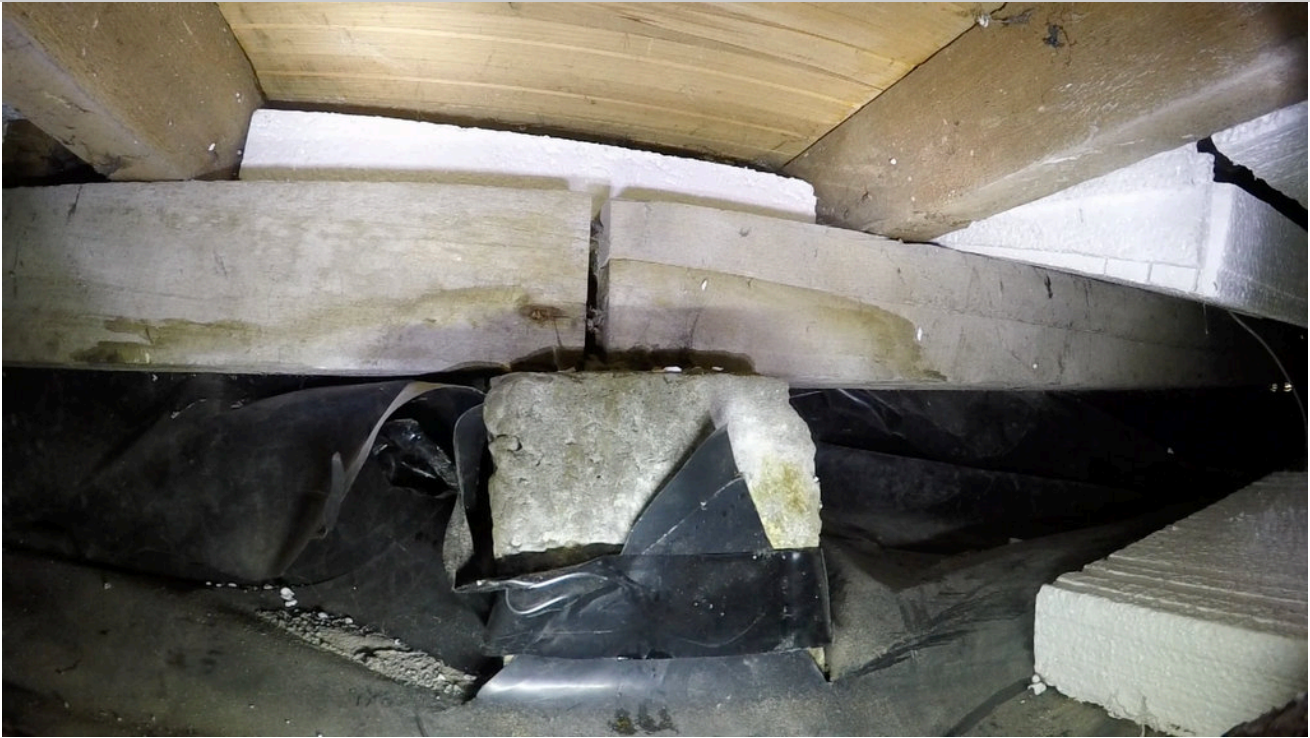
53: Precast concrete pile with no connection. The bearer join appears to have pulled apart.

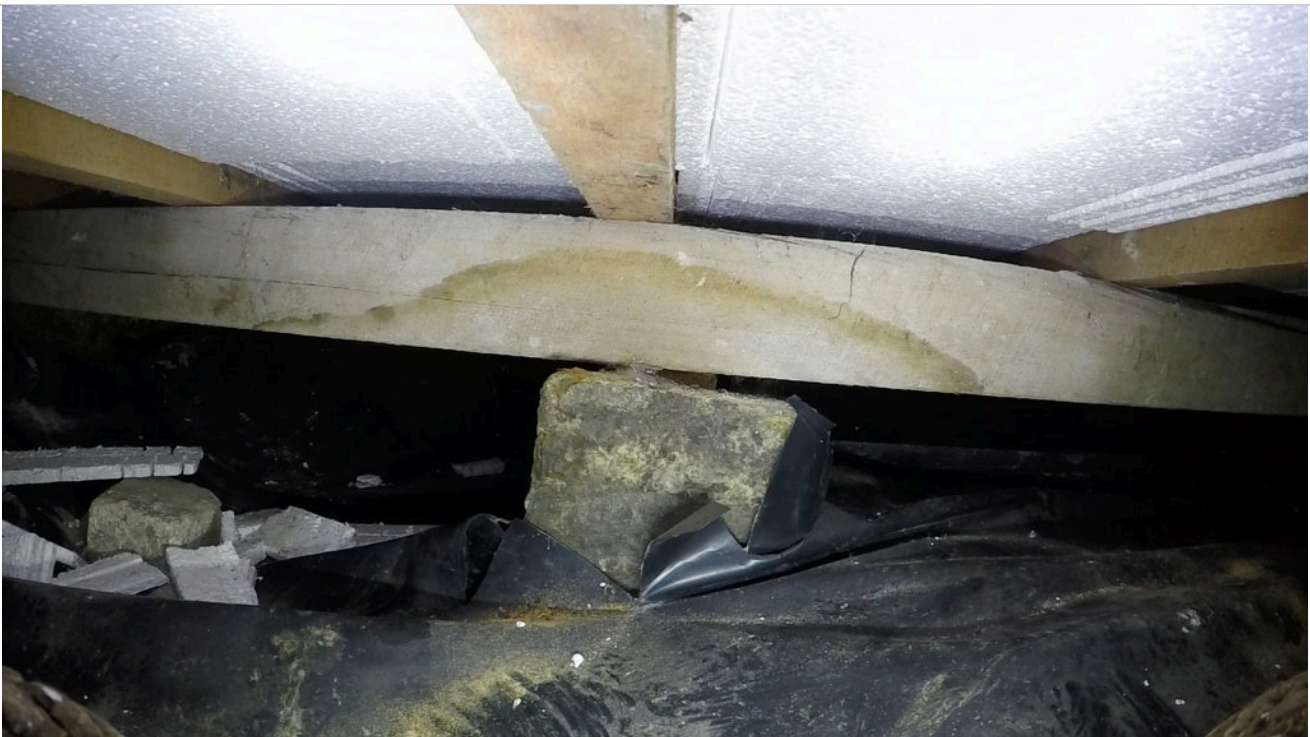
54: Pile with no connection and non-compliant packer. This pile is leaning to the right.

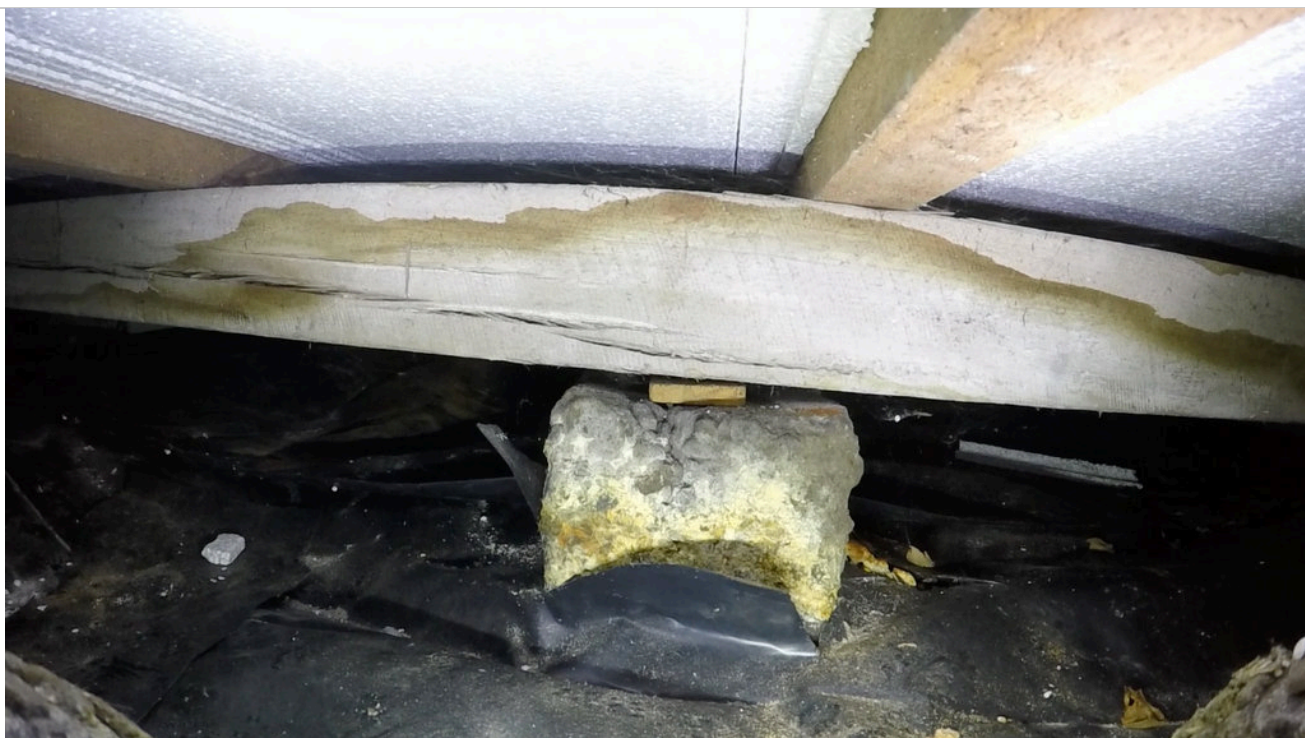
56: Pile with no connection and non-compliant packer.

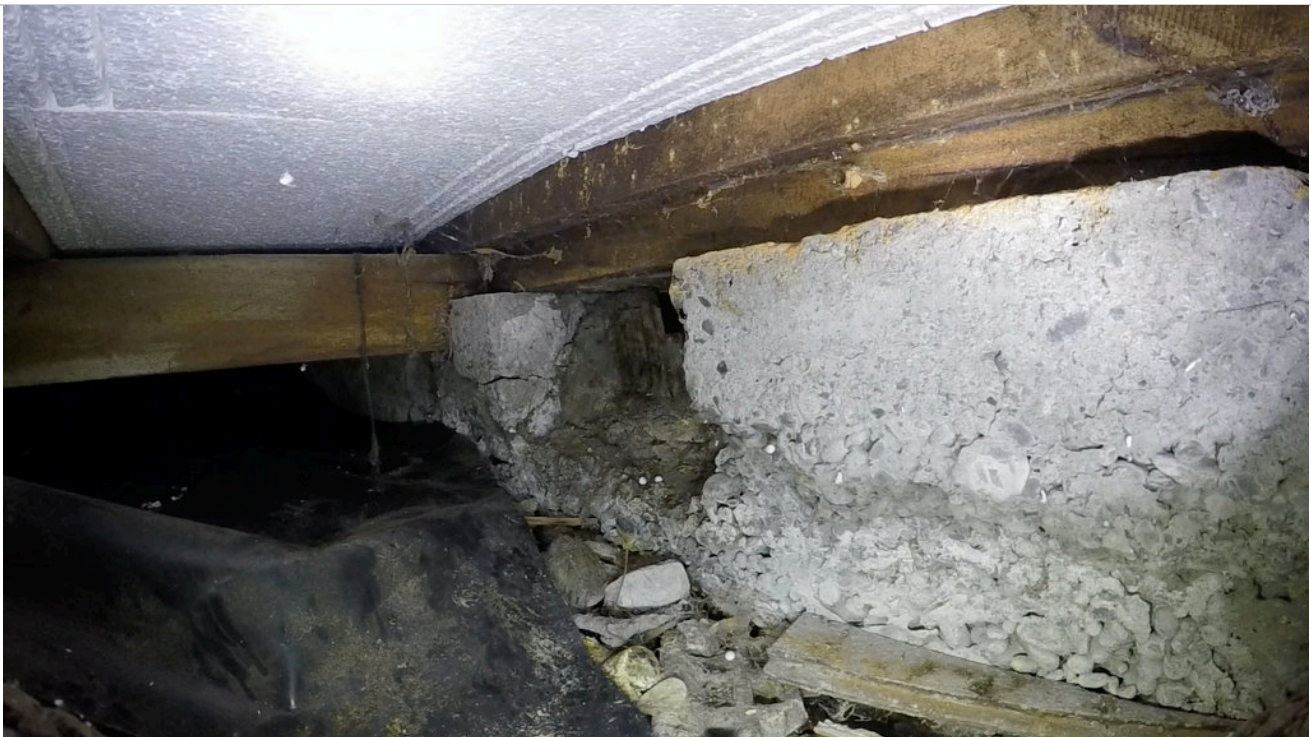
58: View of bearer meeting ring foundation. Note the cracked concrete. Also that the joist has significant borer.

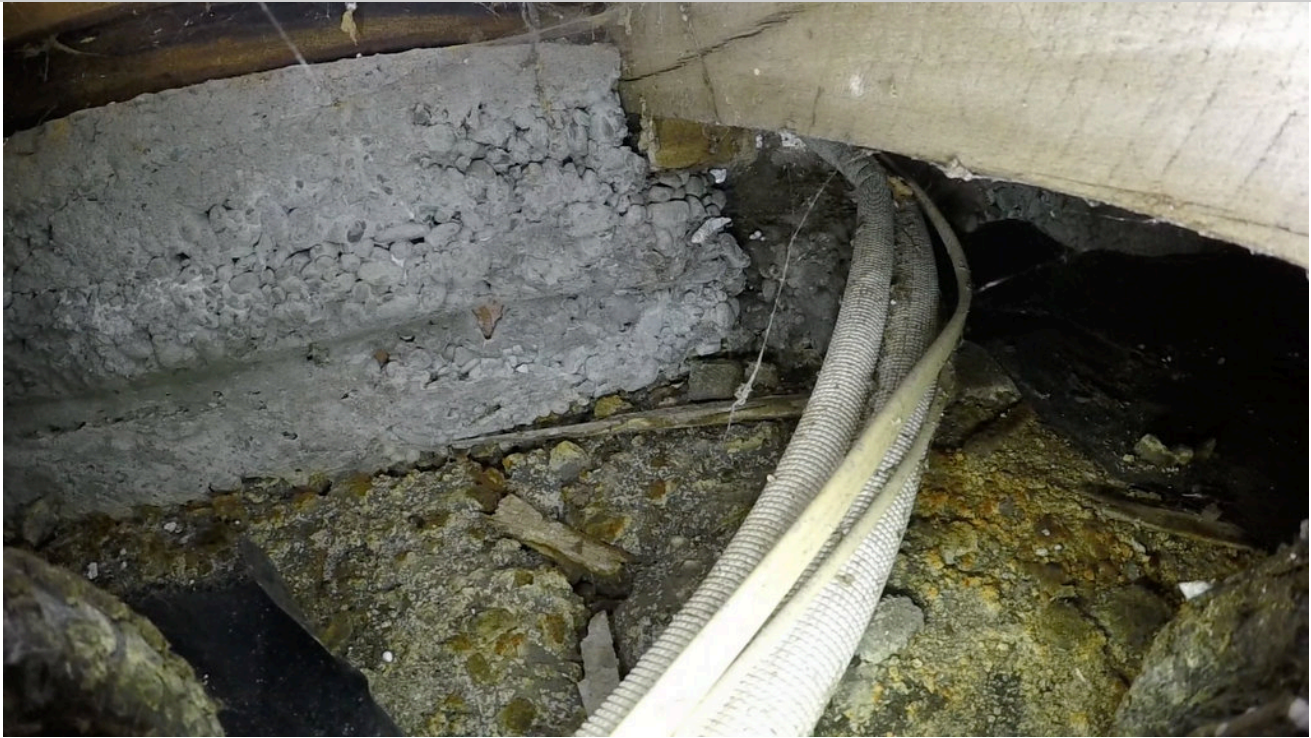
59: View of bearer meeting ring foundation with non-complaint packing.
