Cavity Critter

Under floor Inspections

Date: 6 September 2017

Prepared by: Gideon Couper

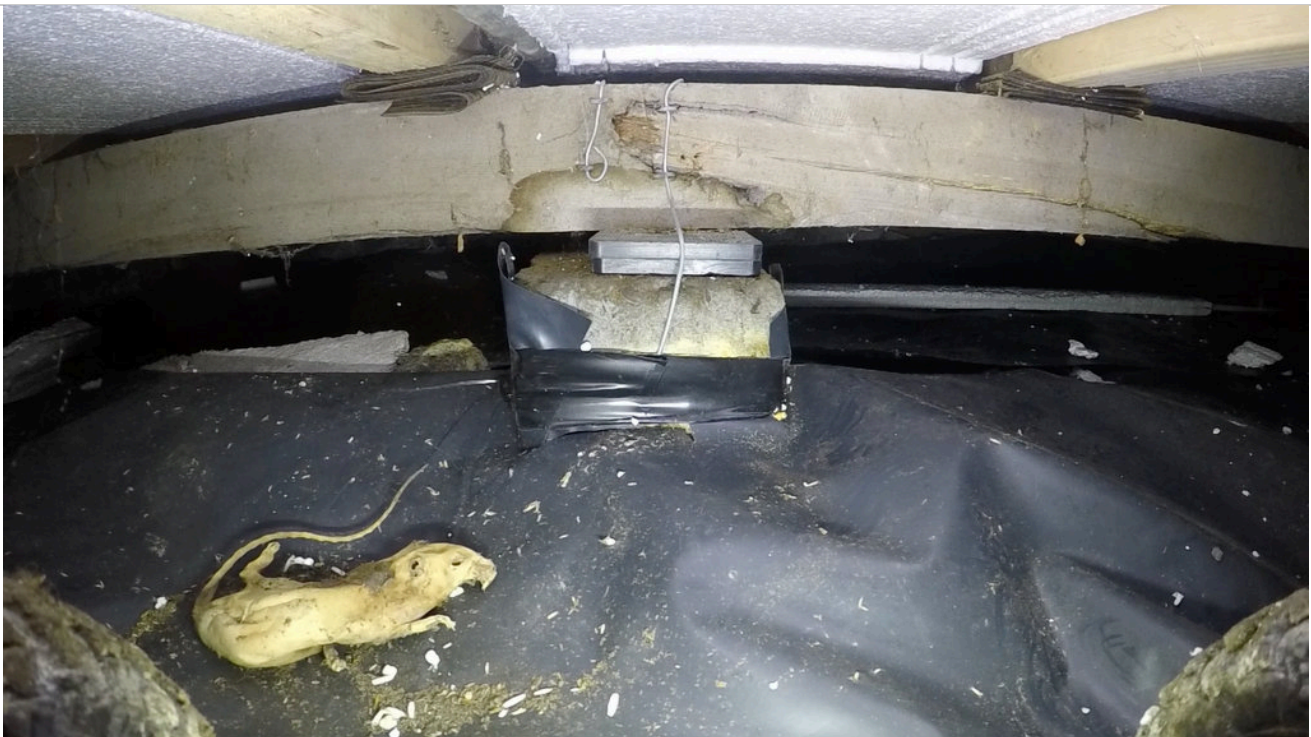
60: Pile with non-compliant connection and non-compliant packing. Note the dead rat.

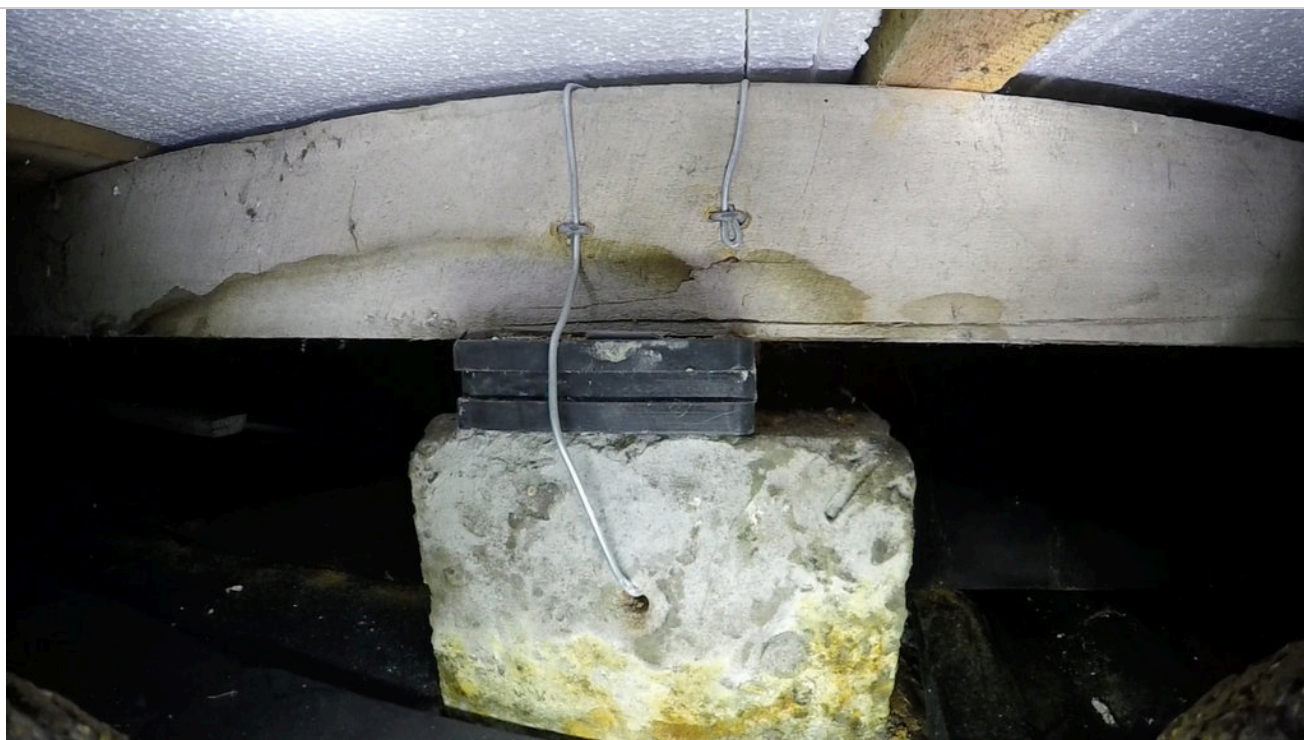
61: Pile with non-compliant connection and non-compliant packing.

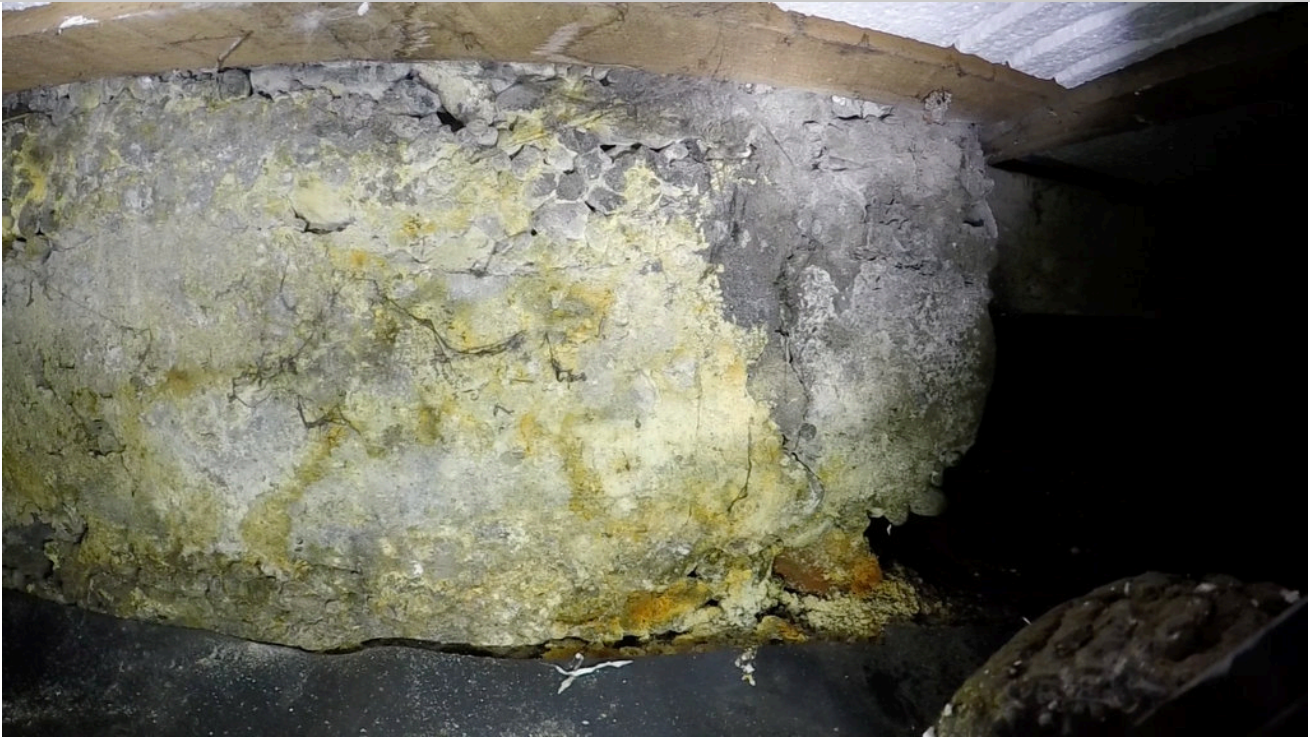
65: View of the chimney breast. It would appear that there has been some damage to the concrete around the bearer and a repair has taken place.

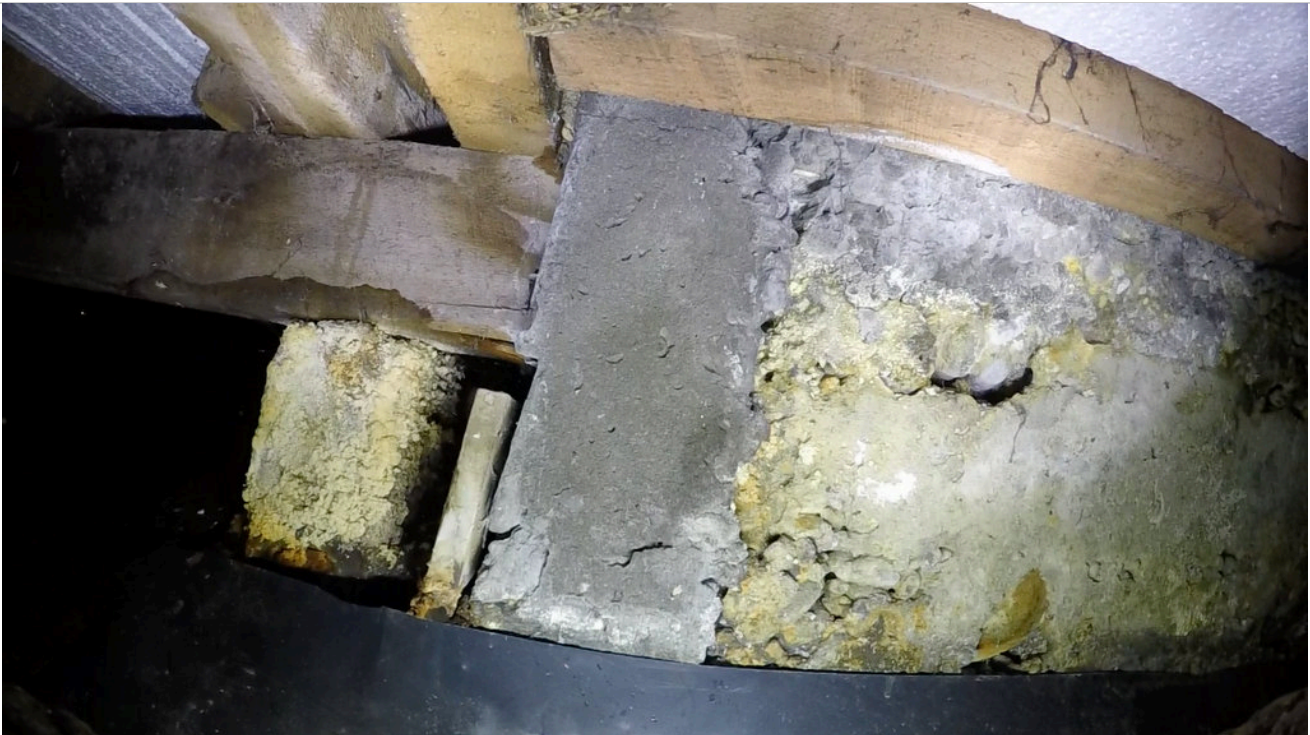
66: As above the concrete has been damaged and a repair has taken place. The brick has been used to hold the bearer and has been left in place. The bearer has not been held by the repair and relies solely on the brick for support. Moisture is being pulled into the bearer though the brick.

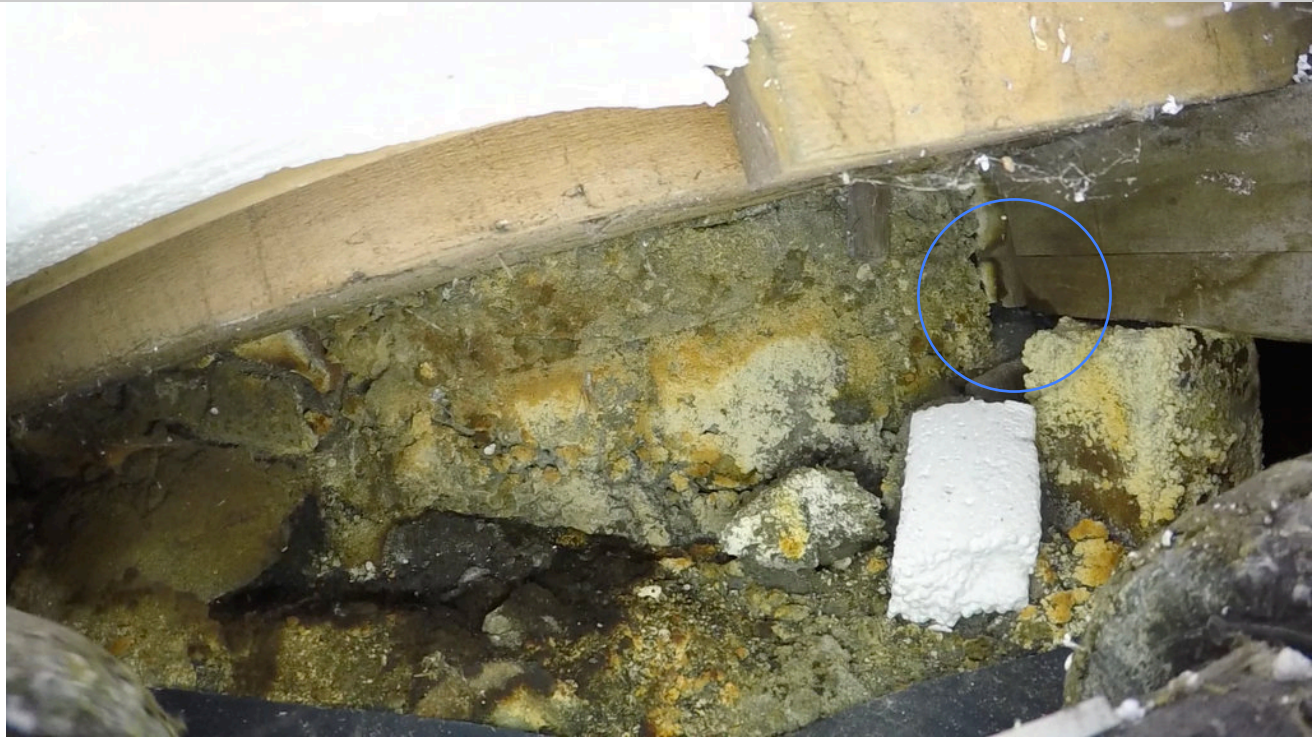
67: View of the chimney breast. We can see here that the new concrete does not support the bearer.

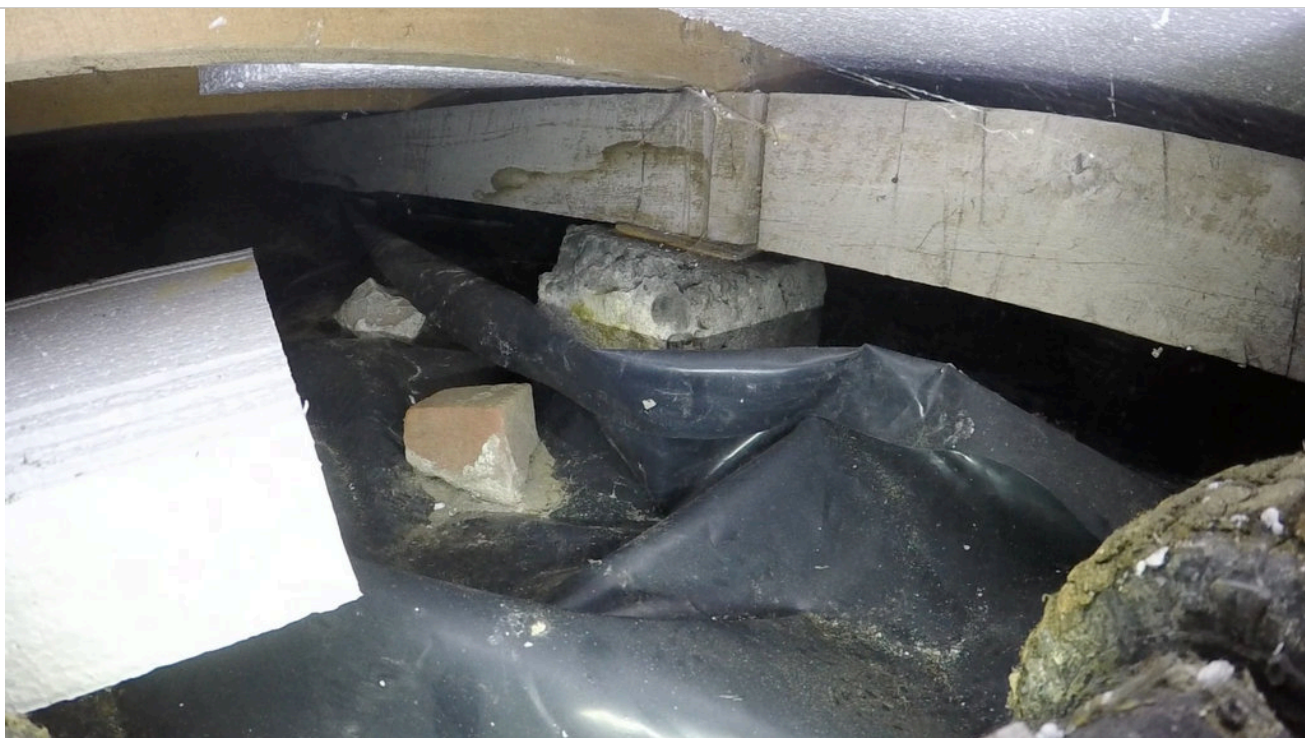
70: Pile with no connection and non-compliant packer. Note that the bearer join has moved out of line and is unsupported.

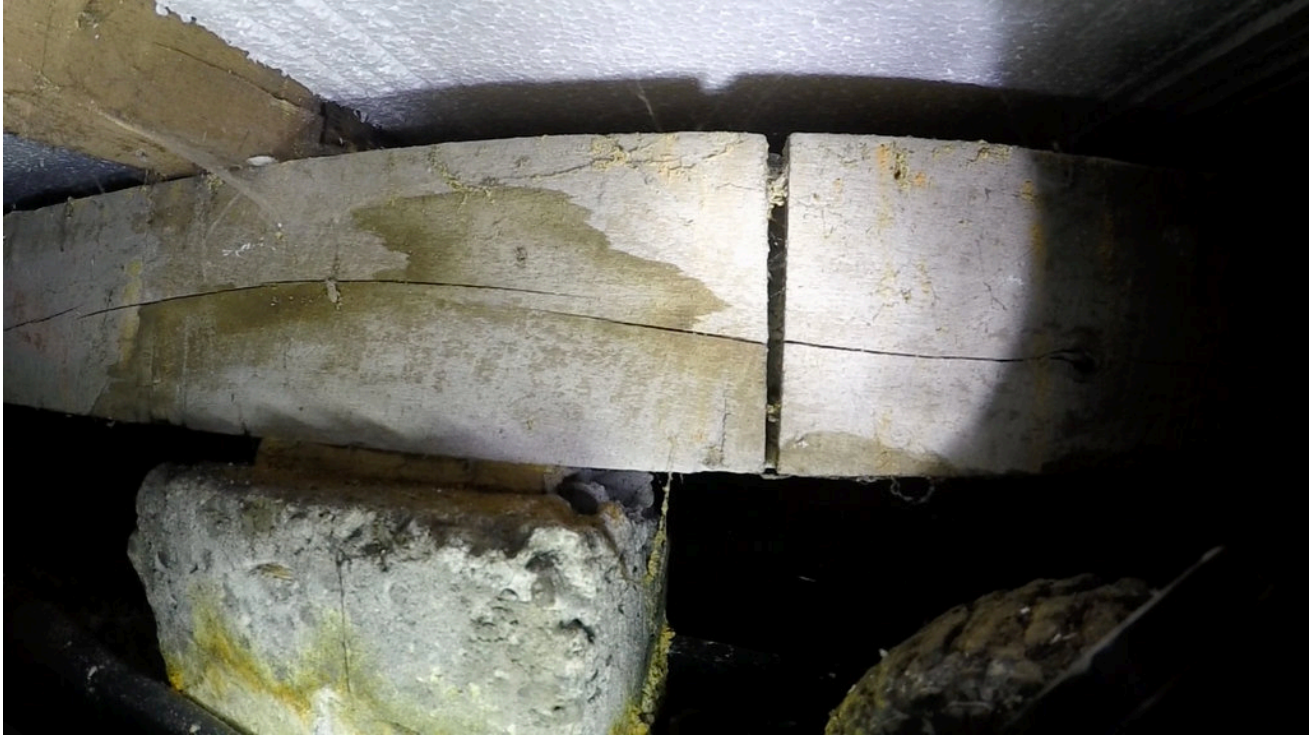
71: Here again the bearer join is unsupported. It may in fact not be a bearer join and could be a half cut, put in the bearer at the time of construction to straighten it. This is indicated by the crack running though both sides of the cut. This however would weaken the timber and it should still be supported.

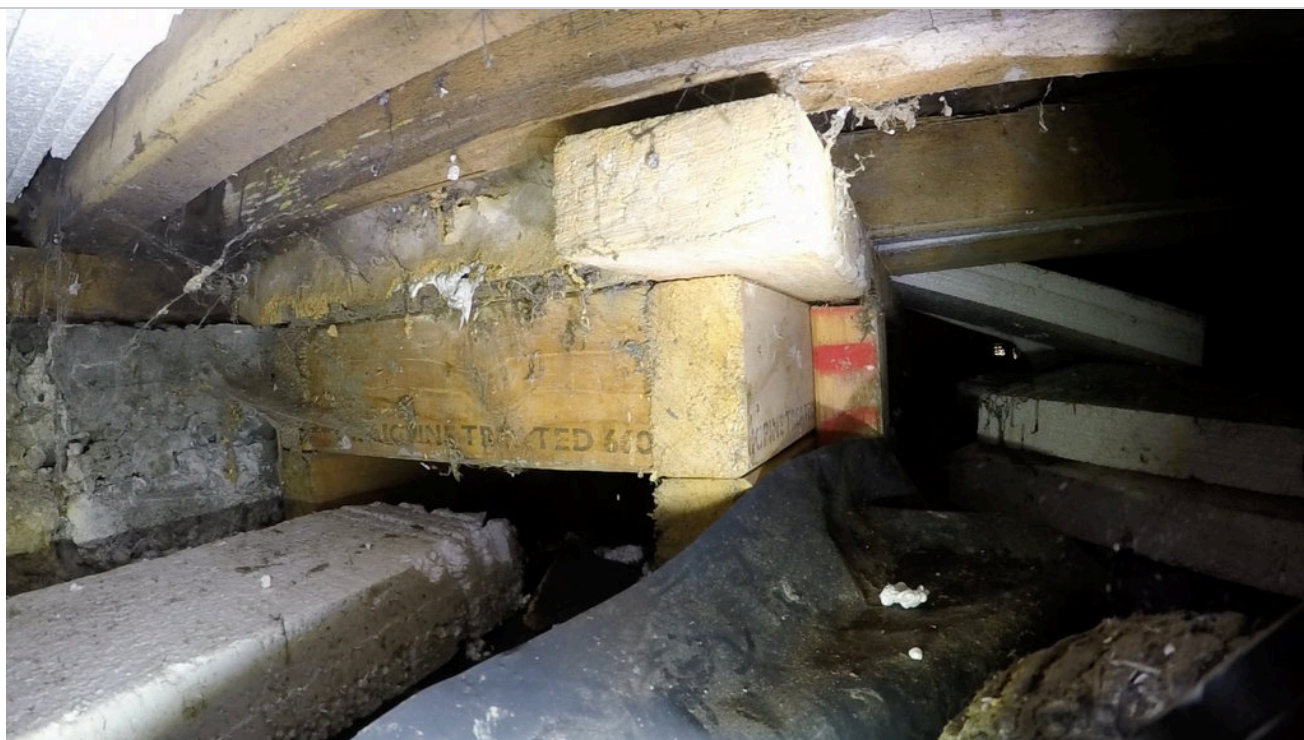
73: It appears that a concrete slab has been poured here but if so it is supported on untreated timber, which will soon rot. The timber is also supporting the joists.

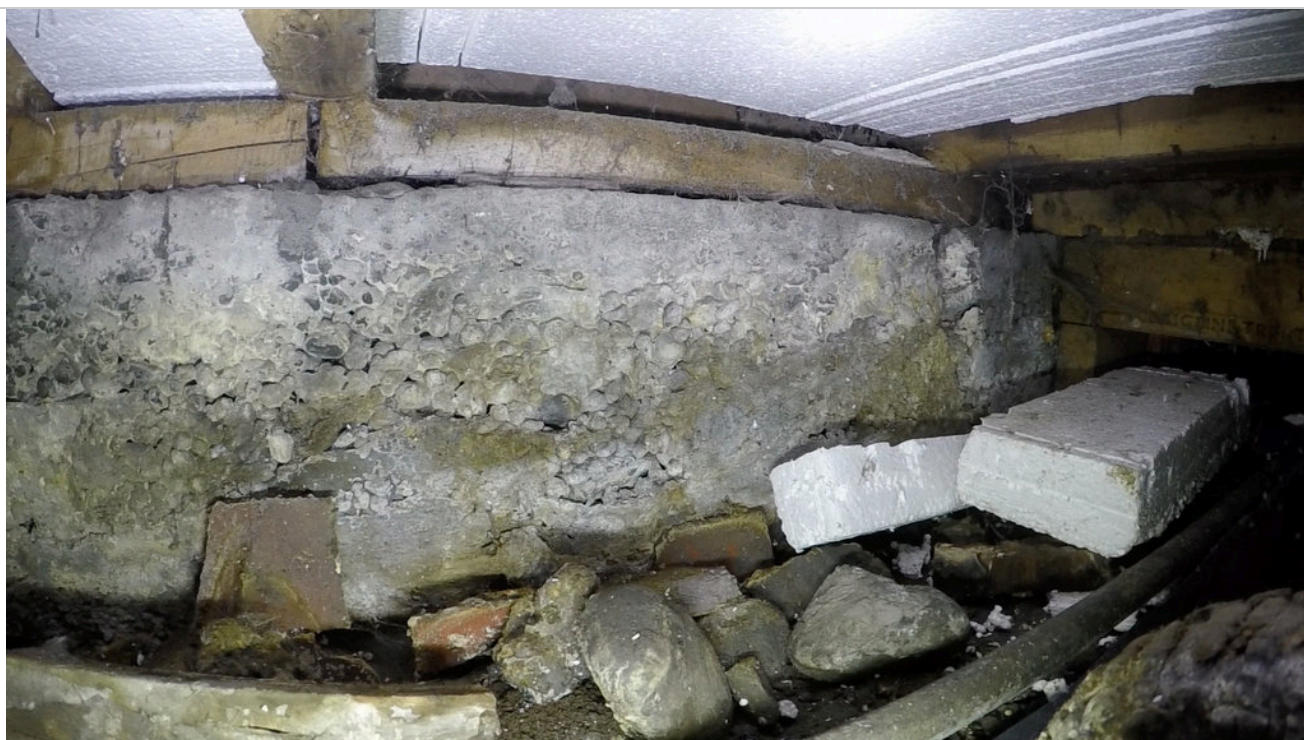
75: Here again see packing of the ring foundation plate but with scraps and no fixing bracket has been used.

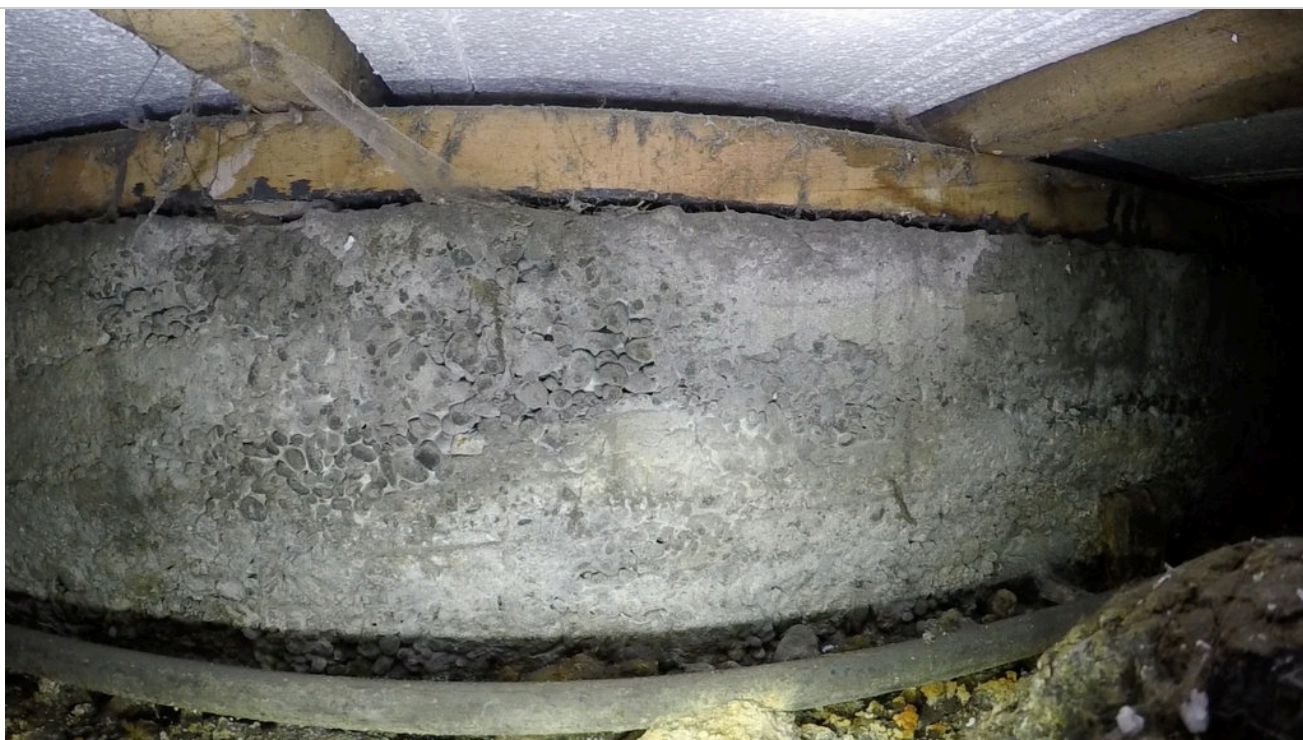
77: More packing of the ring foundation plate.

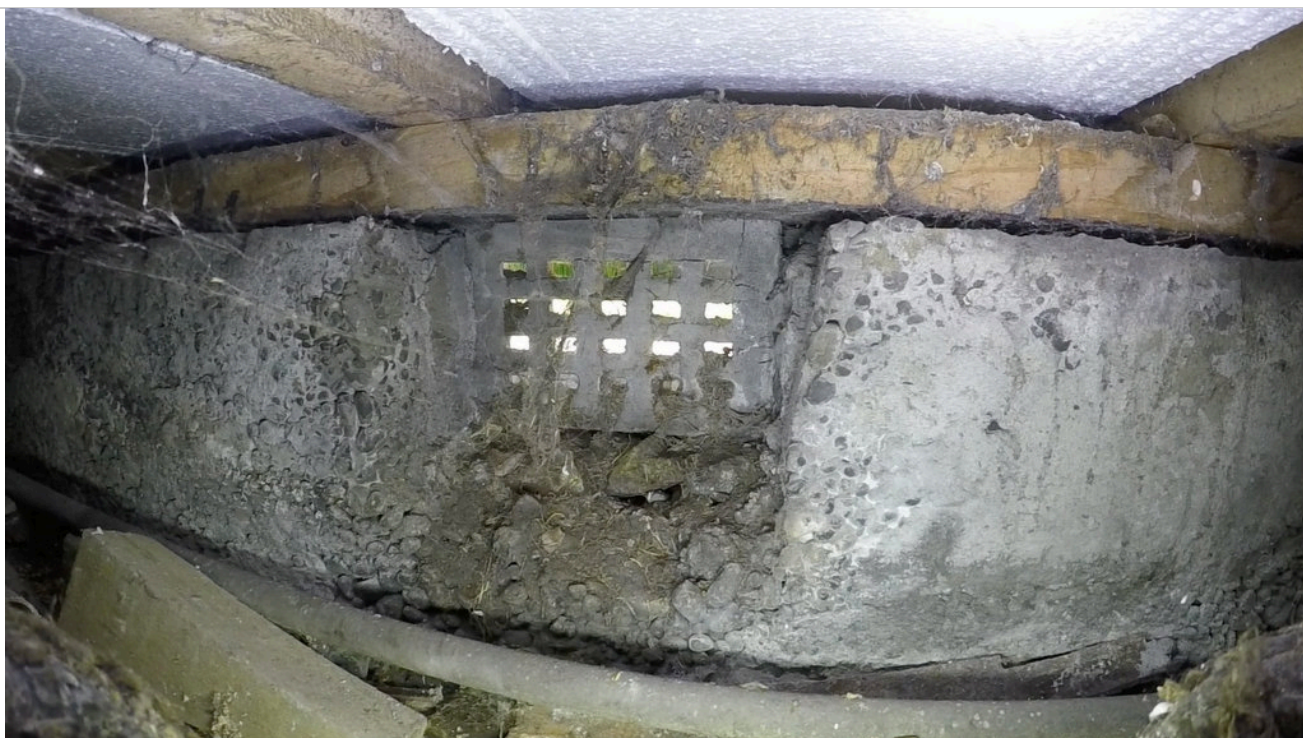
78: Here the plate appears to be supported by the vent, which has cracked.

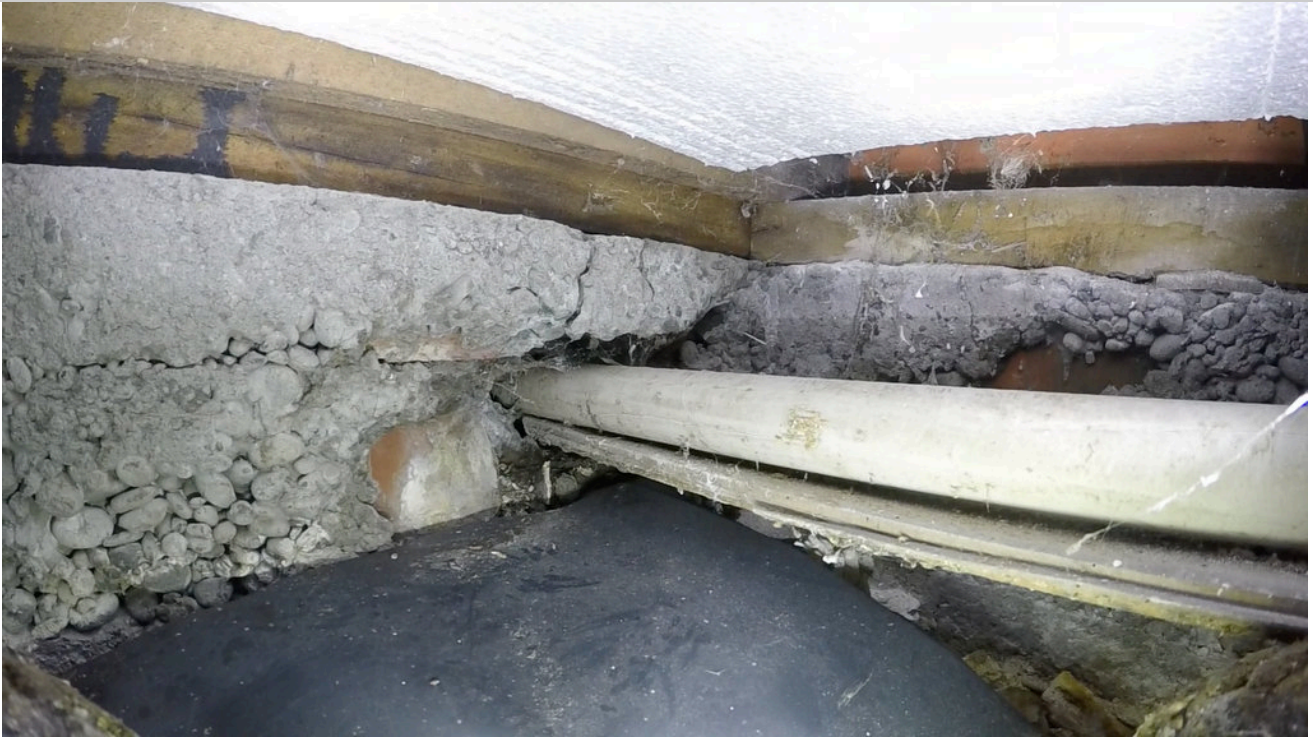
81: View of ring foundation and here we can see the cracking of the foundation around the bricks.

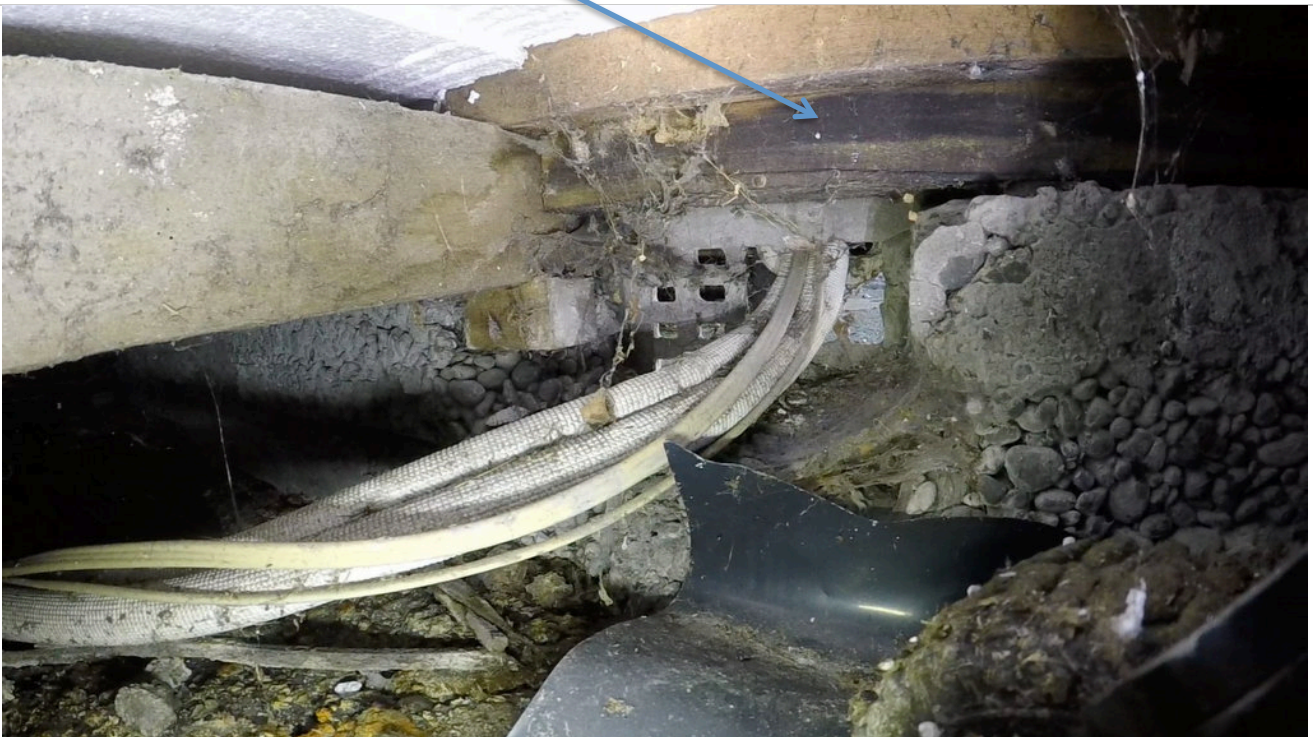
82: View of bearer meeting ring foundation with non-compliant packer and no fixing. The timber in this area is suffering from rot and mold.
