Cavity Critter

Under floor Inspections

Date: 6 September 2017

Prepared by: Gideon Couper

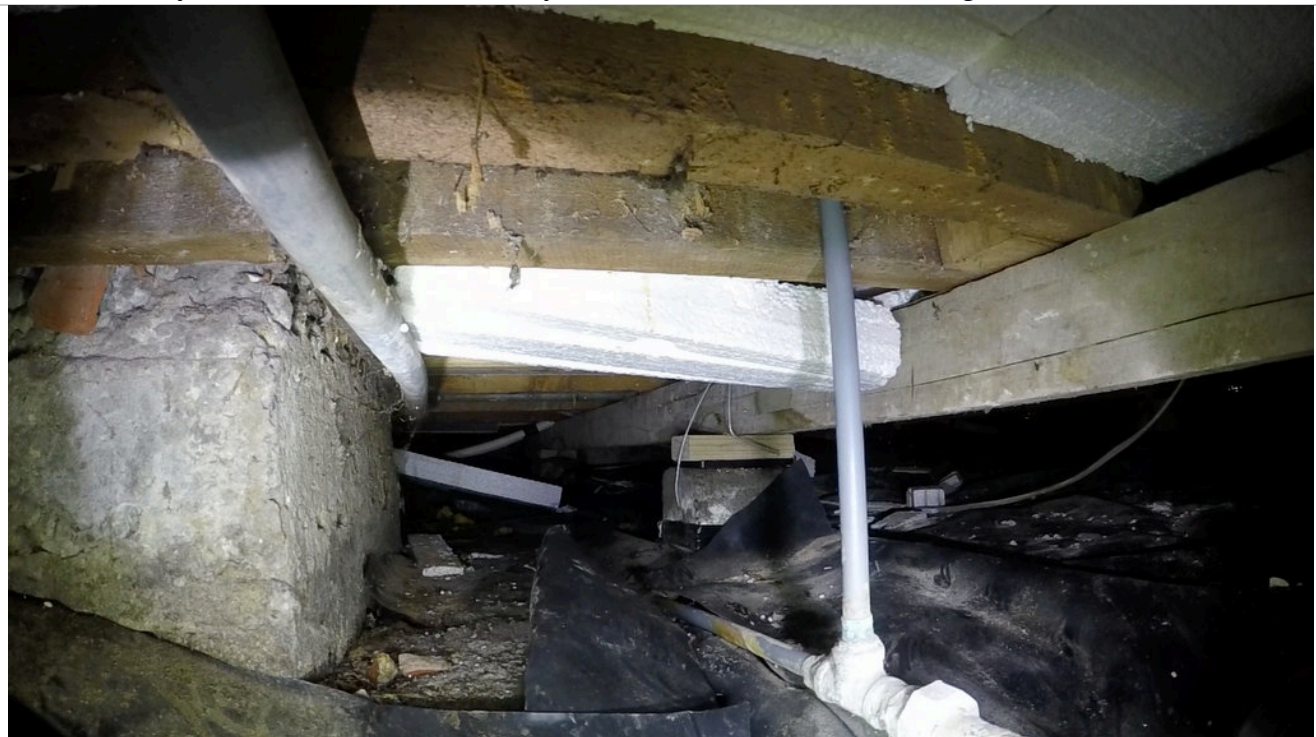
3: Here we can see that the ring foundation plate has been packed. This has taken place right along this foundation. Plastic packers are not recommended, as they are slippery and hard to fix in place. These are not fixed in place and there is no fixing bracket to the foundation.

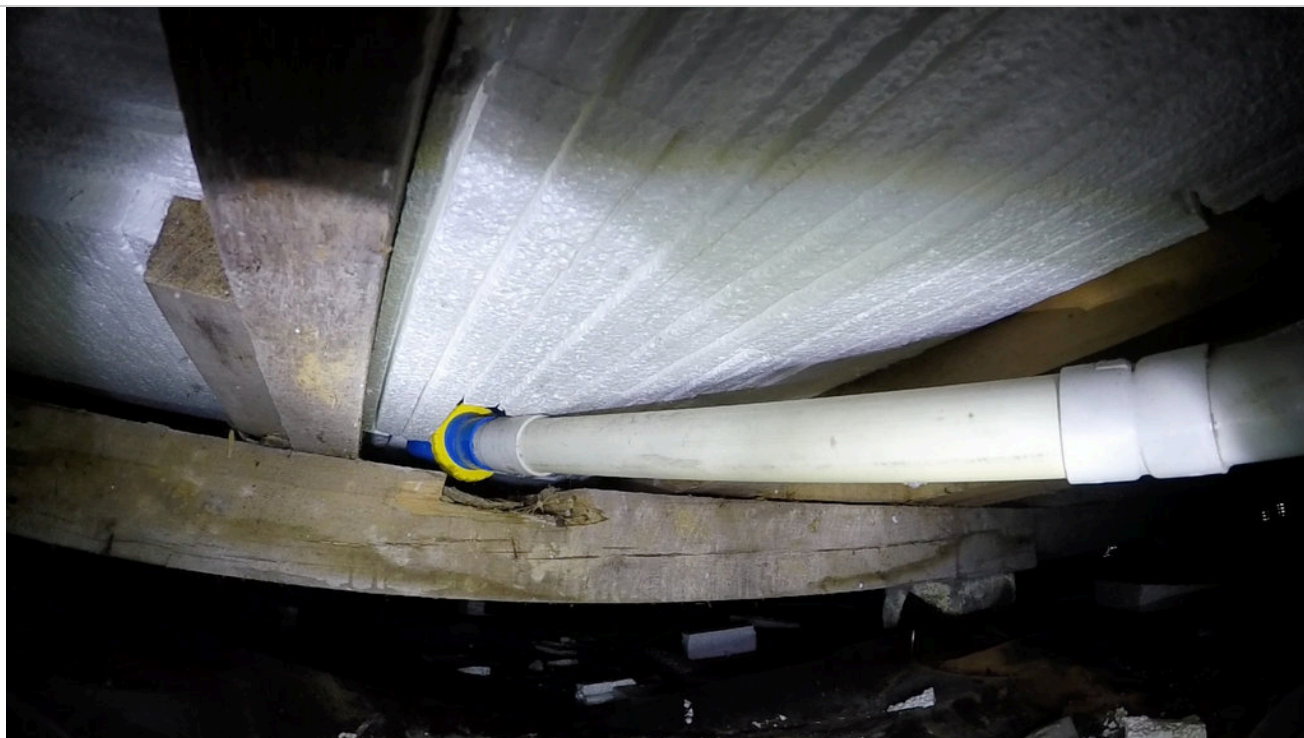
12: Here again liquefaction is blocking the vent.

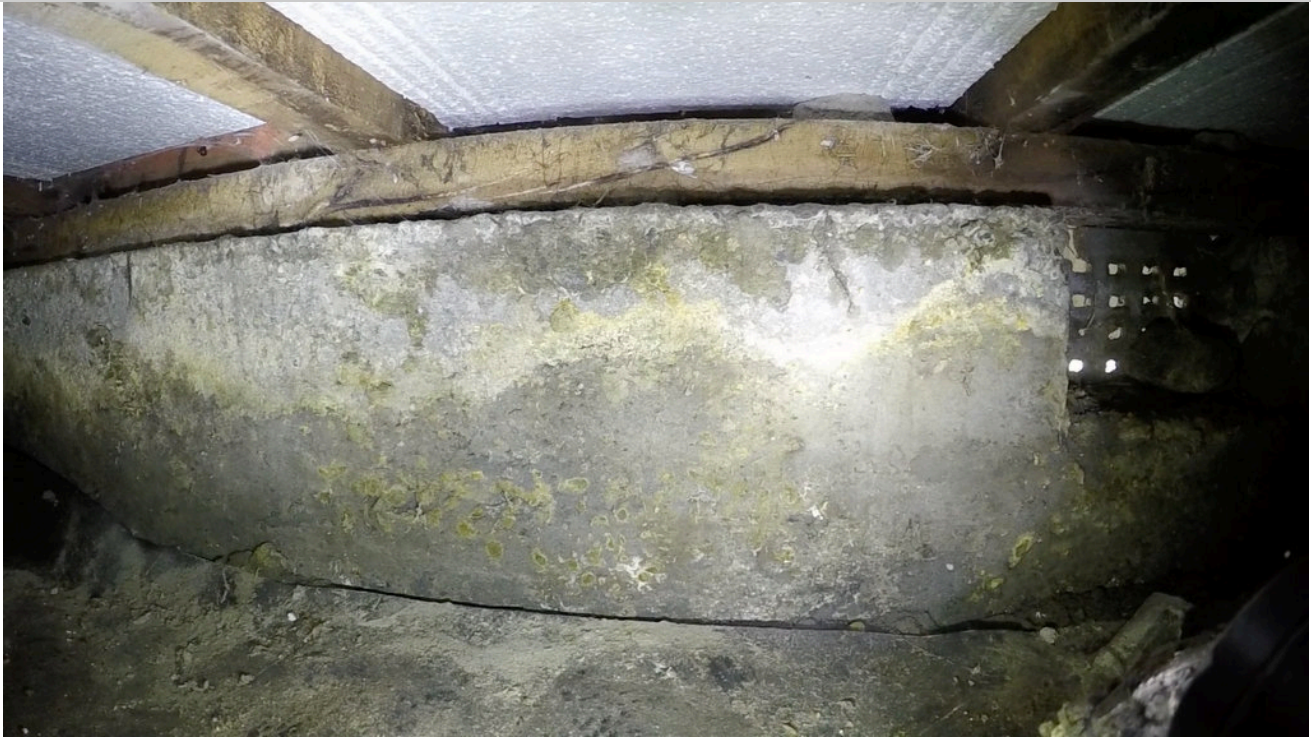
16: View of ring foundation. Here we can see the height that the liquefaction was at before being removed.

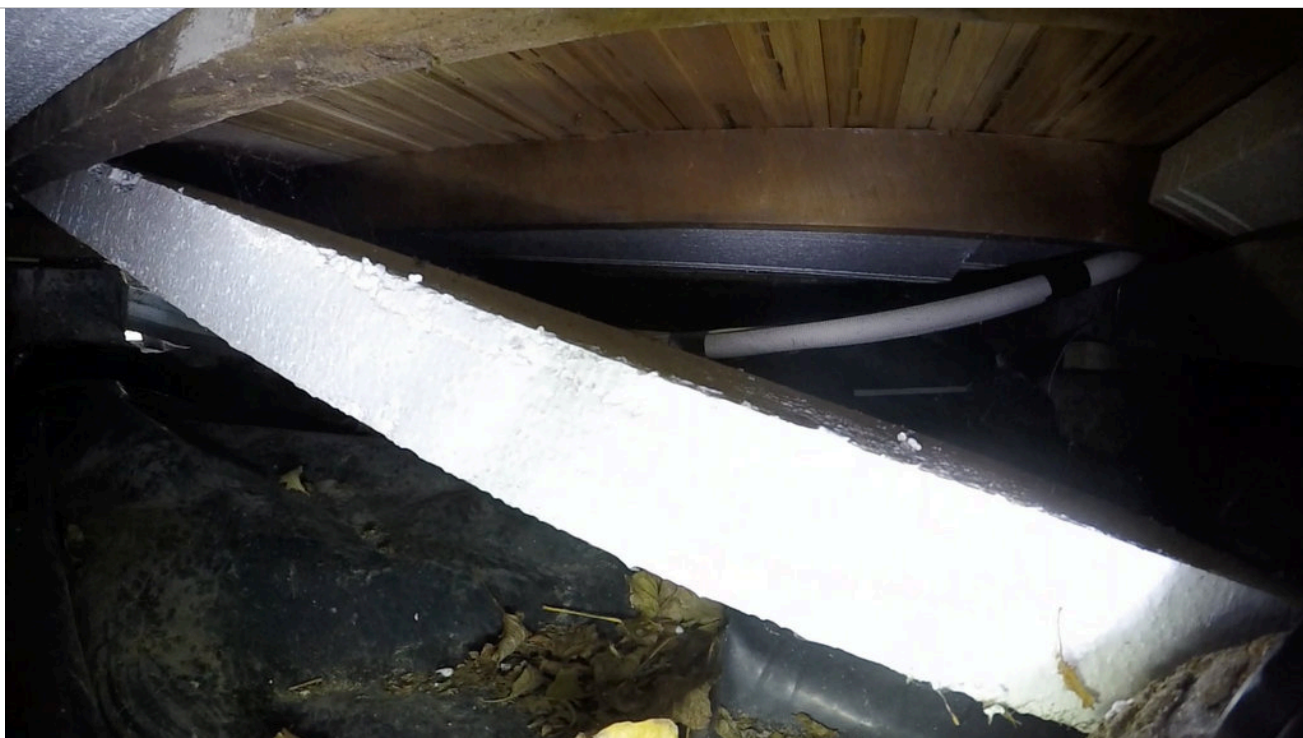
35: Pile with connection packer. The bearer appears to be rolling over.

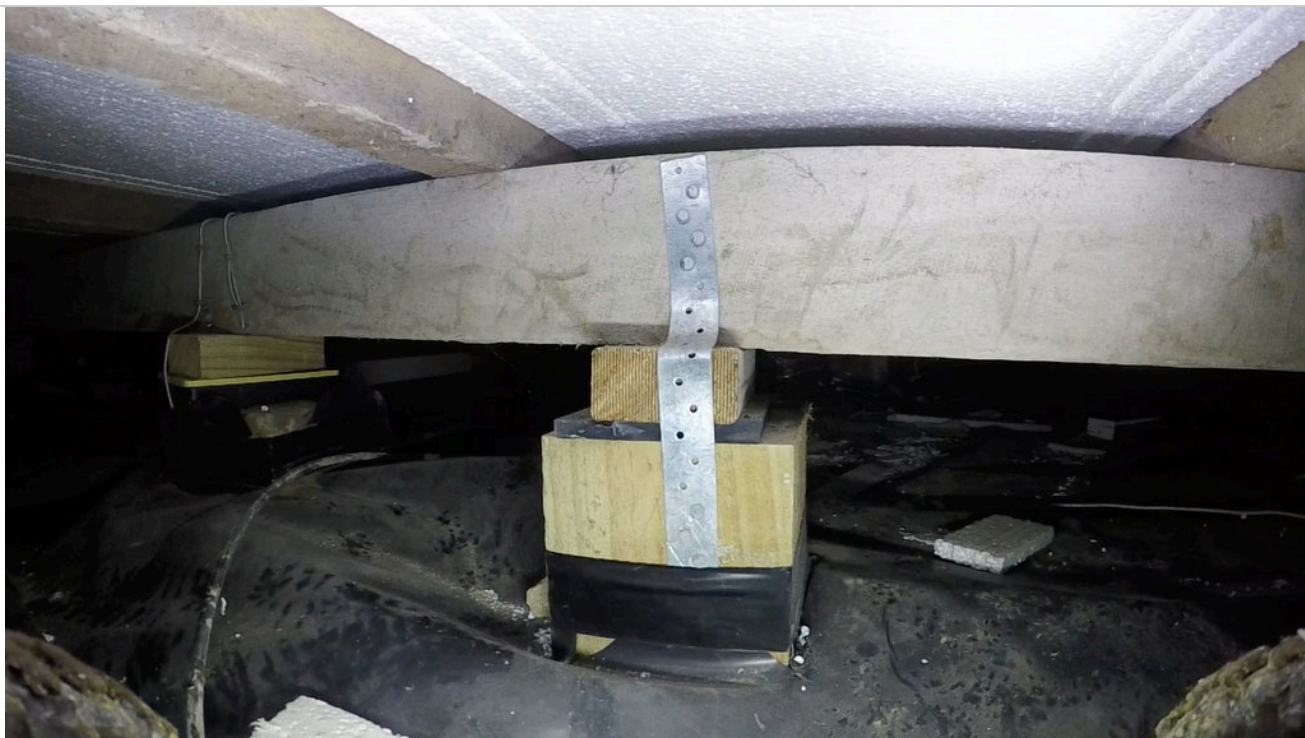
40: Pile with connection and non-compliant packers.

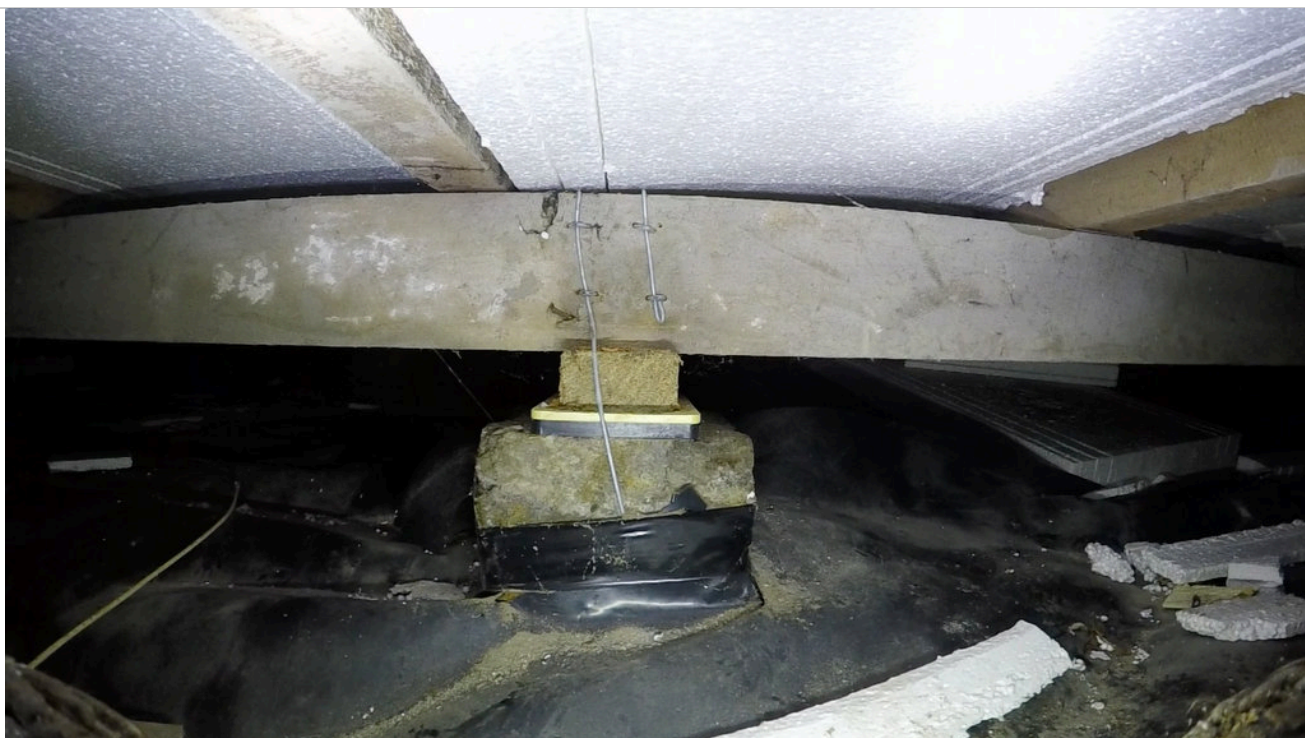
41: Here the packing used is not treated, there is no pile connection, no bearer connection and the bearer to the right has extensive borer. Note also that the joist to the left has been packed and has extensive borer.

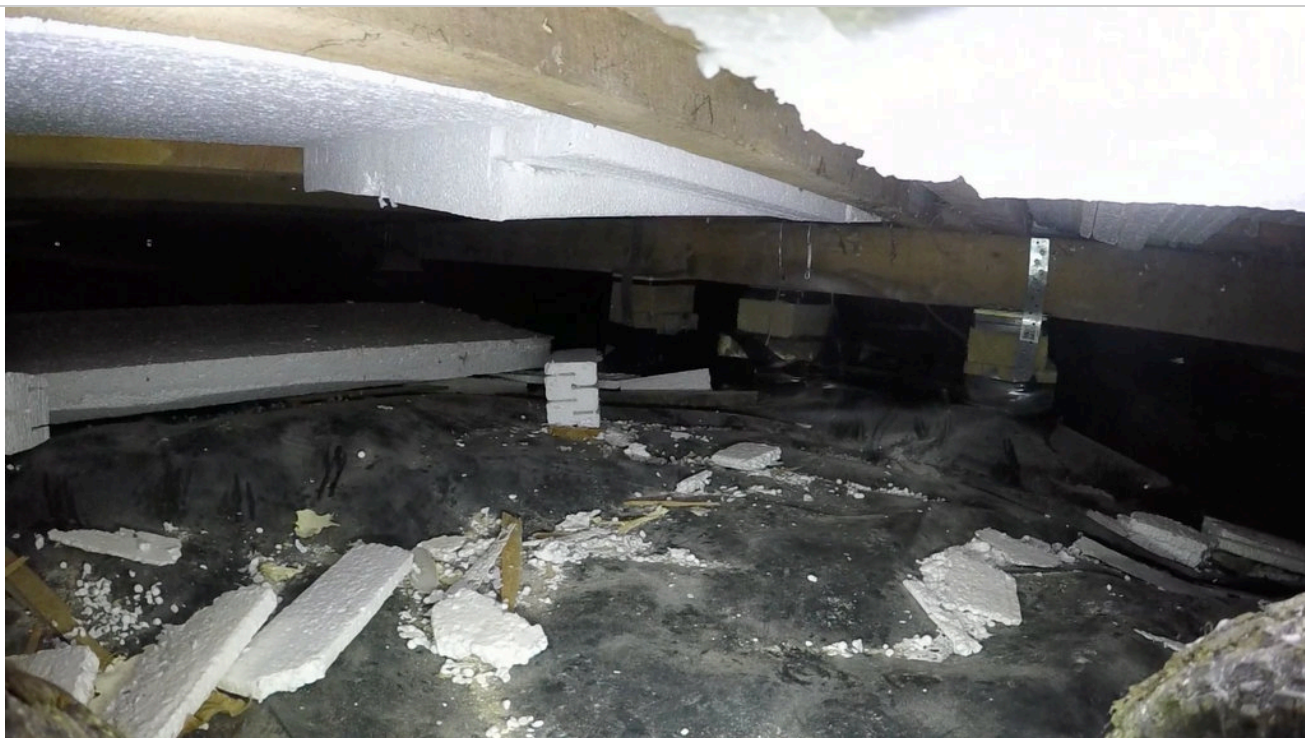
50: Pile with non-compliant connection mostly compliant packing.

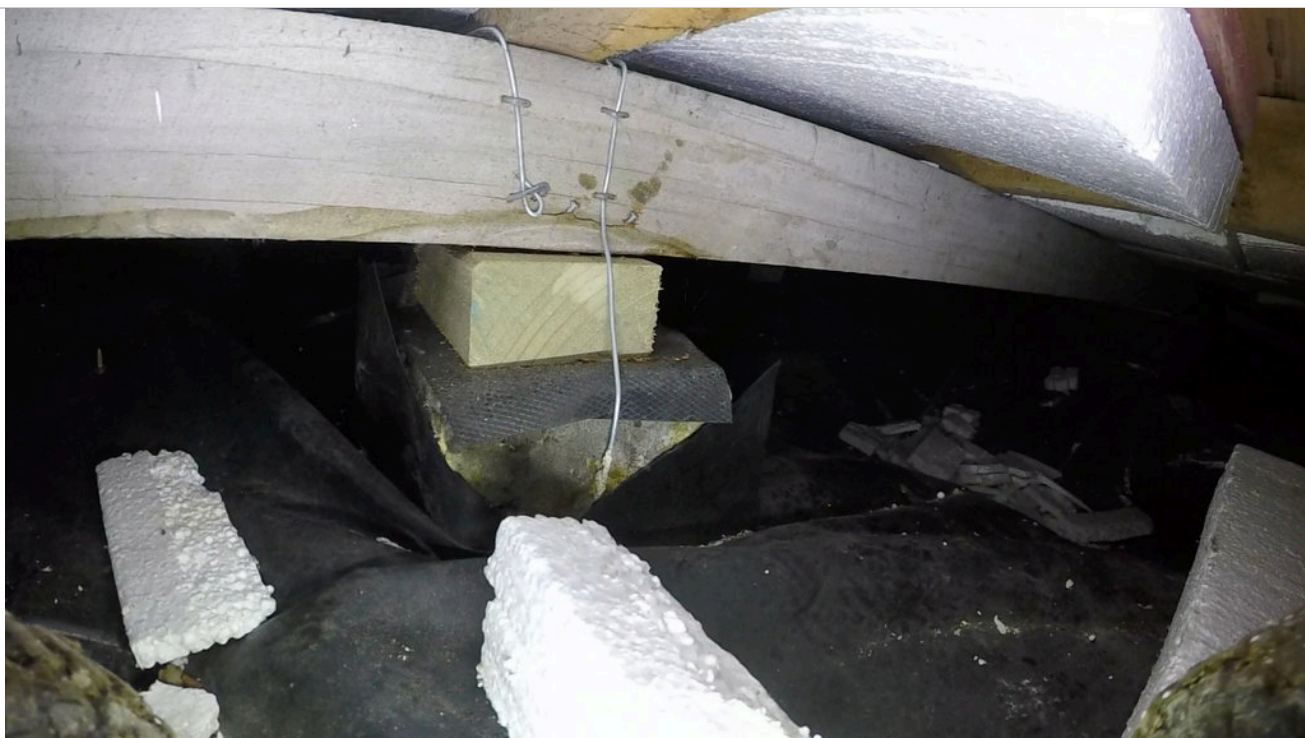
51: Pile with non-compliant connection and non-compliant packing.

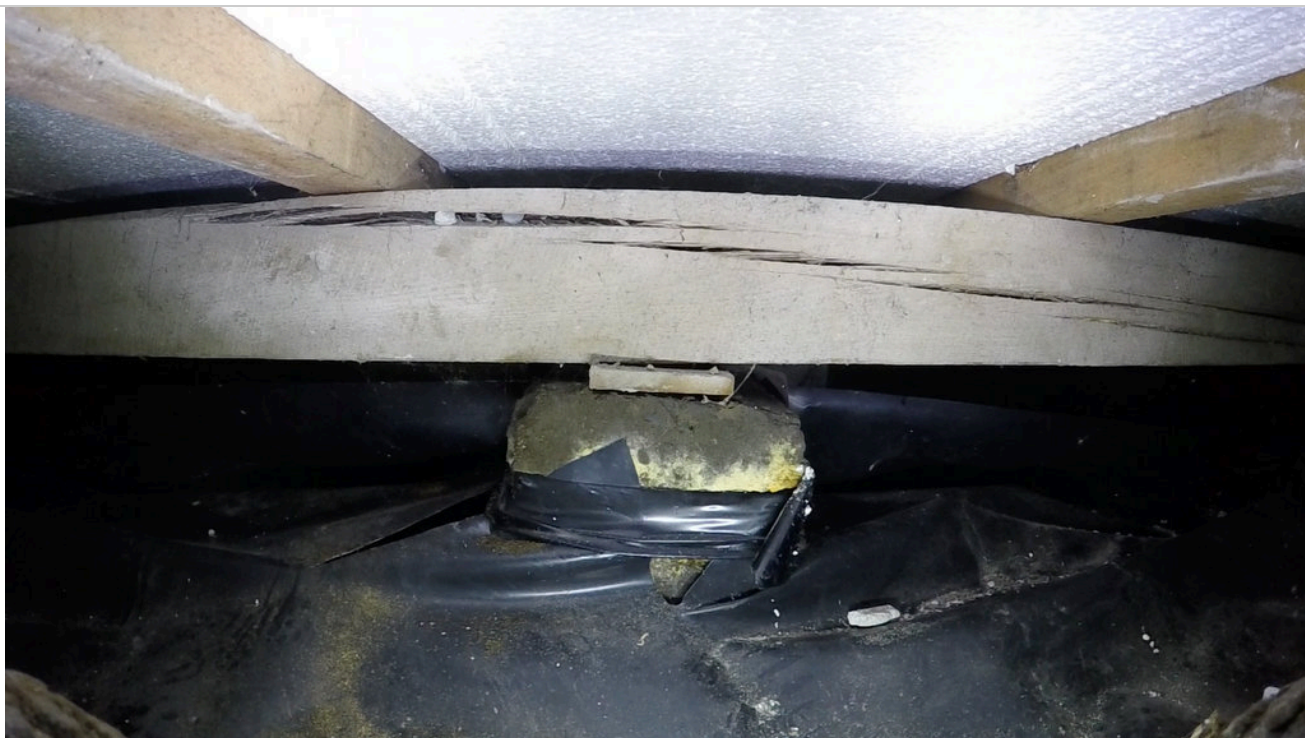
56: Pile with no connection and non-compliant packer.

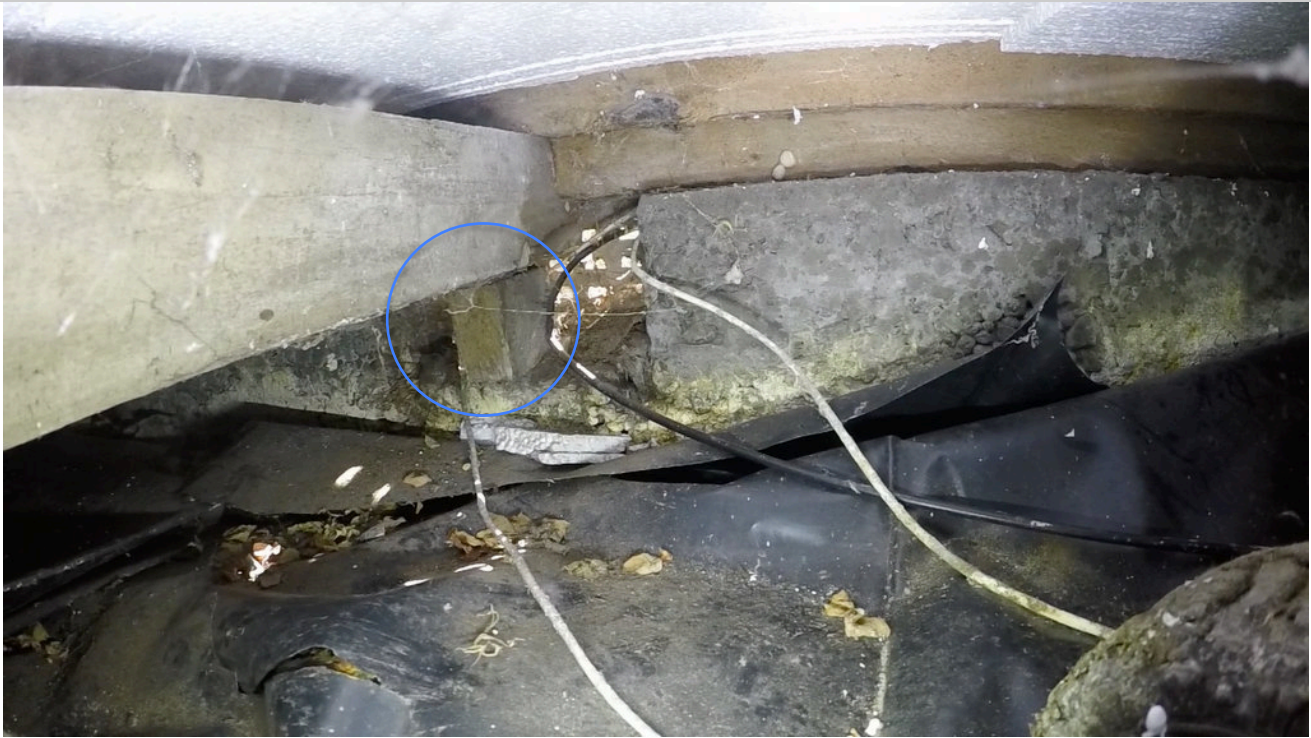
58: View of bearer meeting ring foundation. Note the cracked concrete. Also that the joist has significant borer.

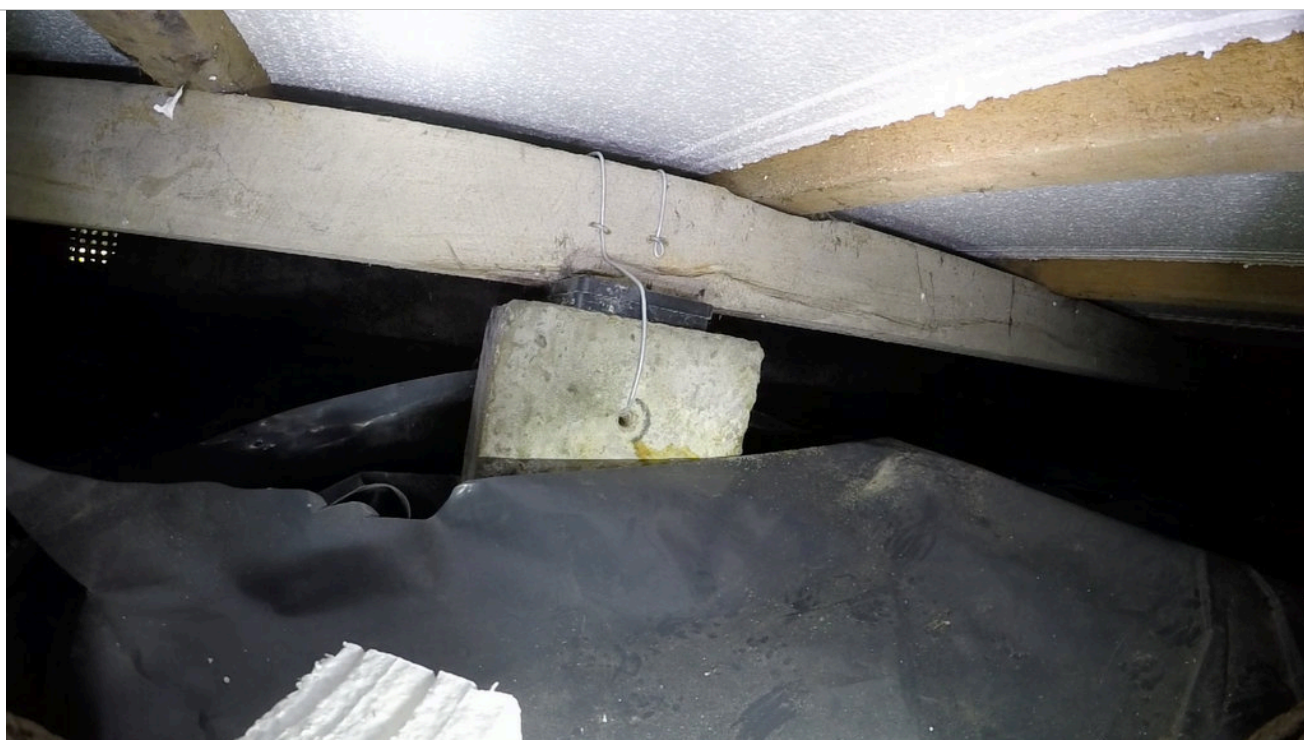
63: View of bearer meeting chimney breast.

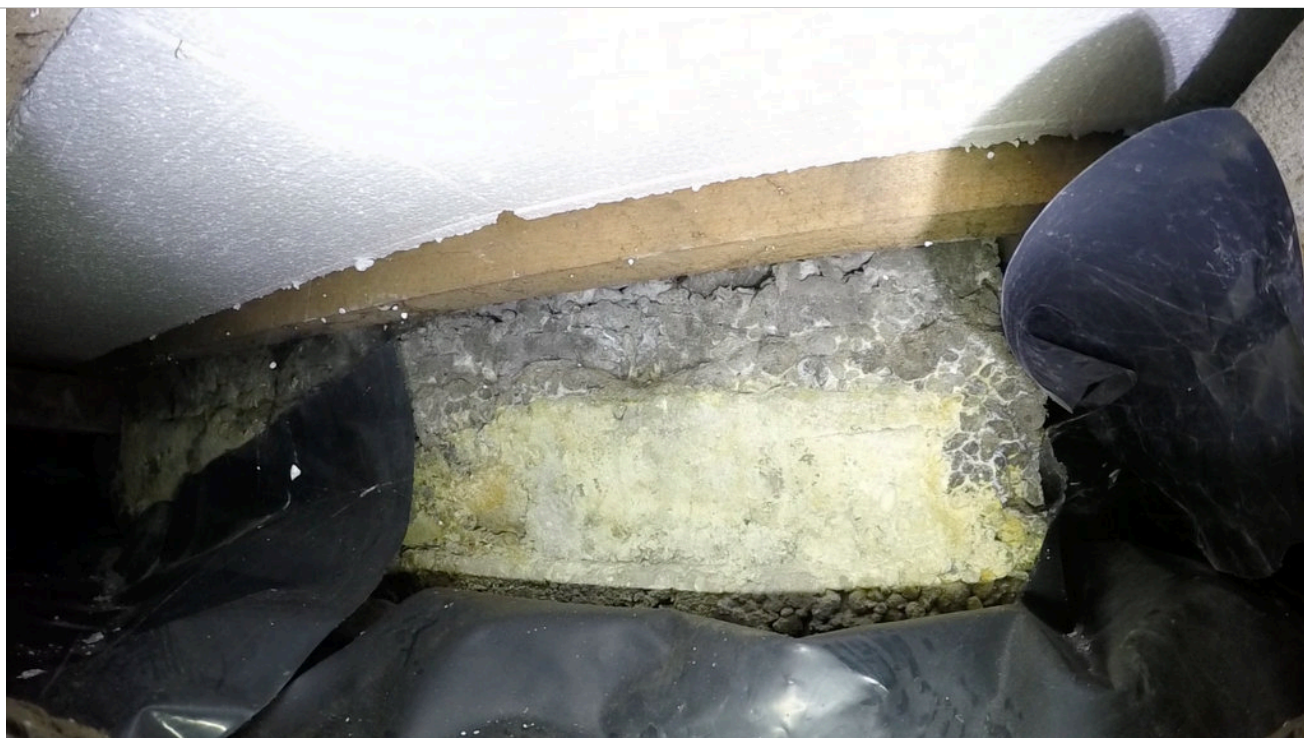
65: View of the chimney breast. It would appear that there has been some damage to the concrete around the bearer and a repair has taken place.

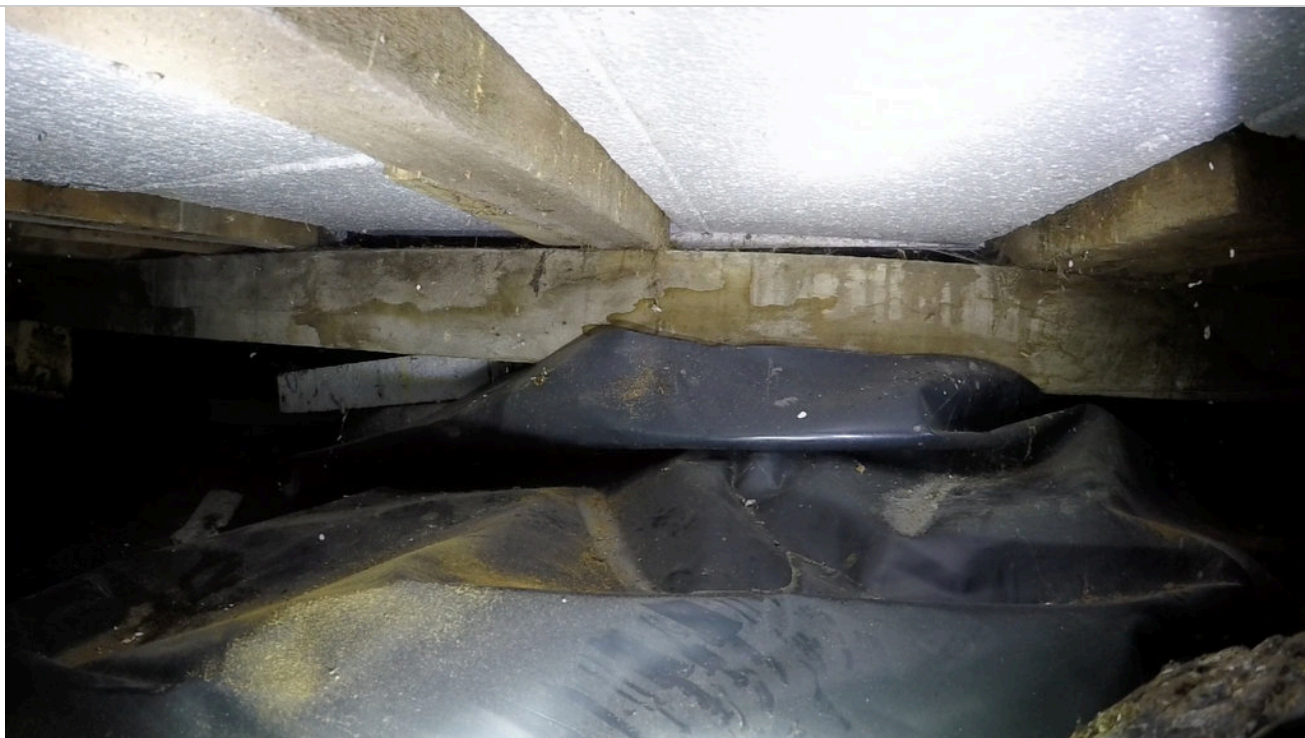
70: Pile with no connection and non-compliant packer. Note that the bearer join has moved out of line and is unsupported.

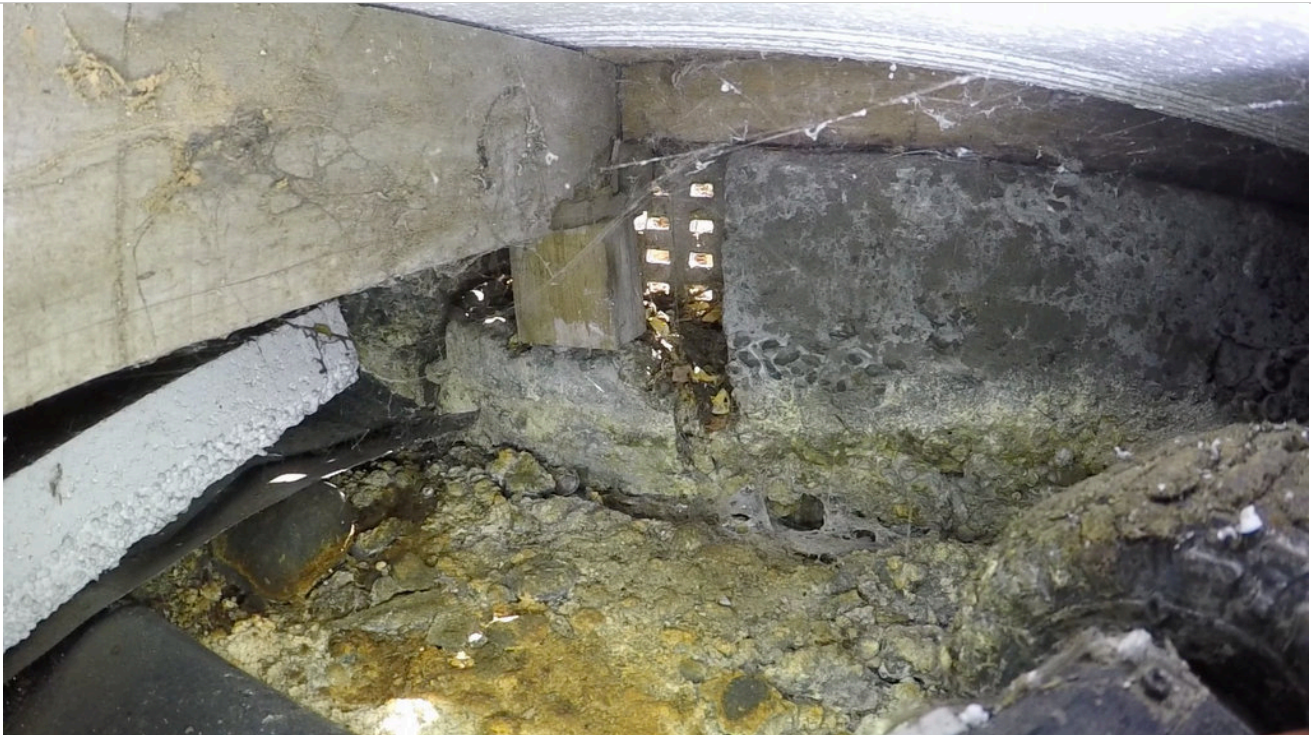
73: It appears that a concrete slab has been poured here but if so it is supported on untreated timber, which will soon rot. The timber is also supporting the joists.

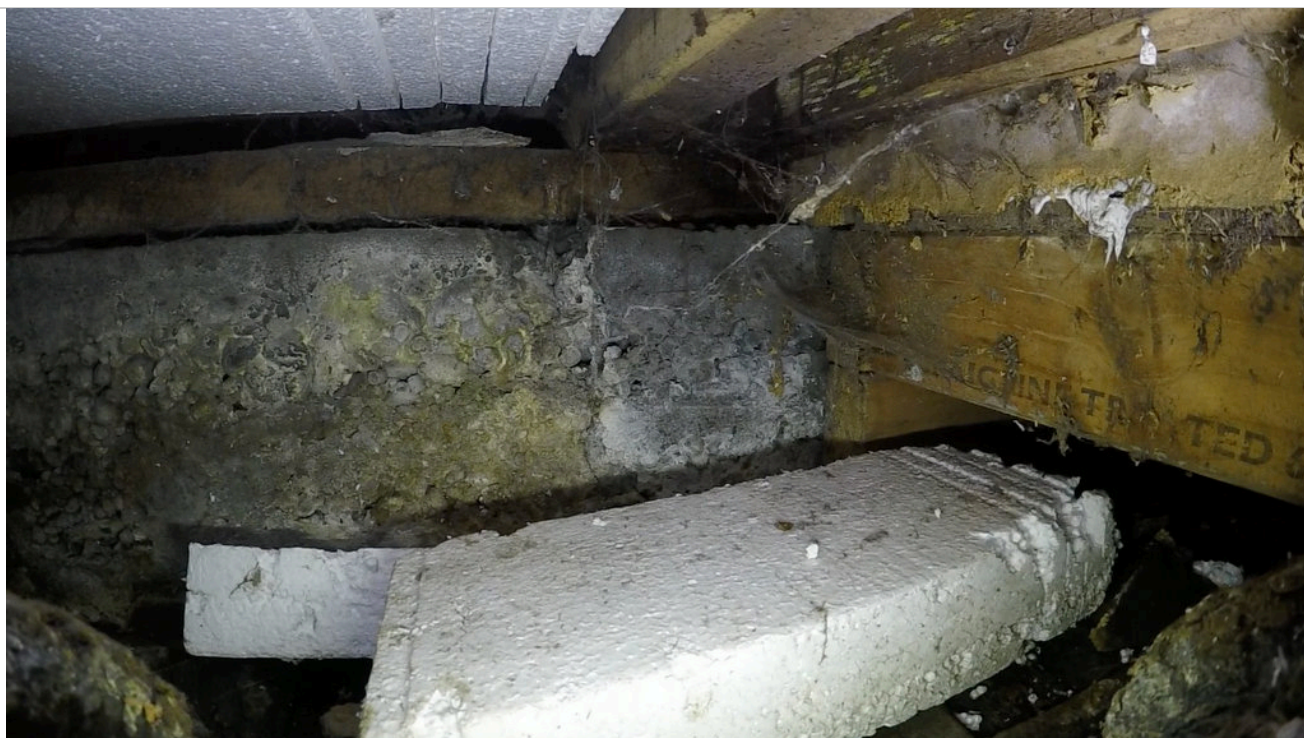
75: Here again see packing of the ring foundation plate but with scraps and no fixing bracket has been used.

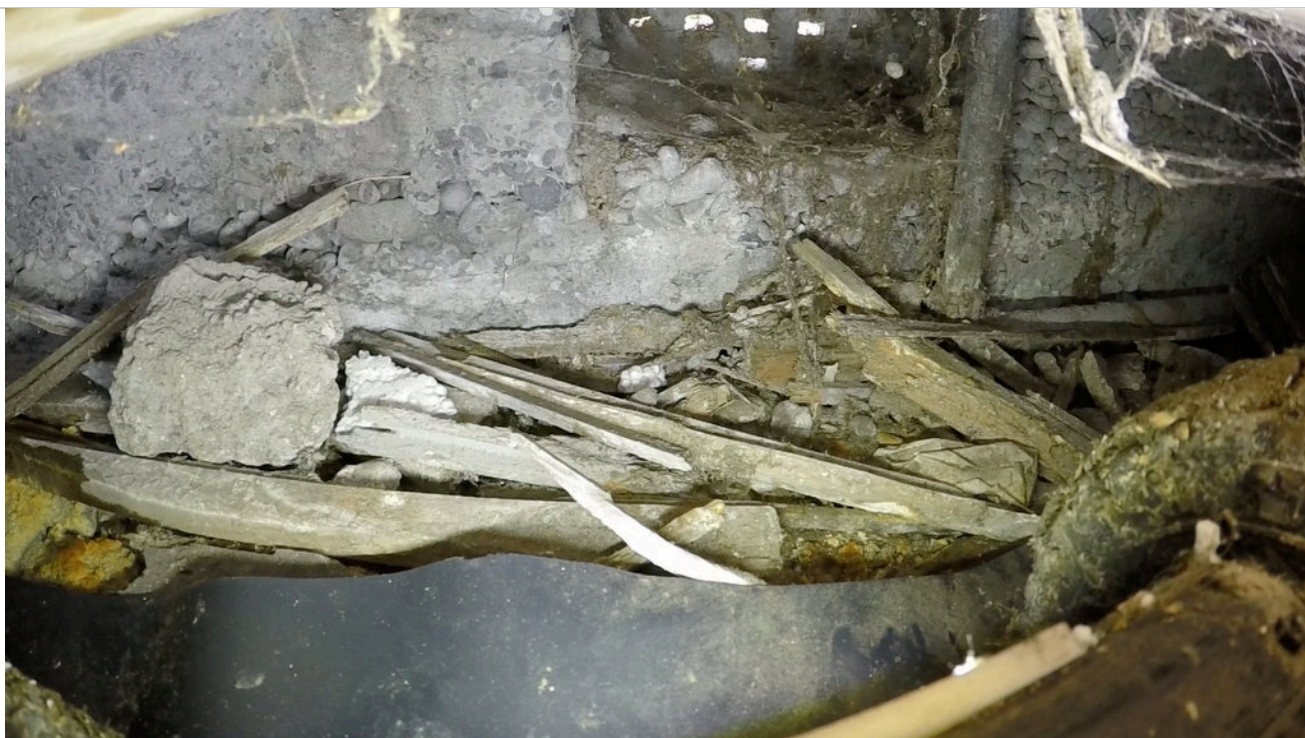
81: View of ring foundation and here we can see the cracking of the foundation around the bricks.
